Contract #: 04-0120F4Cty: SF/ALA Rte: 80 PM: 13.2/13.9File #: 1.28**WELDING INSPECTION REPORT****Resident Engineer:** Siegenthaler, Peter**Address:** 333 Burma Road**City:** Oakland, CA 94607**Report No:** WIR-025187**Date Inspected:** 16-Jul-2011**Project Name:** SAS Superstructure**OSM Arrival Time:** 700**Prime Contractor:** American Bridge/Fluor Enterprises, a JV**OSM Departure Time:** 1530**Contractor:** American Bridge/Fluor Enterprises, a JV**Location:** Job Site

Bridge No: 34-0006**Component:** SAS Tower**Summary of Items Observed:**

At Tower Base Elevation 13Meters Shear Plate Electro Slag Welding (ESW);

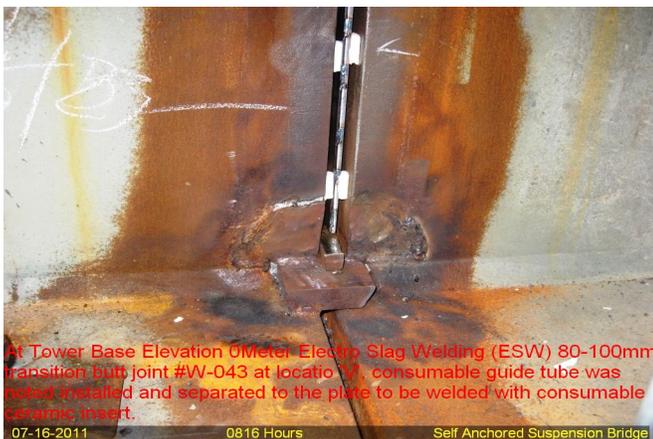
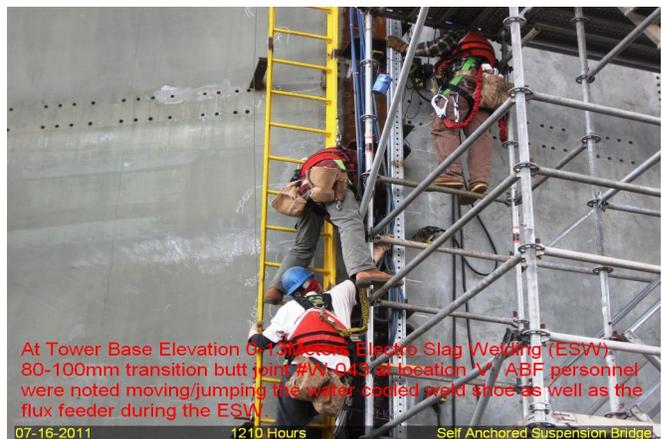
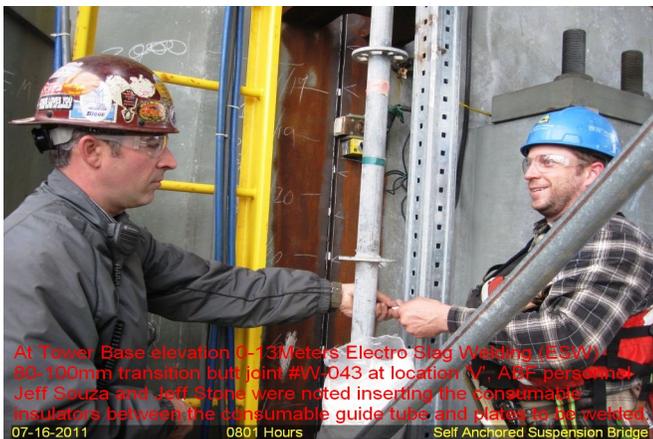
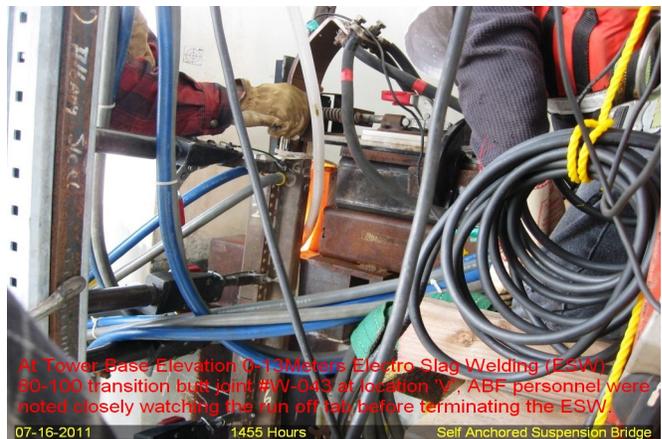
This QA was present at the Tower Base to observe the Electro Slag Welding of the weld number W-043 located at 'V' position per ABF weld map. The weld joint to be welded is an 80-100mm transition butt joint at corner 'B' and 'C' of Tower West Shaft. ABF intends to implement Caltrans approved welding procedure ABF-WPS-ESW-80-100TR in performing the ESW.

Upon QA's arrival, ABF personnel were noted preparing to weld the shear plate butt joint by checking all the necessary electrical and water hose weld shoe cooling connections are all in place prior to commence ESW. It was noted that three weld shoes were in position at each opposing side of the joint and so with the consumable guide tube that was placed in between the joint gap which was separated by consumable ceramic insulators. Other ABF personnel that were noted assisting the preparation of the ESW include ABF Production Manager John Callaghan and ABF Senior Field Engineer Daniel Hester.

The fit up alignment was previously checked by ABF QC Jesse Cayabyab and this QA. The root gap was measured from bottom to top and the result noted was 19mm minimum and 25mm maximum which deemed in compliance to the WPS. The offset exceeded the maximum allowed on various locations from 4mm to 9mm and

this was brought to ABF and Caltrans for review.

Initial firing of the ESW has started at 0951 hours but this was considered false start due to one filler wire was not moving and got stuck somewhere inside the consumable guide tube. ABF personnel momentarily stopped the operation and fixed the filler wire issue. After fixing and checking the filler wire, ABF has re-started the ESW at 0956hours. This time, the firing of the ESW was successful and that both filler wires were moving and the welding parameters have stabilized. The ESW has continued without a hitch until the completion of the joint at around 1452 hours for a total of four (4) hours and fifty six (56) minutes welding time. Overall, the ESW was completed without any major issues during the operation and the surface profile of the completed transition butt joint appears satisfactory.
