Quality Assurance and Source Inspection

Contract #: 04-0120F4Cty: SF/ALA Rte: 80 PM: 13.2/13.9File #: 1.28**WELDING INSPECTION REPORT****Resident Engineer:** Siegenthaler, Peter**Address:** 333 Burma Road**City:** Oakland, CA 94607**Report No:** WIR-025212**Date Inspected:** 12-Jul-2011**Project Name:** SAS Superstructure**OSM Arrival Time:** 700**Prime Contractor:** American Bridge/Fluor Enterprises, a JV**OSM Departure Time:** 1730**Contractor:** American Bridge/Fluor Enterprises, a JV**Location:** Job Site**CWI Name:** See Below**CWI Present:** Yes No**Inspected CWI report:** Yes No N/A**Rod Oven in Use:** Yes No N/A**Electrode to specification:** Yes No N/A**Weld Procedures Followed:** Yes No N/A**Qualified Welders:** Yes No N/A**Verified Joint Fit-up:** Yes No N/A**Approved Drawings:** Yes No N/A**Approved WPS:** Yes No N/A**Delayed / Cancelled:** Yes No N/A**Bridge No:** 34-0006**Component:** Orthotropic Box Girder**Summary of Items Observed:**

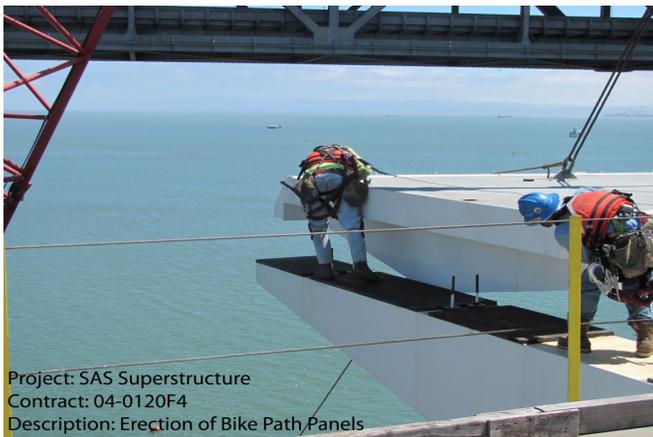
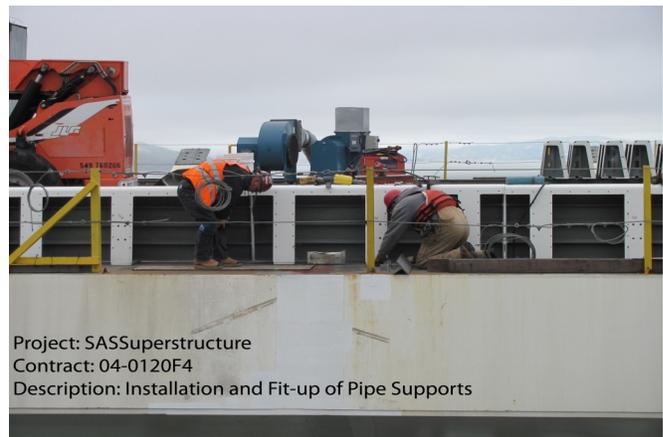
The QAI observed the CJP Welding of the 2.5" domestic water and 4.0" compressed air line systems field splices along gridline W5 at Orthotropic Box Girder (OBG) W1. The welding was performed by Rick Kiikvee ID-5319 utilizing the SMAW process as per the WPS identified as 1-12-1.

The QAI observed the CJP welding of the lifting lug holes located on the west orthotropic box girders identified as WN: 9E-PP88-E4-W2. The welding was performed by Mike Jiminez ID-4671 utilizing the WPS identified as ABF-WPS-D15-1050A-CU, Rev. 0. The QAI also observed the QC inspector perform the visual inspection and verify the welding parameters during the production welding. The inspections performed by Fred Von Hoff were observed by the QAI at random intervals and appeared to comply with the contract specifications. The CJP welding of the lifting lug hole was not completed during this scheduled shift.

The digital photographs below illustrate some of the work observed during this scheduled work date.
