Contract #: 04-0120F4Cty: SF/ALA Rte: 80 PM: 13.2/13.9File #: 1.28**WELDING INSPECTION REPORT****Resident Engineer:** Siegenthaler, Peter**Address:** 333 Burma Road**City:** Oakland, CA 94607**Report No:** WIR-025253**Date Inspected:** 20-Jul-2011**Project Name:** SAS Superstructure**OSM Arrival Time:** 700**Prime Contractor:** American Bridge/Fluor Enterprises, a JV**OSM Departure Time:** 1730**Contractor:** American Bridge/Fluor Enterprises, a JV**Location:** Job Site

WELDING INSPECTION REPORT

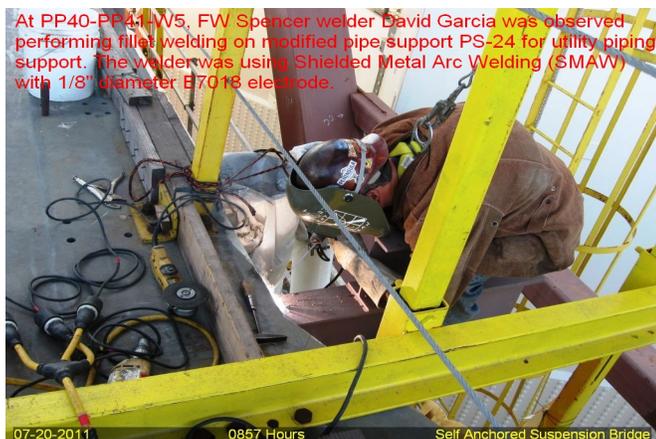
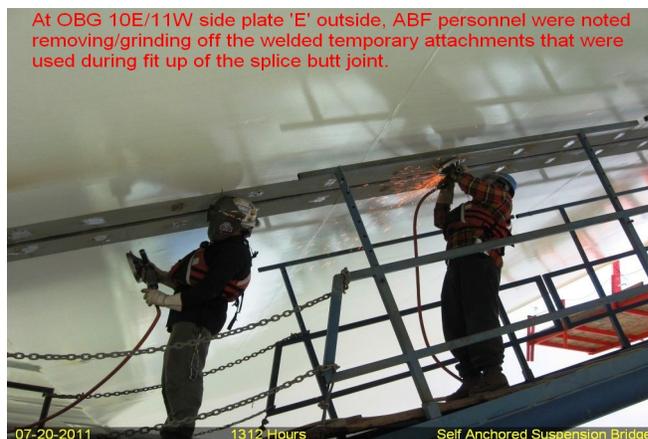
At location 6W-PP41 to PP44 gridline W5, this QA observed the fillet welding of the pipe supports identified as PS-24. The pipe support being installed is a modified PS-24 per Request for Information (RFI) ABF-RFI-002432R00. The modified support PS-24 beam W10x30 was 6mm fillet welded to the doubler plate welded to the OBG edge plate 'F'. QA randomly observed David Garcia perform all position fillet welding all around the W10x30 beam support to the welded doubler plate. The welder was noted using Shielded Metal Arc Welding (SMAW) with 1/8" diameter E7018H4R electrode. ABF QC Steve Jensen was noted monitoring the welder. At the end of the shift, the welder has completely welded two PS-24 supports to the doubler plate of the OBG edge plate 'F'.

At location 6W-PP41 to PP44 gridline E5, this QA observed the installation and fit-up of the pipe supports identified as PS-24. The pipe support being installed is a modified PS-24 per Request for Information (RFI) ABF-RFI-002432R00. The modified support PS-24 beam W10x30 was tack welded to the doubler plate welded to the OBG edge plate 'F'. QA randomly observed Rick Kickvee perform tack welding the W10x30 beam support to the welded doubler plate. The welder was noted using Shielded Metal Arc Welding (SMAW) with 1/8" diameter E7018H4R electrode. ABF QC Steve Jensen was noted monitoring the welder. At the end of the shift, the welder has completely tack welded two PS-24 supports to the doubler plate of the OBG edge plate 'F'.
