Quality Assurance and Source Inspection

Contract #: 04-0120F4Cty: SF/ALA Rte: 80 PM: 13.2/13.9File #: 99.28**WELDING INSPECTION REPORT****Resident Engineer:** Siegenthaler, Peter**Address:** 333 Burma Road**City:** Oakland, CA 94607**Report No:** WIR-025283**Date Inspected:** 22-Jul-2011**Project Name:** SAS Superstructure**OSM Arrival Time:** 700**Prime Contractor:** American Bridge/Fluor Enterprises, a JV**OSM Departure Time:** 1900**Contractor:** Zhenhua Port Machinery Company, Ltd (ZPMC), Changxing Island **Location:** Shanghai**CWI Name:****CWI Present:****Yes No****Inspected CWI report:** Yes No N/A**Rod Oven in Use:****Yes No N/A****Electrode to specification:** Yes No N/A**Weld Procedures Followed:****Yes No N/A****Qualified Welders:** Yes No N/A**Verified Joint Fit-up:****Yes No N/A****Approved Drawings:** Yes No N/A**Approved WPS:****Yes No N/A****Delayed / Cancelled:****Yes No N/A****Bridge No:** 34-0006**Component:** OBG**Summary of Items Observed:**

Trial Assembly 13W

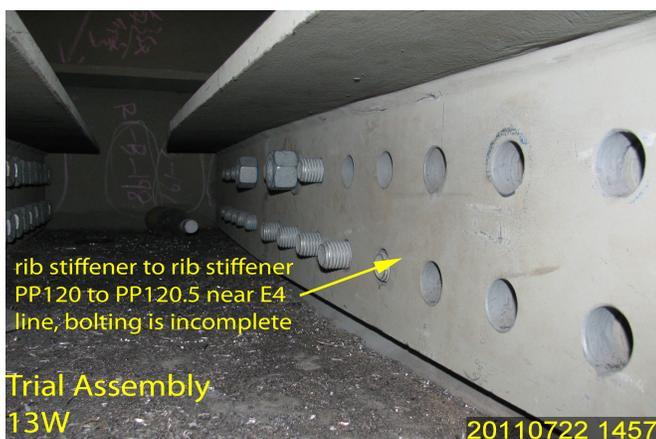
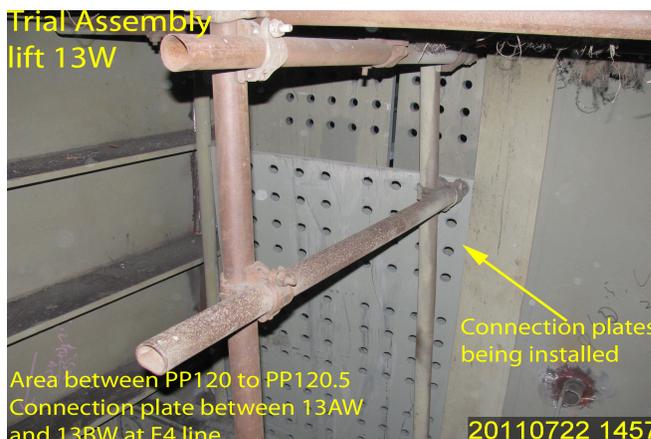
This QA Inspector witnessed the in-process high strength bolt installation on bolts connecting the following connections:

- Vertical connection plates connecting longitudinal diaphragm to longitudinal diaphragm at W3 & W4 at PP120 to PP120.5 and PP122 to PP122.5.
- Horizontal connection plates connecting longitudinal diaphragm to deck panels at W3 and W4 lines between PP120 and PP124.5.

Bolting on the above named areas is in progress and still requires final tension verification prior to final acceptance. The QA Inspector verified installation of the high strength bolts on a random basis and the results appeared to be in general compliance.
