Contract #: 04-0120F4Cty: SF/ALA Rte: 80 PM: 13.2/13.9File #: 1.28**WELDING INSPECTION REPORT****Resident Engineer:** Siegenthaler, Peter**Address:** 333 Burma Road**City:** Oakland, CA 94607**Report No:** WIR-025351**Date Inspected:** 25-Jul-2011**Project Name:** SAS Superstructure**OSM Arrival Time:** 700**Prime Contractor:** American Bridge/Fluor Enterprises, a JV**OSM Departure Time:** 1530**Contractor:** American Bridge/Fluor Enterprises, a JV**Location:** Job Site**CWI Name:** Tony Sherwood**CWI Present:** Yes No**Inspected CWI report:** Yes No N/A**Rod Oven in Use:** Yes No N/A**Electrode to specification:** Yes No N/A**Weld Procedures Followed:** Yes No N/A**Qualified Welders:** Yes No N/A**Verified Joint Fit-up:** Yes No N/A**Approved Drawings:** Yes No N/A**Approved WPS:** Yes No N/A**Delayed / Cancelled:** Yes No N/A**Bridge No:** 34-0006**Component:** OBG Sections**Summary of Items Observed:**

WELDING INSPECTION REPORT

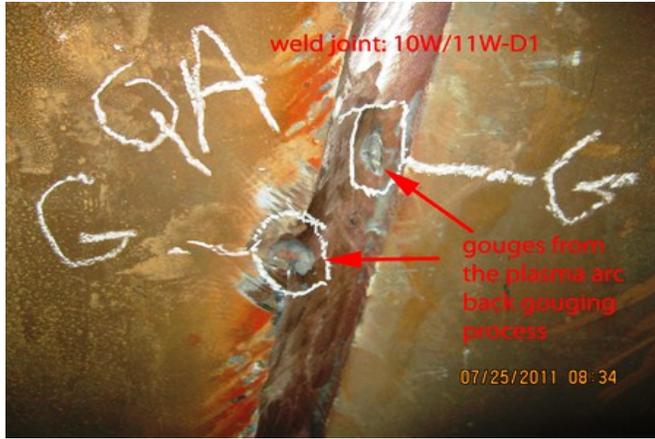
10W/11W-D1: While observing the work at the location above this QA Inspector observed gouges in the back gouged area of the weld which lead into the base material. The gouges were each approximately 25 mm in length and several mm's deep. They appeared to have been caused by the plasma arc torch used in the back gouging process. This QA Inspector asked QC Inspector Tony Sherwood if the visual and Magnetic Particle Testing (MT) had been performed on the back gouged weld joint. QC Inspector Tony Sherwood stated he not aware of the statues of the work and this QA Inspector did not observe any paint markings indicating the MT had been performed. This QA Inspector circled each of the areas with a soapstone marker. See photo of gouged areas below.
