DEPARTMENT OF TRANSPORTATION

Quality Assurance and Source Inspection

Contract #: 04-0120F4Cty: SF/ALA Rte: 80 PM: 13.2/13.9File #: 1x.28**WELDING INSPECTION REPORT****Resident Engineer:** Siegenthaler, Peter**Address:** 333 Burma Road**City:** Oakland, CA 94607**Report No:** WIR-025360**Date Inspected:** 27-Jul-2011**Project Name:** SAS Superstructure**OSM Arrival Time:** 700**Prime Contractor:** American Bridge/Fluor Enterprises, a JV**OSM Departure Time:** 1530**Contractor:** American Bridge/Fluor Enterprises, a JV**Location:** Job Site**CWI Name:** William Sherwood**CWI Present:** Yes No**Inspected CWI report:** Yes No N/A**Rod Oven in Use:** Yes No N/A**Electrode to specification:** Yes No N/A**Weld Procedures Followed:** Yes No N/A**Qualified Welders:** Yes No N/A**Verified Joint Fit-up:** Yes No N/A**Approved Drawings:** Yes No N/A**Approved WPS:** Yes No N/A**Delayed / Cancelled:** Yes No N/A**Bridge No:** 34-0006**Component:** OBG Components**Summary of Items Observed:**

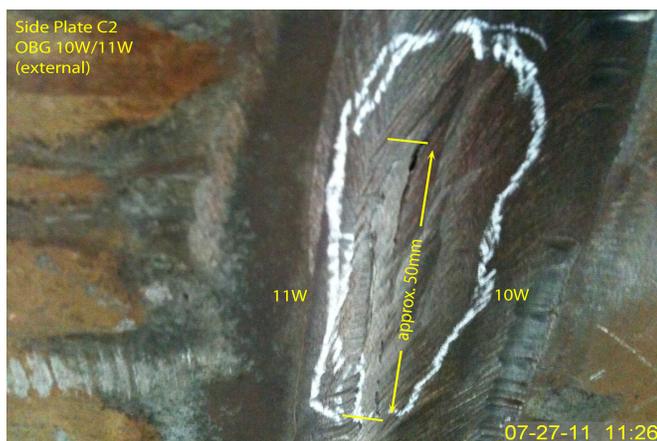
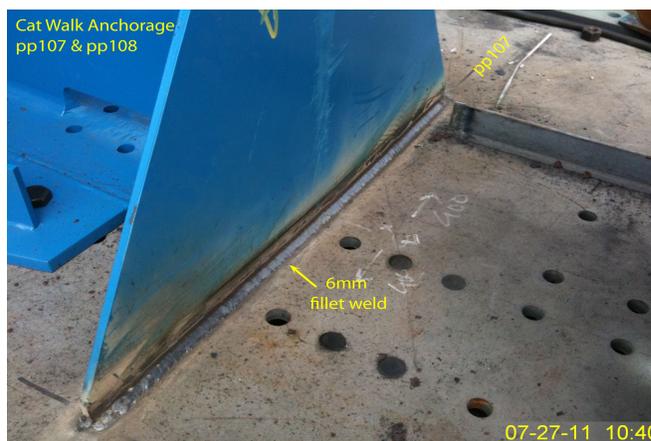
-During random visual inspection this QA inspector observed three (3) individual locations where slag inclusions could be seen in the weld groove prior to Mr. Zhen starting the weld procedure. Mr. Zhen employed an angle grinder to remove these inclusions before welding was initiated.

A photograph representing these inclusions is attached to this report.
