**DEPARTMENT OF TRANSPORTATION**

Quality Assurance and Source Inspection

Contract #: 04-0120F4Cty: SF/ALA Rte: 80 PM: 13.2/13.9File #: 82.28**WELDING INSPECTION REPORT****Resident Engineer:** Siegenthaler, Peter**Address:** 333 Burma Road**City:** Oakland, CA 94607**Report No:** WIR-025411**Date Inspected:** 19-Jul-2011**Project Name:** SAS Superstructure**OSM Arrival Time:** 630**Prime Contractor:** American Bridge/Fluor Enterprises, a JV**OSM Departure Time:** 1500**Contractor:** Westmont Industries**Location:** Santa Fe Springs, CA**CWI Name:** Ruben Dominguez**CWI Present:** Yes No**Inspected CWI report:** Yes No N/A**Rod Oven in Use:** Yes No N/A**Electrode to specification:** Yes No N/A**Weld Procedures Followed:** Yes No N/A**Qualified Welders:** Yes No N/A**Verified Joint Fit-up:** Yes No N/A**Approved Drawings:** Yes No N/A**Approved WPS:** Yes No N/A**Delayed / Cancelled:** Yes No N/A**Bridge No:** 34-0006 L & R**Component:** Maintenance Travelers**Summary of Items Observed:**

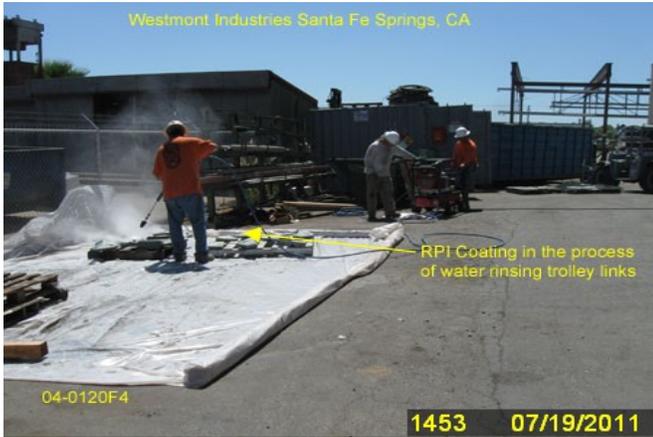
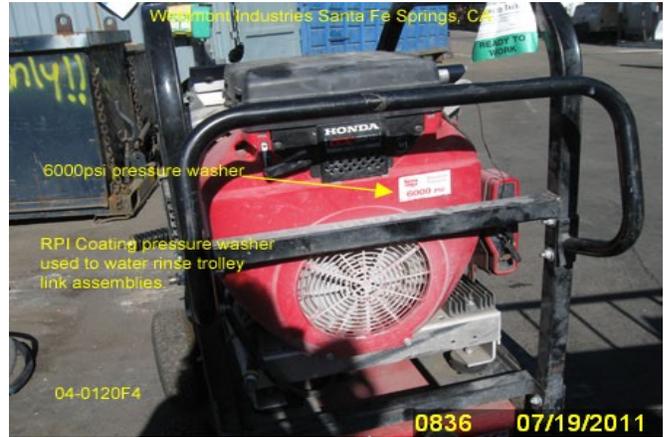
This QA Inspector randomly observed RPI Coating personnel sanding dry spray or overspray on Trolley links that were prime coated 7-13-11 using scotch brite heavy duty. After sanding was completed QA Inspector observed RPI Coating personnel water rinsing trolley links with a minimum pressure of 35Mpa/5,077 PSI pressure washer. After rinsing was completed RPI moved the components inside Bay 6.

Note: The above mentioned Trolley Link Assemblies had been previously abrasive blasted and primed coated and was determined by Sherman Williams Representative Mr. Eric Anderson, RPI Coating Mr. Gary McDonald and RPI Coating Mr. Carlos Torres that RPI Coating had greatly exceeded the 3.4 mils to 5.9 mils for prime coating

requirements and made the decision to re-blast and re-prime Suspension Arms and Trolley Link Assemblies. RPI Coating Mr. Gary McDonald and RPI Coating Mr. Carlos Torres will also reevaluate the E2/E3 EB Traveler prime coating thickness at a later date.
