DEPARTMENT OF TRANSPORTATION

Quality Assurance and Source Inspection

Contract #: 04-0120F4Cty: SF/ALA Rte: 80 PM: 13.2/13.9File #: 82.28**WELDING INSPECTION REPORT****Resident Engineer:** Siegenthaler, Peter**Address:** 333 Burma Road**City:** Oakland, CA 94607**Report No:** WIR-025413**Date Inspected:** 21-Jul-2011**Project Name:** SAS Superstructure**OSM Arrival Time:** 630**Prime Contractor:** American Bridge/Fluor Enterprises, a JV**OSM Departure Time:** 1630**Contractor:** Westmont Industries**Location:** Santa Fe Springs, CA**CWI Name:** Ruben Dominguez**CWI Present:** Yes No**Inspected CWI report:** Yes No N/A**Rod Oven in Use:** Yes No N/A**Electrode to specification:** Yes No N/A**Weld Procedures Followed:** Yes No N/A**Qualified Welders:** Yes No N/A**Verified Joint Fit-up:** Yes No N/A**Approved Drawings:** Yes No N/A**Approved WPS:** Yes No N/A**Delayed / Cancelled:** Yes No N/A**Bridge No:** 34-0006 L & R**Component:** Maintenance Travelers**Summary of Items Observed:**

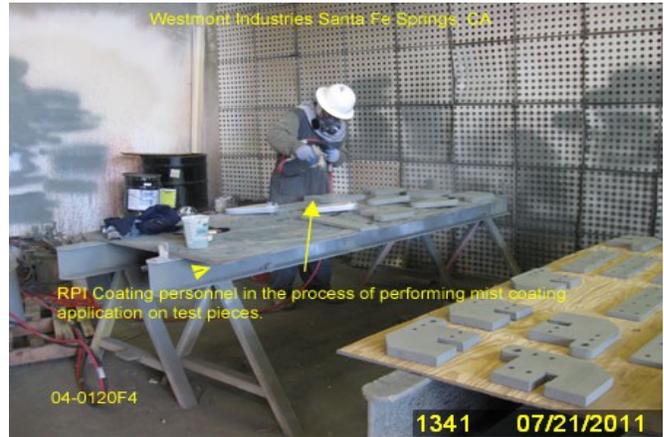
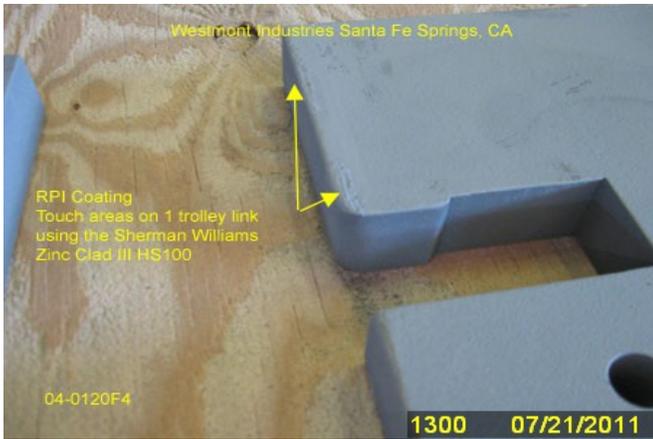
RPI Coating applied the Sherman Williams Polysiloxane XLE-80 Epoxy Siloxane using different methods; Final coating test are as follows:

2 test pieces - 1st - light mist coat, waited 30 minutes, 2nd – final coat – results – gassing occurred.

2 test pieces - 1st - light mist coat, waited 15 minutes 2nd coat heavier mist coat wait 15 minutes, 3rd – final coat – results – light out gassing occurred.

1 test piece - 1st - heavy mist coat, waited 30 minutes, 2nd – final coat – results – gassing occurred.

1 test piece - 1st - light mist coat (out gassing occurred), waited 15 minutes 2nd– final coat – results – no out gassing.

1 test piece - 1st - medium mist coat (out gassing occurred), waited 15 minutes 2nd– final coat – results – no out

gassing.
