**DEPARTMENT OF TRANSPORTATION**

Contract #: 04-0120F4Cty: SF/ALA Rte: 80 PM: 13.2/13.9File #: 82.28**WELDING INSPECTION REPORT****Resident Engineer:** Siegenthaler, Peter**Address:** 333 Burma Road**City:** Oakland, CA 94607**Report No:** WIR-025414**Date Inspected:** 22-Jul-2011**Project Name:** SAS Superstructure**OSM Arrival Time:** 630**Prime Contractor:** American Bridge/Fluor Enterprises, a JV**OSM Departure Time:** 1530**Contractor:** Westmont Industries**Location:** Santa Fe Springs, CA**CWI Name:** Christopher Concha**CWI Present:** Yes No**Inspected CWI report:** Yes No N/A**Rod Oven in Use:** Yes No N/A**Electrode to specification:** Yes No N/A**Weld Procedures Followed:** Yes No N/A**Qualified Welders:** Yes No N/A**Verified Joint Fit-up:** Yes No N/A**Approved Drawings:** Yes No N/A**Approved WPS:** Yes No N/A**Delayed / Cancelled:** Yes No N/A**Bridge No:** 34-0006 L & R**Component:** Maintenance Travelers**Summary of Items Observed:**

**SAS-WB Traveler – Lower Truss Frame Assembly**

**E2/E3-WB Traveler**

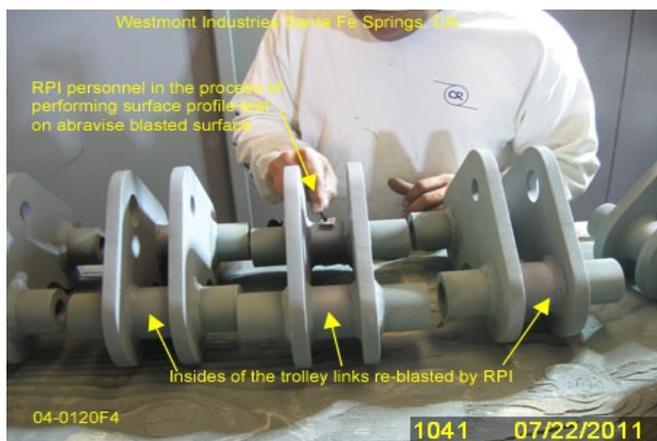
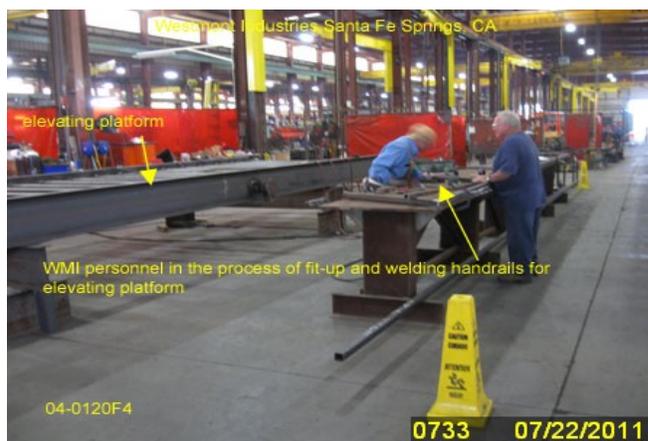
This QA Inspector randomly observed RPI Coating performing what appeared to be primer application activities within what appeared to be within and 8 hour time frame of the above mentioned blasting activities.

Environmental readings taken by RPI at the time of blast/primer application are as follows respectively: Air Temperature 70 F/77 F, Relative Humidity 57%/48%, Wet Bulb Temperature 61 F/63 F, Dew point 55 F/56 F and Surface Temperature 68 F/75 F.
