Contract #: 04-0120F4Cty: SF/ALA Rte: 80 PM: 13.2/13.9File #: 69.28**WELDING INSPECTION REPORT****Resident Engineer:**Siegenthaler, Peter**Address:** 333 Burma Road**City:** Oakland, CA 94607**Report No:** WIR-025603**Date Inspected:** 16-Jul-2011**Project Name:** SAS Superstructure**OSM Arrival Time:** 700**Prime Contractor:** American Bridge/Fluor Enterprises, a JV**OSM Departure Time:** 1900**Contractor:** Zhenhua Port Machinery Company, Ltd (ZPMC), Changxing Island **Location:** Shanghai, China**CWI Name:** Lu Hua Jie**CWI Present:** Yes No**Inspected CWI report:** Yes No N/A**Rod Oven in Use:** Yes No N/A**Electrode to specification:** Yes No N/A**Weld Procedures Followed:** Yes No N/A**Qualified Welders:** Yes No N/A**Verified Joint Fit-up:** Yes No N/A**Approved Drawings:** Yes No N/A**Approved WPS:** Yes No N/A**Delayed / Cancelled:** Yes No N/A**Bridge No:** 34-0006**Component:** OBG**Summary of Items Observed:**

OBG TA YARD, SEGMENT 14W

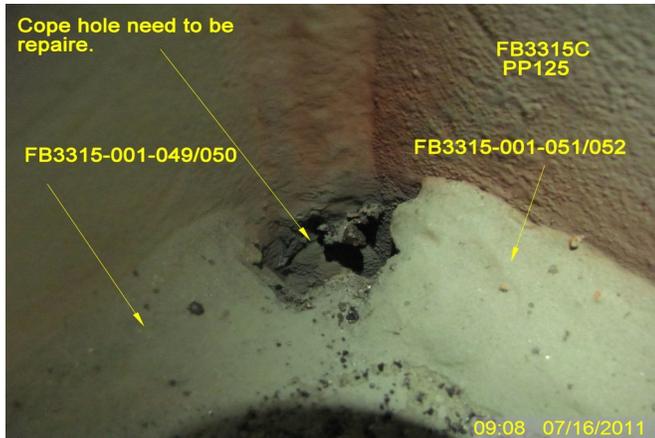
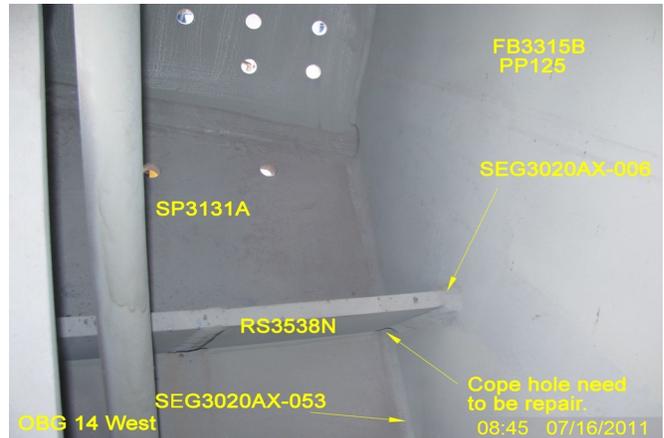
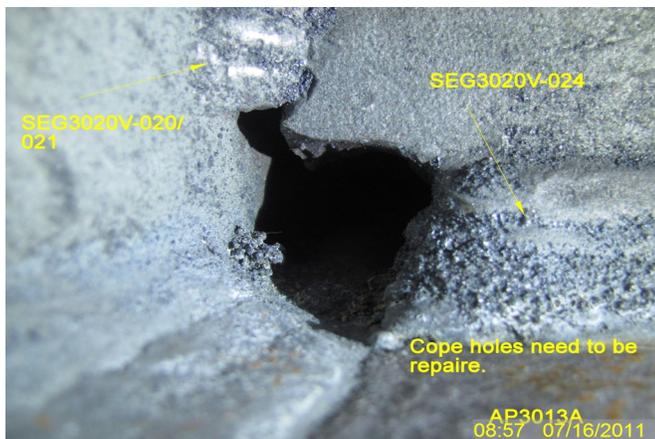
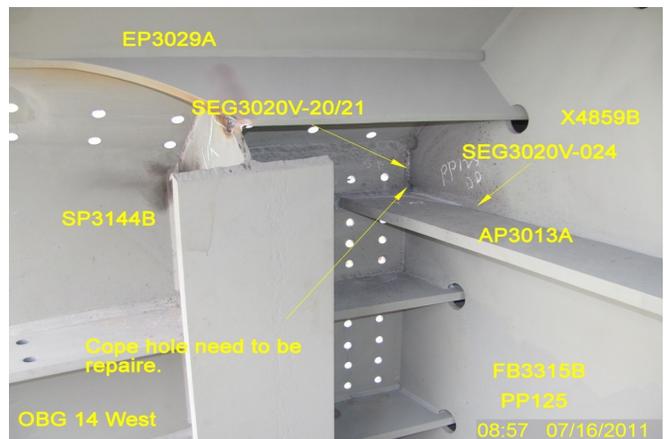
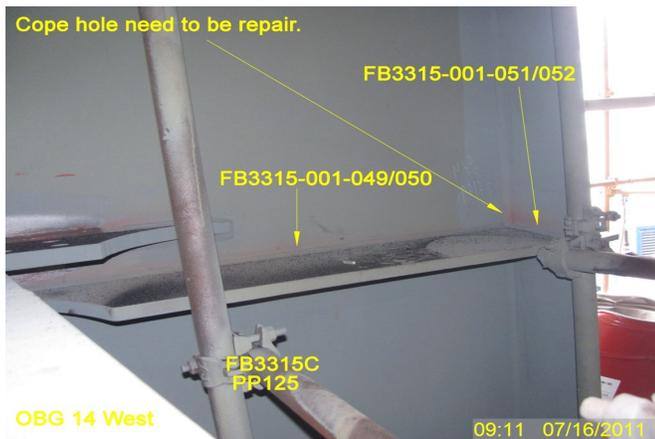
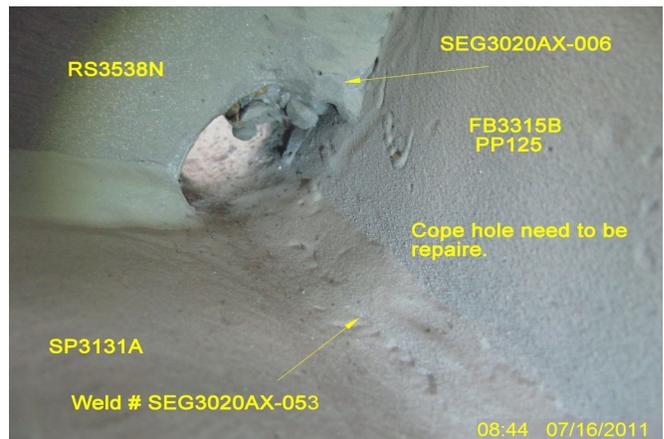
This QA Inspector performed random visual Inspection for verification of the cope holes in internal section of OBG 14 West on bike path side from panel point 125 to 126. During the verification this QA Inspector observed some cope holes are not acceptable that need to be repaired by grinding and welding. See attached photos for additional detail.
