Contract #: 04-0120F4Cty: SF/ALA Rte: 80 PM: 13.2/13.9File #: 69.28**WELDING INSPECTION REPORT****Resident Engineer:** Siegenthaler, Peter**Address:** 333 Burma Road**City:** Oakland, CA 94607**Report No:** WIR-025647**Date Inspected:** 29-Jul-2011**Project Name:** SAS Superstructure**OSM Arrival Time:** 1900**Prime Contractor:** American Bridge/Fluor Enterprises, a JV**OSM Departure Time:** 700**Contractor:** Zhenhua Port Machinery Company, Ltd (ZPMC), Changxing Island **Location:** Shanghai, China**CWI Name:** Mr. Li Ping**CWI Present:** Yes No**Inspected CWI report:** Yes No N/A**Rod Oven in Use:** Yes No N/A**Electrode to specification:** Yes No N/A**Weld Procedures Followed:** Yes No N/A**Qualified Welders:** Yes No N/A**Verified Joint Fit-up:** Yes No N/A**Approved Drawings:** Yes No N/A**Approved WPS:** Yes No N/A**Delayed / Cancelled:** Yes No N/A**Bridge No:** 34-0006**Component:** OBG**Summary of Items Observed:**

# WELDING INSPECTION REPORT

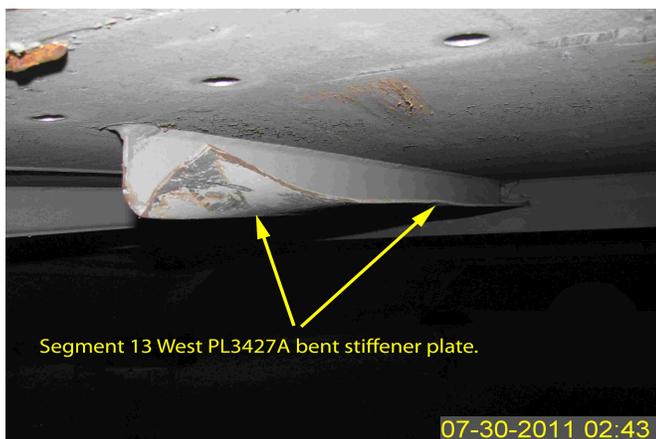
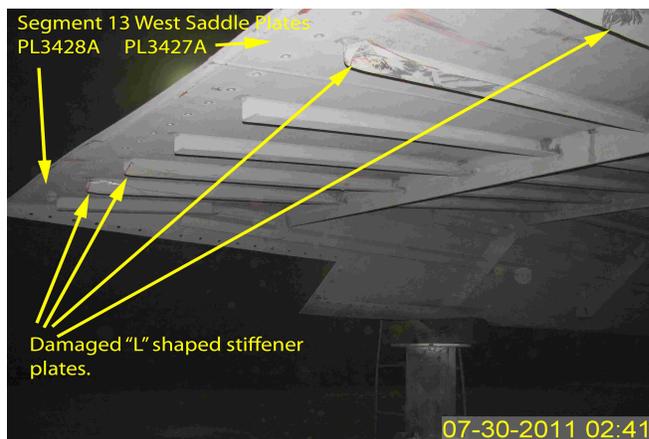
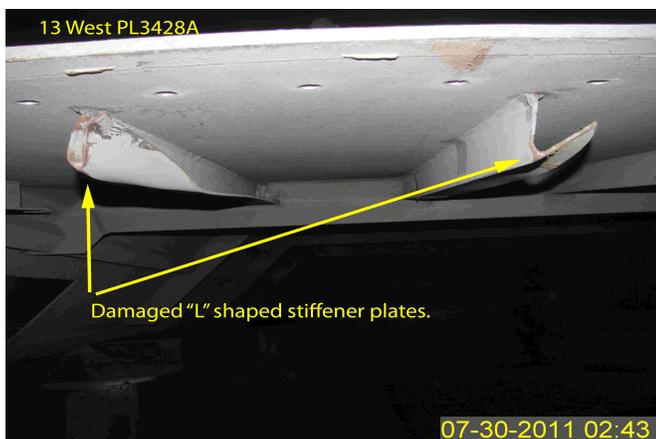
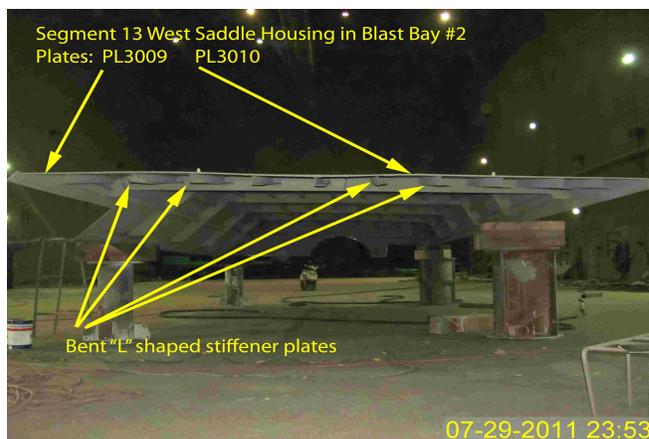
Caltrans QA Inspector Mr. Kenneth Cason informed this QA Inspector that ZPMC has placed OBG segment 13 West Saddle Housing plates PL3427A and PL3428A in blast bay #2 and that several of the “L” shaped stiffener plates appear to have been damaged during handling of this assembly. This QA Inspector visually observed several stiffener plates on the saddle housing have been bent out of shape and this QA Inspector issued an incident report to document this problem. See the description and photographs below for additional information.

- The saddle housing plates are shown on drawings SH3009 and SH3010.
- The “L” shape stiffeners are identified as X7548E.
- Four different “L” shaped stiffener plates have been damaged, two on PL3427A and two on PL3428A.
- These stiffeners are welded to plates PL3427A (SH3009) and PL3428A (SH3010)
- These materials are identified as Non-Seismic Performance Critical Members (SPCM).
- These materials are located in blast bay #2.
