Contract #: 04-0120F4Cty: SF/ALA Rte: 80 PM: 13.2/13.9File #: 1.28**WELDING INSPECTION REPORT****Resident Engineer:** Siegenthaler, Peter**Address:** 333 Burma Road**City:** Oakland, CA 94607**Report No:** WIR-025900**Date Inspected:** 09-Aug-2011**Project Name:** SAS Superstructure**OSM Arrival Time:** 700**Prime Contractor:** American Bridge/Fluor Enterprises, a JV**OSM Departure Time:** 1530**Contractor:** American Bridge/Fluor Enterprises, a JV**Location:** Jobsite

Bridge No: 34-0006**Component:** SAS OBG**Summary of Items Observed:**

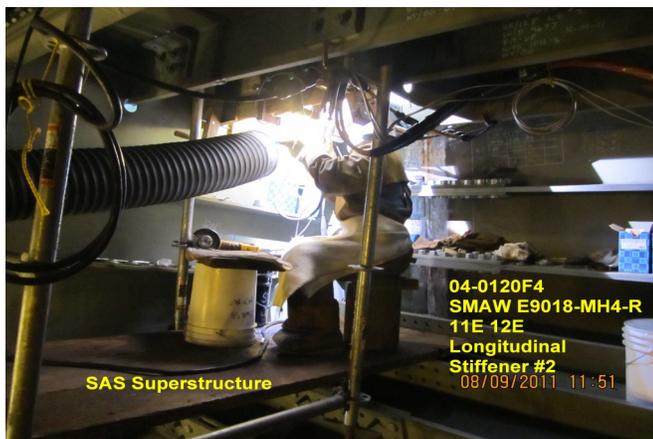
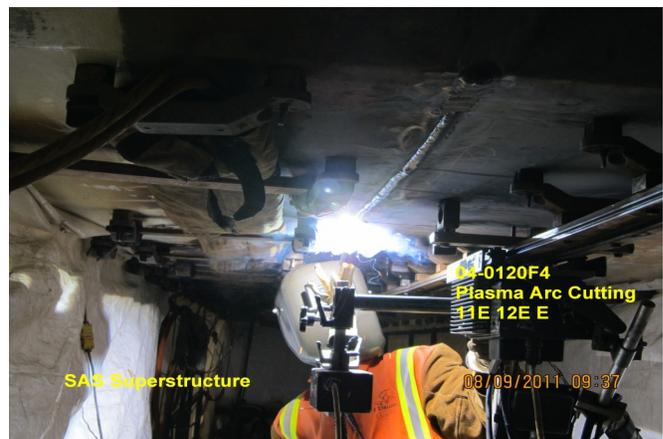
The QA inspector randomly observed ABF welding operator Fred Kaddu ID#2188 performing Plasma Arc Cutting (PAC) utilizing a "Bug-O" motorized rail system with a magnetic base attached in the overhead position to remove the backing bar from the underside of side plate E, at 11E 12E of the OBG.

The QA Inspector observed the operator adjust the equipment in order to make consecutive passes to remove the backing bar and back gouge the weld. The QA inspector made subsequent observations throughout the shift to monitor quality and noted that the removal of the backing bar was complete and the weld had been back gouged.

The QA inspector randomly observed ABF welding operators James Zhen ID#6001 and Jin Pei Wang ID#7299 performing Flux Core Arc Welding with gas (FCAW/g) utilizing a “Bug-O” motorized rail system with a magnetic base attached in the 4G overhead position on the underside of side plate C, at 11E 12E of the OBG. The QA inspector observed the QC inspector identified as Steve Jensen monitoring the progress to ensure the welding parameters were in compliance pertaining to ABF-WPS-D15-3042B-1. The parameters were recorded as (A=240/V=22/TS=300/HI=1.06). The QA inspector made subsequent observations throughout the shift to monitor quality and noted that the work is in progress and appears to be in general conformance to the contract requirements.

The QA inspector observed ABF welder Xiao Jian Wan ID#9677 performing Shielded Metal Arc Welding (SMAW) in the 3G vertical position on Longitudinal Stiffener (LS)#2 located at 11E 12E in the interior of the OBG. The QA inspector noted the use of an electrode oven at the required temperature for the E9018-MH4-R electrodes. The QA inspector observed the QC inspector identified as Fred Von Hoff monitoring the progress to ensure the welding parameters were in compliance pertaining to ABF-WPS-D15-1012-3. The parameters were recorded as (Amperes=134). Upon completion of the south face of the joint, the QC notified the QA inspector that the induction heating blankets were implemented on the completed weld and that the Proheat machine shut down. ABF welding personnel halted welding at this point and the QC inspector reported the incident to the QC Supervisor.
