Contract #: 04-0120F4Cty: SF/ALA Rte: 80 PM: 13.2/13.9File #: 69.28**WELDING INSPECTION REPORT****Resident Engineer:** Siegenthaler, Peter**Address:** 333 Burma Road**City:** Oakland, CA 94607**Report No:** WIR-026046**Date Inspected:** 10-Jul-2011**Project Name:** SAS Superstructure**OSM Arrival Time:** 700**Prime Contractor:** American Bridge/Fluor Enterprises, a JV**OSM Departure Time:** 1100**Contractor:** Zhenhua Port Machinery Company, Ltd (ZPMC), Changxing Island **Location:** Shanghai, China

Orthotropic Box Girder (OBG) at Trial Assembly Areas

Segment 13CE (U-Rib to U-Rib)

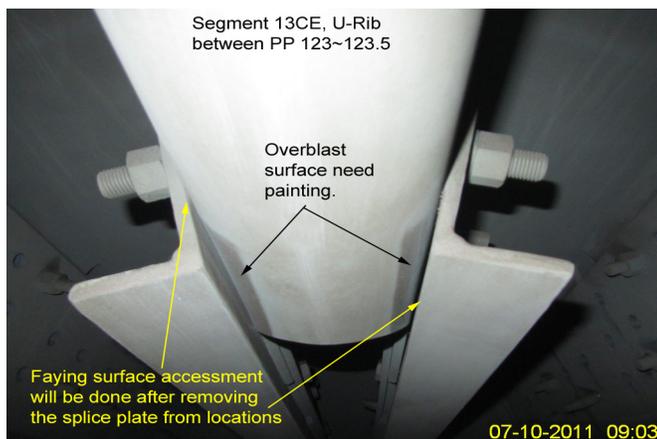
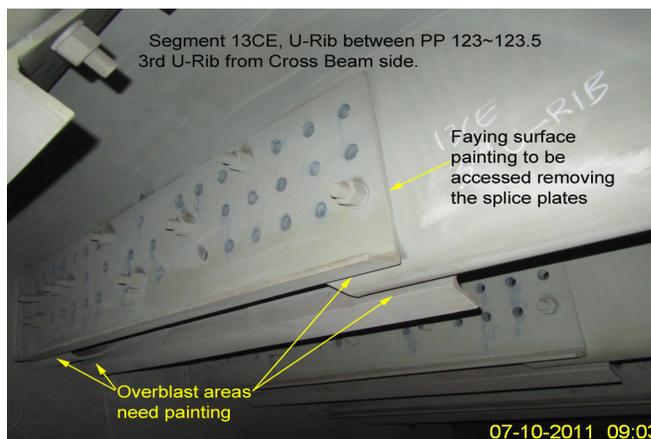
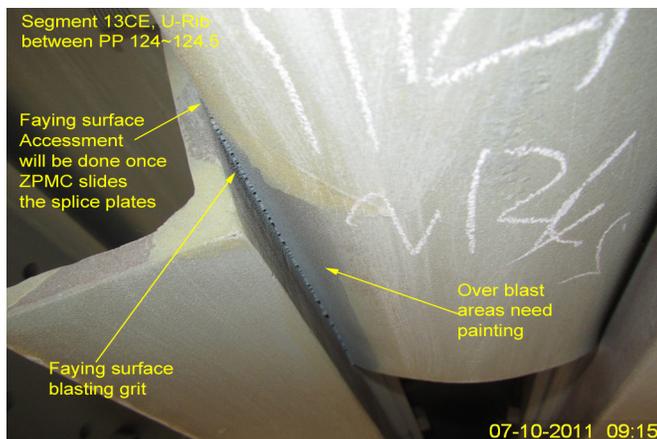
This QA Inspector on the request of ZPMC QA Mr. Lay Tao, Inspected 37 numbers of U-Ribs to U-Ribs, Splice plates installed for the faying surfaces for painting.

Inspection was performed along with CWI Mr. Liu Yang and Caltrans QA shown the locations where there is a sign of flash rust as a result of overblast and asked Mr. Liu Yang for removing the splice plates for proper accessing, whether painting is done or not, so that bolt assemblies can be installed.

The Inspection was performed at Segment 13CE between PP 123 to PP 123.5 and PP 124 to PP 124.5.
