Contract #: 04-0120F4Cty: SF/ALA Rte: 80 PM: 13.2/13.9File #: 69.28**WELDING INSPECTION REPORT****Resident Engineer:** Siegenthaler, Peter**Address:** 333 Burma Road**City:** Oakland, CA 94607**Report No:** WIR-026077**Date Inspected:** 11-Aug-2011**Project Name:** SAS Superstructure**OSM Arrival Time:** 1900**Prime Contractor:** American Bridge/Fluor Enterprises, a JV**OSM Departure Time:** 700**Contractor:** Zhenhua Port Machinery Company, Ltd (ZPMC), Changxing Island **Location:** Shanghai, China**CWI Name:** Mr. Sha Zhi**CWI Present:** Yes No**Inspected CWI report:** Yes No N/A**Rod Oven in Use:** Yes No N/A**Electrode to specification:** Yes No N/A**Weld Procedures Followed:** Yes No N/A**Qualified Welders:** Yes No N/A**Verified Joint Fit-up:** Yes No N/A**Approved Drawings:** Yes No N/A**Approved WPS:** Yes No N/A**Delayed / Cancelled:** Yes No N/A**Bridge No:** 34-0006**Component:** OBG**Summary of Items Observed:**

On this date CALTRANS OSM Quality Assurance (QA) Inspector, Mr. Paul Dawson, arrived on site at the Zhenhua Port Machinery Company (ZPMC) facility at Changxing Island, in Shanghai China, for the purpose of monitoring welding and fabrication of the San Francisco

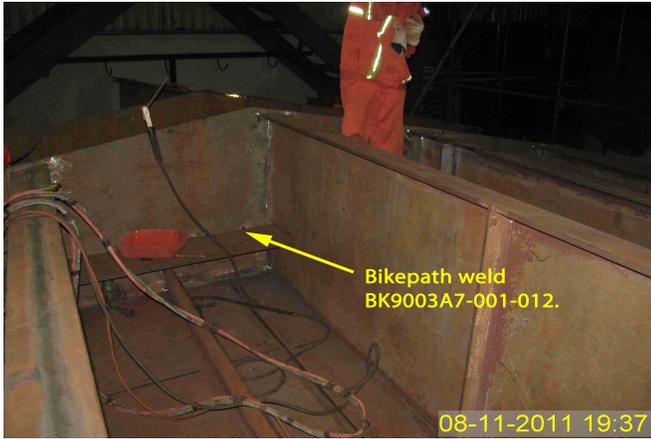
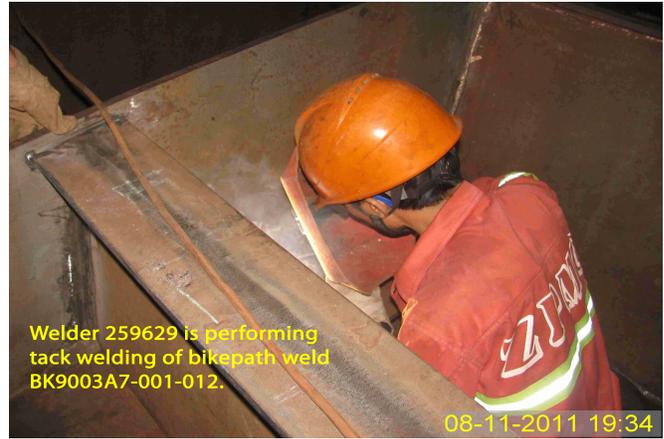
Bay 19

This QA Inspector observed ZPMC welder Mr. Li Jian Feng, stencil 259629 used shielded metal arc welding process to make bikepath tack weld BK9003A7-001-012. This QA Inspector observed Mr. Li Jian Feng appeared to be certified to make this weld, the welding electrodes were stored in a portable electrode storage container that was connected to an electrical power supply and the electrodes were warm to the touch. Items observed on this date appeared to generally comply with applicable contract documents. See the photographs below for additional information.
