Quality Assurance and Source Inspection

Contract #: 04-0120F4Cty: SF/ALA Rte: 80 PM: 13.2/13.9File #: 69.28**WELDING INSPECTION REPORT****Resident Engineer:** Siegenthaler, Peter**Address:** 333 Burma Road**City:** Oakland, CA 94607**Report No:** WIR-026084**Date Inspected:** 31-Jul-2011**Project Name:** SAS Superstructure**OSM Arrival Time:** 1500**Prime Contractor:** American Bridge/Fluor Enterprises, a JV**OSM Departure Time:** 300**Contractor:** Zhenhua Port Machinery Company, Ltd (ZPMC), Changxing Island **Location:** Shanghai, China**CWI Name:** See Below**CWI Present:** Yes No**Inspected CWI report:** Yes No N/A**Rod Oven in Use:** Yes No N/A**Electrode to specification:** Yes No N/A**Weld Procedures Followed:** Yes No N/A**Qualified Welders:** Yes No N/A**Verified Joint Fit-up:** Yes No N/A**Approved Drawings:** Yes No N/A**Approved WPS:** Yes No N/A**Delayed / Cancelled:** Yes No N/A**Bridge No:** 34-0006**Component:** OBG**Summary of Items Observed:**

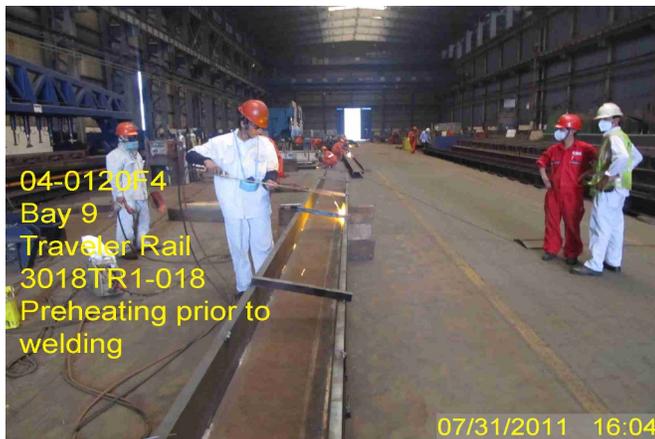
This QA inspector observed ZPMC flux cored arc welding (FCAW). During the observation performed it was noted that in Bay 9 ZPMC was in the process of welding and heat straightening bike path traveler rails. CWI Chen Shi Gang informed this QA inspector of the work in process. It was stated that ZPMC had 3 welders and identified the welders by ZPMC welder identification number appointed to then by ZPMC. This QA inspector verified this information for the following location;

Weld- 3018TR1-018

The following digital picture illustrates traveler rail 3018TR1-018.
