Contract #: 04-0120F4Cty: SF/ALA Rte: 80 PM: 13.2/13.9File #: 1.28**WELDING INSPECTION REPORT****Resident Engineer:** Siegenthaler, Peter**Address:** 333 Burma Road**City:** Oakland, CA 94607**Report No:** WIR-026113**Date Inspected:** 17-Aug-2011**Project Name:** SAS Superstructure**OSM Arrival Time:** 700**Prime Contractor:** American Bridge/Fluor Enterprises, a JV**OSM Departure Time:** 1530**Contractor:** American Bridge/Fluor Enterprises, a JV**Location:** Job Site**CWI Name:** Tony Sherwood**CWI Present:** Yes No**Inspected CWI report:** Yes No N/A**Rod Oven in Use:** Yes No N/A**Electrode to specification:** Yes No N/A**Weld Procedures Followed:** Yes No N/A**Qualified Welders:** Yes No N/A**Verified Joint Fit-up:** Yes No N/A**Approved Drawings:** Yes No N/A**Approved WPS:** Yes No N/A**Delayed / Cancelled:** Yes No N/A**Bridge No:** 34-0006**Component:** OBG Sections**Summary of Items Observed:**

Orthotropic Bridge Girder (OBG) Sections: 11W/12W-LS-1 thru LS-6

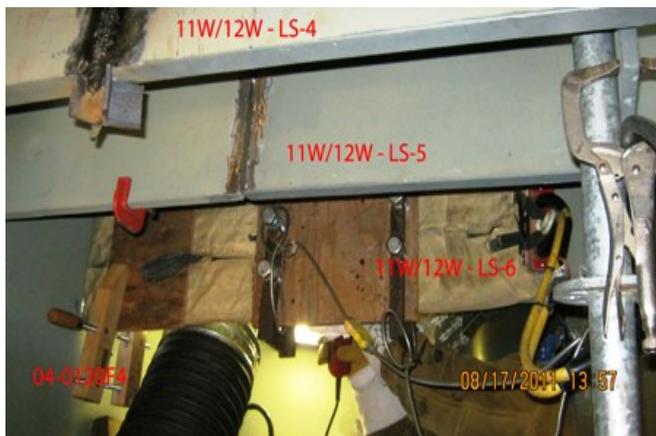
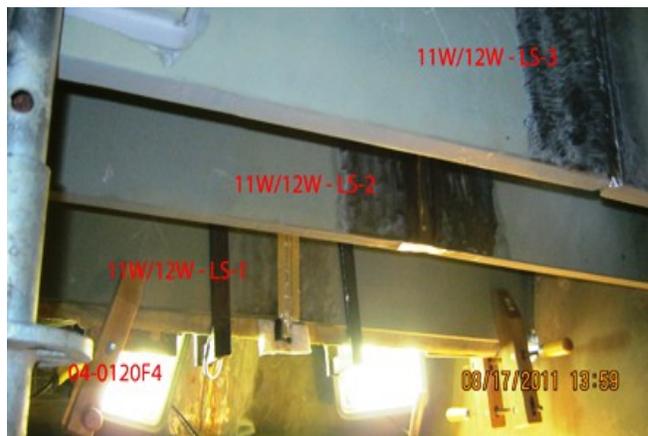
In general this QA Inspector randomly observed QC Inspector Tony Sherwood periodically monitoring the welding/work and each of the locations listed above. This QA Inspector observed a rod oven was located in the work area, marked as containing “9018” and verified the oven was on and heating the electrodes. See photos below of work in progress at the locations above.
