Contract #: 04-0120F4Cty: SF/ALA Rte: 80 PM: 13.2/13.9File #: 1.28**WELDING INSPECTION REPORT****Resident Engineer:** Siegenthaler, Peter**Address:** 333 Burma Road**City:** Oakland, CA 94607**Report No:** WIR-026189**Date Inspected:** 22-Aug-2011**Project Name:** SAS Superstructure**OSM Arrival Time:** 700**Prime Contractor:** American Bridge/Fluor Enterprises, a JV**OSM Departure Time:** 1530**Contractor:** American Bridge/Fluor Enterprises, a JV**Location:** Job Site**CWI Name:** Steve Jensen**CWI Present:** Yes No**Inspected CWI report:** Yes No N/A**Rod Oven in Use:** Yes No N/A**Electrode to specification:** Yes No N/A**Weld Procedures Followed:** Yes No N/A**Qualified Welders:** Yes No N/A**Verified Joint Fit-up:** Yes No N/A**Approved Drawings:** Yes No N/A**Approved WPS:** Yes No N/A**Delayed / Cancelled:** Yes No N/A**Bridge No:** 34-0006**Component:** OBG Sections**Summary of Items Observed:**

Orthotropic Bridge Girder (OBG) Sections: Longitudinal Stiffeners (LS) at 11W/12W

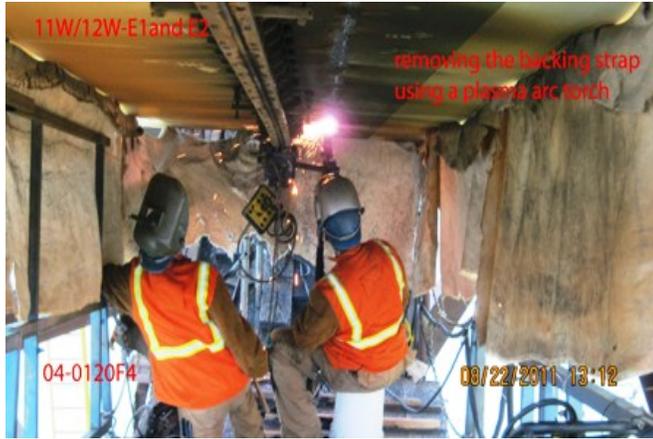
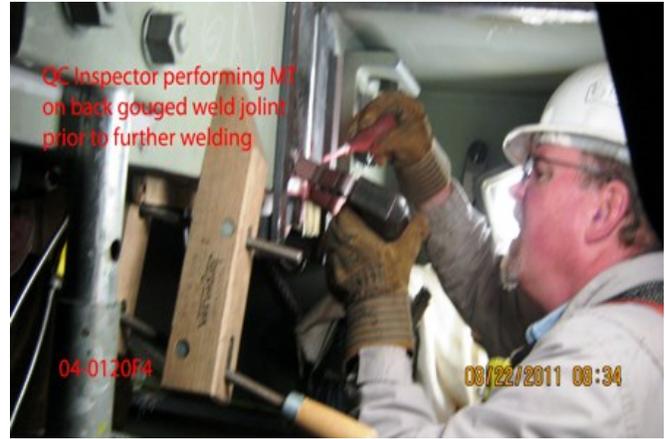
11W/12W – E: This QA Inspector randomly observed ABF welding personnel Todd Jackson (#4639) and Fred Kaddu (#2188) using a plasma torch to remove the back strap from this weld joint, see photo below.
