**DEPARTMENT OF TRANSPORTATION**

Contract #: 04-0120F4Cty: SF/ALA Rte: 80 PM: 13.2/13.9File #: 99.28**WELDING INSPECTION REPORT****Resident Engineer:** Casey, William**Address:** 333 Burma Road**City:** Oakland, CA 94607**Report No:** WIR-026271**Date Inspected:** 13-Sep-2011**Project Name:** SAS Superstructure**OSM Arrival Time:** 800**Prime Contractor:** American Bridge/Fluor Enterprises, a JV**OSM Departure Time:** 1630**Contractor:** Watson Bowman Associates**Location:** Buffalo, NY**CWI Name:** John Miller**CWI Present:** Yes No**Inspected CWI report:** Yes No N/A**Rod Oven in Use:** Yes No N/A**Electrode to specification:** Yes No N/A**Weld Procedures Followed:** Yes No N/A**Qualified Welders:** Yes No N/A**Verified Joint Fit-up:** Yes No N/A**Approved Drawings:** Yes No N/A**Approved WPS:** Yes No N/A**Delayed / Cancelled:** Yes No N/A**Bridge No:** 34-0006**Component:** Hinge A Expansion Joint**Summary of Items Observed:**

# WELDING INSPECTION REPORT

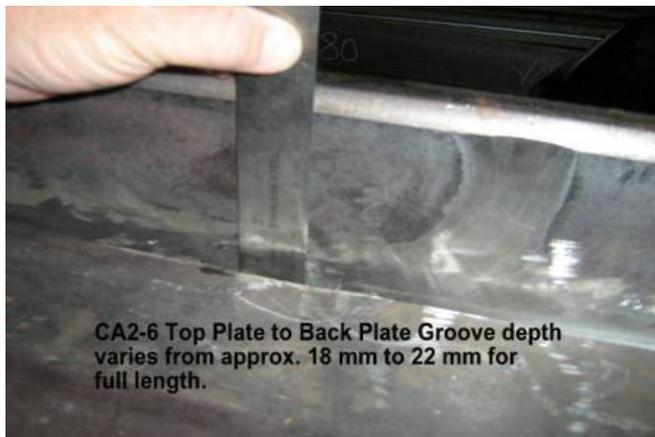
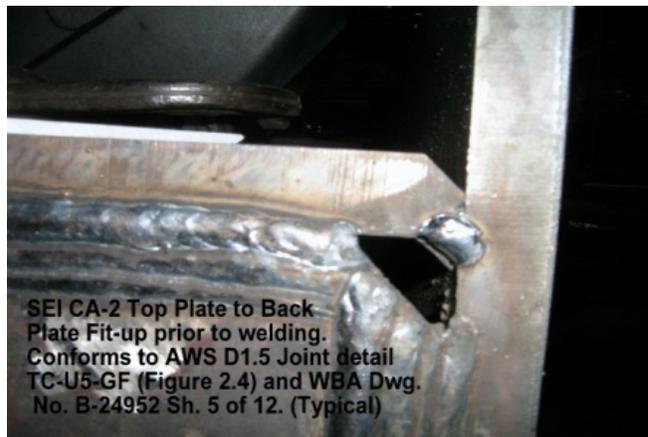
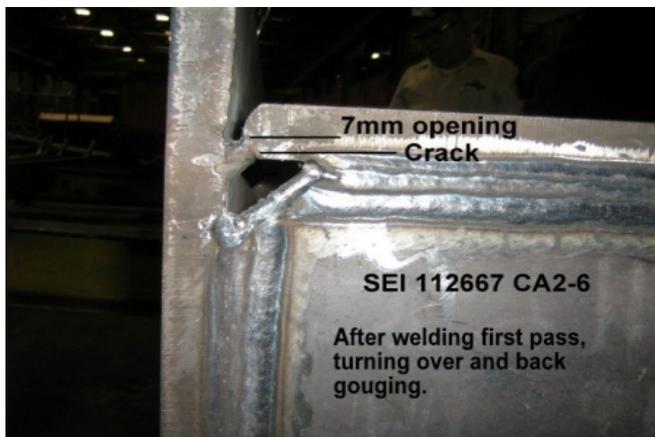
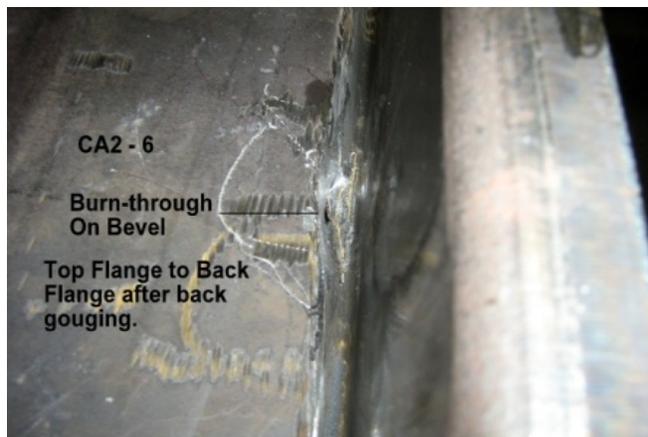
This QAI observed the CJP weld of the top plate to backing plate weld profile after back grinding has an approximately 7 mm opening at the root with a crack at one end and a burn-through (grind-through) in the bevel.

The depth of back grinding is approximately 18 mm to 22 mm through-out the length of the weld. Reference the attached photographs.

QCS Miller commented to this QAI that WBA will run a fillet weld soundness test tomorrow and that they may run a 6 mm single pass instead of an 8 mm single pass fillet weld. AWS CWI Davis informed this QAI that he saw numerous slag inclusions in the deposited weld metal while observing the back grinding of the top plate to back plate CJP weld (CA2 -6).
