Contract #: 04-0120F4Cty: SF/ALA Rte: 80 PM: 13.2/13.9File #: 82.28**WELDING INSPECTION REPORT****Resident Engineer:** Casey, William**Address:** 333 Burma Road**City:** Oakland, CA 94607**Report No:** WIR-026292**Date Inspected:** 13-Sep-2011**Project Name:** SAS Superstructure**OSM Arrival Time:** 600**Prime Contractor:** American Bridge/Fluor Enterprises, a JV**OSM Departure Time:** 1430**Contractor:** Westmont Industries**Location:** Santa Fe Springs, CA**CWI Name:** Ruben Dominguez**CWI Present:** Yes No**Inspected CWI report:** Yes No N/A**Rod Oven in Use:** Yes No N/A**Electrode to specification:** Yes No N/A**Weld Procedures Followed:** Yes No N/A**Qualified Welders:** Yes No N/A**Verified Joint Fit-up:** Yes No N/A**Approved Drawings:** Yes No N/A**Approved WPS:** Yes No N/A**Delayed / Cancelled:** Yes No N/A**Bridge No:** 34-0006 L & R**Component:** Maintenance Travelers**Summary of Items Observed:**

On this date, Caltrans Quality Assurance Inspector (QA) Sherri Brannon is present at the Westmont Industries (WMI) jobsite in Santa Fe Springs, California for the purpose of observing fabrication and QC functions for the SAS Superstructure, Bid Item #99, Maintenance Traveler

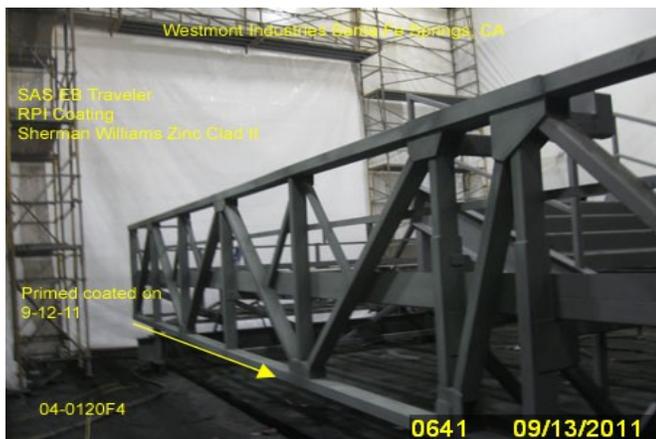
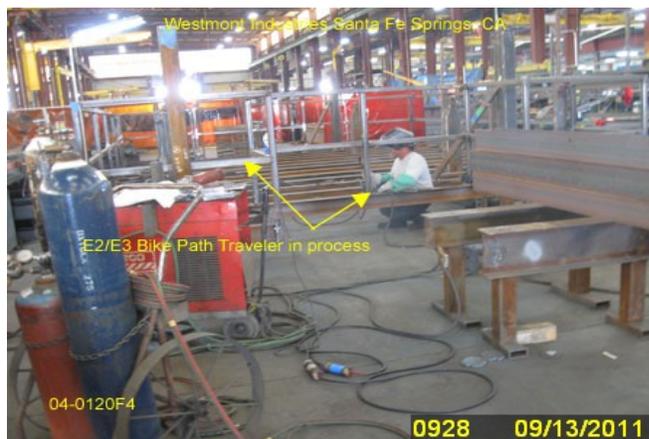
This QA Inspector observed that the activities mentioned above, appeared to be in compliance with the contract requirements and this QA Inspector observed no non-conforming issues, on this date.
