Contract #: 04-0120F4Cty: SF/ALA Rte: 80 PM: 13.2/13.9File #: 1.28**WELDING INSPECTION REPORT**

**Report No:** WIR-026294  
**Date Inspected:** 16-Sep-2011

**Project Name:** SAS Superstructure  
**Prime Contractor:** American Bridge/Fluor Enterprises, a JV  
**Contractor:** American Bridge/Fluor Enterprises, a JV

<b>CWI Name:</b>	See Below	<b>CWI Present:</b>	Yes	No
<b>Inspected CWI report:</b>	Yes No N/A	<b>Rod Oven in Use:</b>	Yes No N/A	
<b>Electrode to specification:</b>	Yes No N/A	<b>Weld Procedures Followed:</b>	Yes No N/A	
<b>Qualified Welders:</b>	Yes No N/A	<b>Verified Joint Fit-up:</b>	Yes No N/A	
<b>Approved Drawings:</b>	Yes No N/A	<b>Approved WPS:</b>	Yes No N/A	
		<b>Delayed / Cancelled:</b>	Yes No N/A	
<b>Bridge No:</b>	34-0006	<b>Component:</b>	SAS Tower & OBG

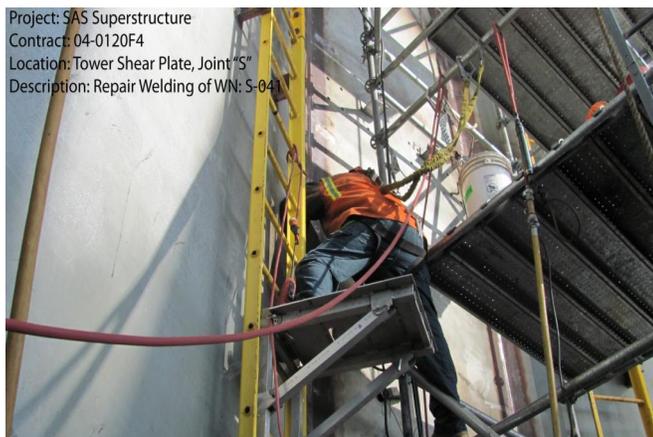
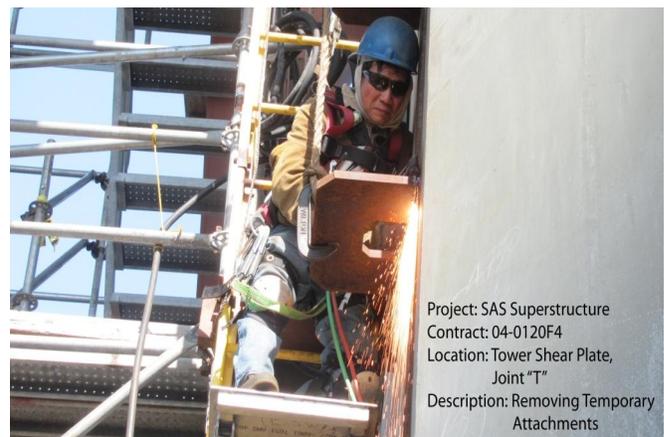
This QAI also observed the ongoing repair welding and grinding by various ABF personnel at the joint locations "N", "W", "D" and "A" on the B-face of the joints. The monitoring of the work and the inspection was performed by QC inspector, Bernie Docena. The repair welding was performed to correct the following types of discontinuities discovered and marked by QC during a visual inspection; overlap, the removal of slag trapped at the toes of the weld and the weld profiles.

Later in the shift the QAI observed Richard Garcia ID-5892 performing the repair welding at the shear plate joint "S", also identified as WN: S-041, utilizing the Shielded Metal Arc Welding (SMAW) process as per the WPS identified as ABF-WPS-D15-1000 Repair, Rev. 2. The welding was monitored and the parameters were measured

The digital photographs below illustrate some of the work observed during this scheduled work date.
