Contract #: 04-0120F4Cty: SF/ALA Rte: 80 PM: 13.2/13.9File #: 99.28**WELDING INSPECTION REPORT**

Report No: WIR-026323
Date Inspected: 23-Sep-2011

Project Name: SAS Superstructure
Prime Contractor: American Bridge/Fluor Enterprises, a JV
Contractor: Watson Bowman ACME

On this date, Quality Assurance Inspector (QAI) Kenneth Riley was present at the Watson Bowman Acme Corporation (WBA) facility, as requested, in Buffalo, New York to observe fabrication activities of the Seismic Expansion Joint Hinge A lanes for the San Francisco Oakland Bay Bridge (SFOBB) project.

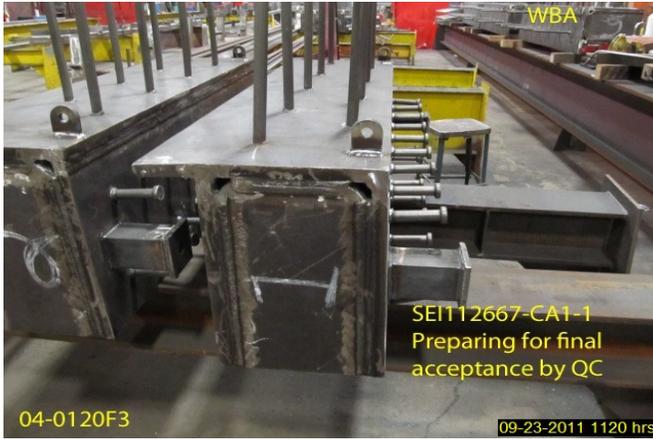
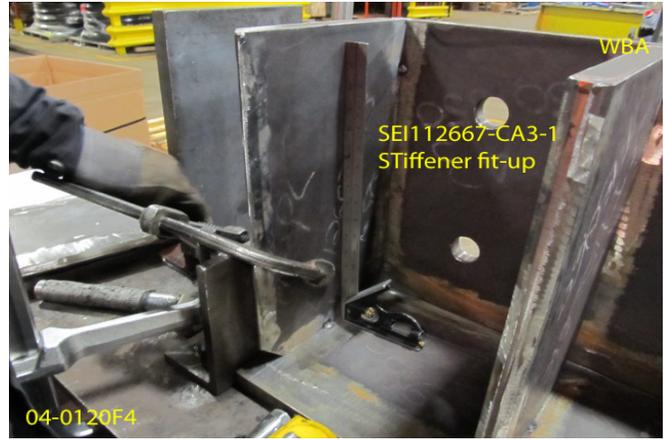
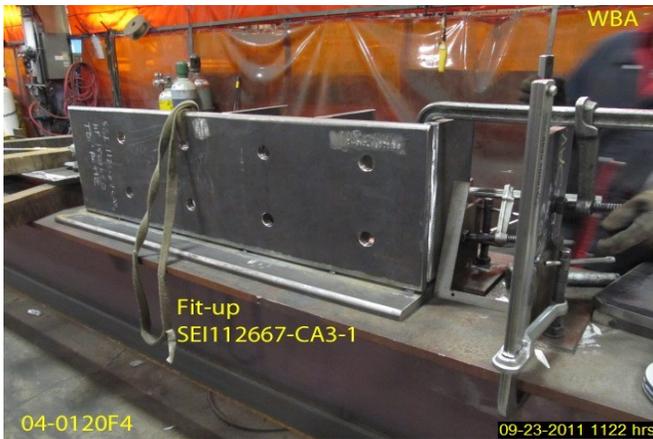
This QAI observed certified welder Jayson Gray (welder ID#J) using the FCAW process (dual shield, 100% CO₂), filler metal TM-811N1, to perform the fit-up of component number SEI112667 CA3-1, Channel Assembly (1 of 2). The weld joints fit were the top plate to back plate CJP groove weld with a measured root opening of 0 (tight fit) and the stiffener fillet welds to top plate and back plate (tight fit). Also noted was that WBA is in the process of cleaning Components SEI112667-CA2- 1, 4, 6, and 8 for final visual acceptance by the WBA QC department. The sniped areas were being ground to a smooth profile to remove weld termination imperfections along with weld spatter and other various items associated with the final visual acceptance.
