**DEPARTMENT OF TRANSPORTATION**

Contract #: 04-0120F4Cty: SF/ALA Rte: 80 PM: 13.2/13.9File #: 1.28**WELDING INSPECTION REPORT****Resident Engineer:** Casey, William**Address:** 333 Burma Road**City:** Oakland, CA 94607**Report No:** WIR-026437**Date Inspected:** 01-Oct-2011**Project Name:** SAS Superstructure**OSM Arrival Time:** 700**Prime Contractor:** American Bridge/Fluor Enterprises, a JV**OSM Departure Time:** 1530**Contractor:** American Bridge/Fluor Enterprises, a JV**Location:** Job Site

# WELDING INSPECTION REPORT

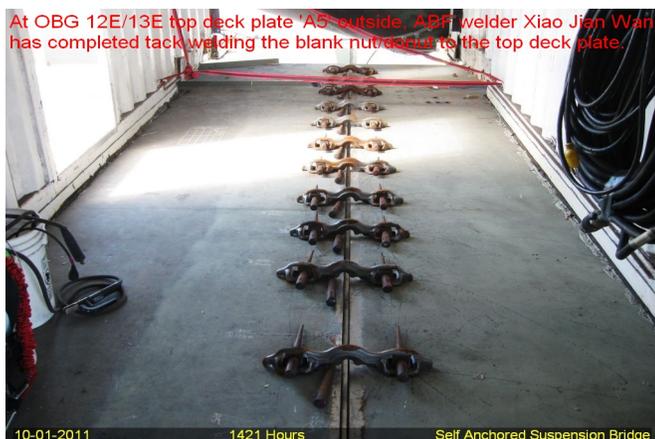
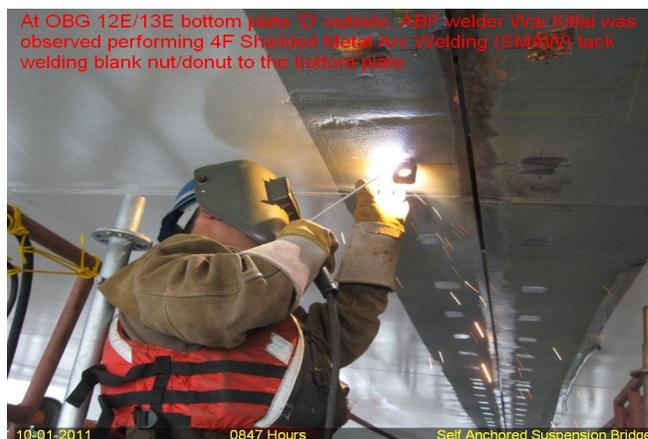
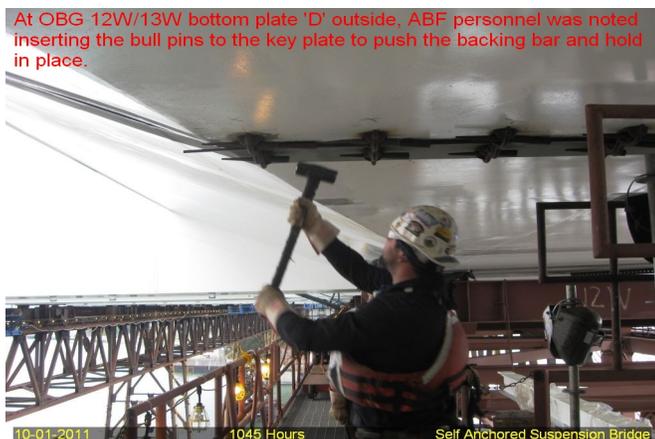
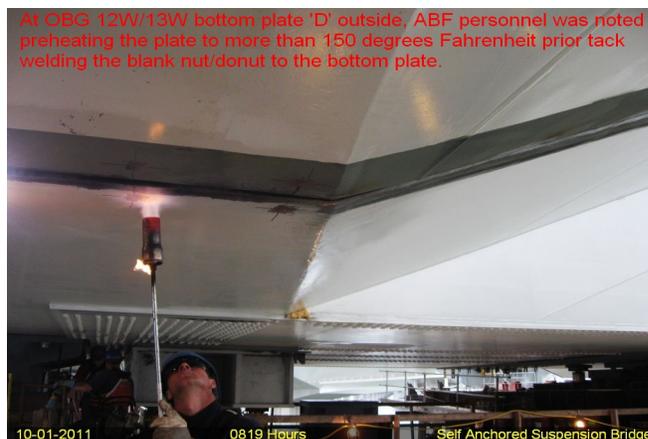
At OBG 12W/13W bottom plate 'D' outside, ABF welder Rick Clayborn was observed performing fit up of the bottom plates. The welder has tack welded blank nuts/donuts temporary attachments to both sides of the bottom plates using Shielded Metal Arc Welding (SMAW). The welder was noted welding in 4F (overhead) position utilizing 1/8" diameter E7018H4R electrode implementing Caltrans approved Welding Procedure Specification ABF-WPS-D15-F1200A. The welder was noted preheating the plate to more than 150°F prior welding. ABF QC William Sherwood was noted at site monitoring the welder and his welding parameter and so with the usage of electrode due to its limited exposure to Fracture Critical Members (FCM). During the shift, the welder has welded 27 pairs of blank nut for a total of 54 blank nuts. After the completion of the tack welding of the blank nuts, the welder has installed the backing bar by inserting the bull pins to the blank nuts and key plates. Installation of the backing bar was completed and the welder and QC went inside the OBG and started aligning the bottom plates. The alignment of the north and middle areas of the bottom plate were initially measured 0 to 3mm but the alignment at the south area was measured 0 to 4mm which could still be adjusted.

At OBG 12E/13E bottom plate 'D' outside, ABF welder Wai Kitlai was observed performing fit up of the bottom plates. The welder has tack welded blank nuts/donuts temporary attachments to both sides of the bottom plates using Shielded Metal Arc Welding (SMAW). The welder was noted welding in 4F (overhead) position utilizing 1/8" diameter E7018H4R electrode implementing Caltrans approved Welding Procedure Specification

ABF-WPS-D15-F1200A. The welder was noted preheating the plate to more than 150°F prior welding. ABF QC Mike Johnson was noted at site monitoring the welder and his welding parameter and so with the usage of electrode due to its limited exposure to Fracture Critical Members (FCM). During the shift, the welder has welded 31 pairs of blank nut for a total of 62 blank nuts. After the completion of the tack welding of the blank nuts, the welder has installed the backing bar by inserting the bull pins to the blank nuts and key plates. Installation of the backing bar was not completed during the end of the shift but should remain on Monday.

At OBG 12E/13E top deck plate 'A1' and 'A5' outside, ABF welder Xiao Jian Wan was observed performing fit up of the top deck plates. The welder has tack welded blank nuts/donuts temporary attachments to both sides of the top deck plate A1 and A5 using Shielded Metal Arc Welding (SMAW). The welder was noted welding in 2F (horizontal) position utilizing 1/8" diameter E7018H4R electrode implementing Caltrans approved Welding Procedure Specification ABF-WPS-D15-F1200A. The welder was noted preheating the plate to more than 150°F prior welding. ABF QC Fred Von Hoff was noted at site monitoring the welder and his welding parameter and so with the usage of electrode due to its limited exposure to Fracture Critical Members (FCM). During the shift, the welder has welded 11 pairs of blank nut for a total of 22 blank nuts on each A1 and A5. After the completion of the tack welding of the blank nuts, the welder has inserted the bull pins to the blank nuts and key plates. The alignment of the top deck plates was not performed due to bolting crew still installing the U rib connection plates.
