Contract #: 04-0120F4Cty: SF/ALA Rte: 80 PM: 13.2/13.9File #: 1.28**WELDING INSPECTION REPORT****Resident Engineer:** Casey, William**Address:** 333 Burma Road**City:** Oakland, CA 94607**Report No:** WIR-026487**Date Inspected:** 08-Oct-2011**Project Name:** SAS Superstructure**OSM Arrival Time:** 700**Prime Contractor:** American Bridge/Fluor Enterprises, a JV**OSM Departure Time:** 1530**Contractor:** American Bridge/Fluor Enterprises, a JV**Location:** Job Site**CWI Name:** Pat Swain**CWI Present:** Yes No**Inspected CWI report:** Yes No N/A**Rod Oven in Use:** Yes No N/A**Electrode to specification:** Yes No N/A**Weld Procedures Followed:** Yes No N/A**Qualified Welders:** Yes No N/A**Verified Joint Fit-up:** Yes No N/A**Approved Drawings:** Yes No N/A**Approved WPS:** Yes No N/A**Delayed / Cancelled:** Yes No N/A**Bridge No:** 34-0006**Component:** SAS Tower**Summary of Items Observed:**

WELDING INSPECTION REPORT

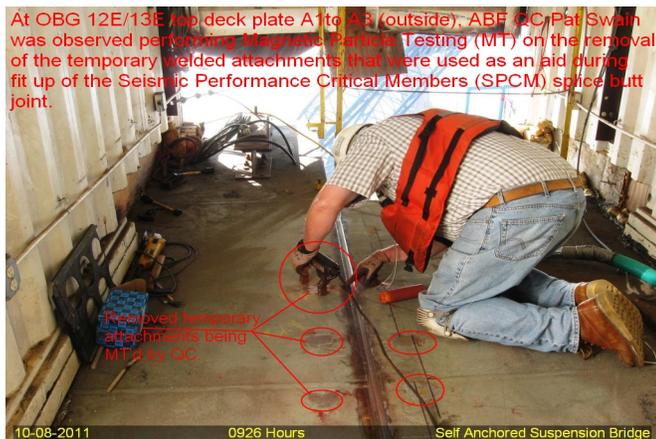
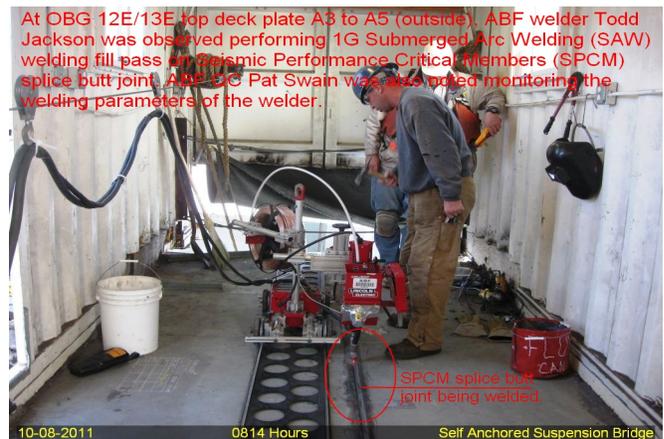
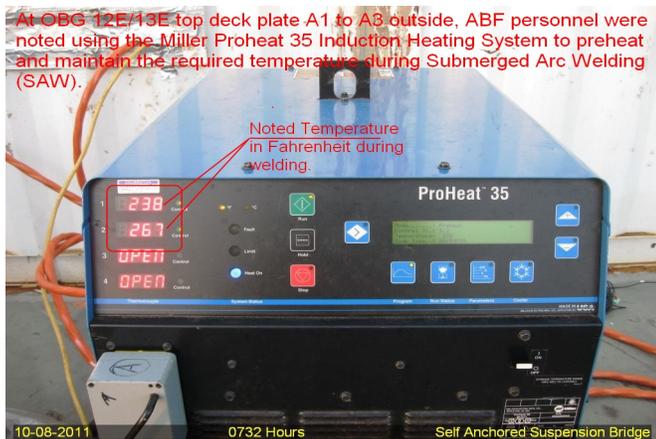
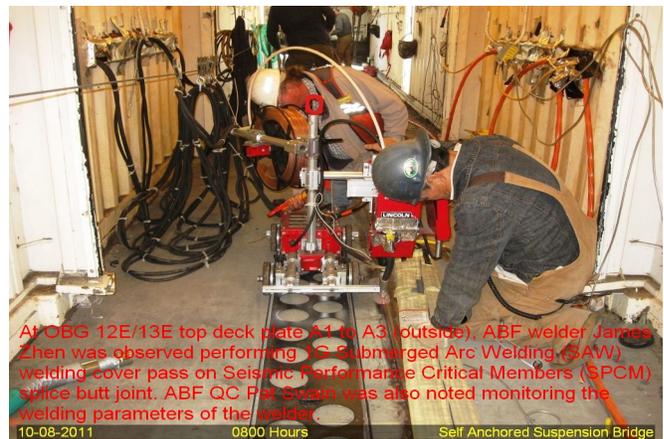
At OBG 12E/13E top deck plate 'A1 to A3' (outside), QA randomly observed ABF certified welder James Zhen ID #6001 continuing to perform 1G (flat position) Submerged Arc Welding (SAW) welding cover pass on the splice butt joint. The welder was utilizing F7A6-EM12K-H8, 3.2mm electrode with corresponding Esab OK Flux 10.62 flux and implementing Caltrans approved Welding Procedure Specification (WPS)

At OBG 12E/13E top deck plate 'A3 to A5' (outside), QA randomly observed ABF certified welder Todd Jackson ID #4639 continuing to perform 1G (flat position) Submerged Arc Welding (SAW) welding fill pass to cover pass on the splice butt joint. The welder was utilizing F7A6-EM12K-H8, 3.2mm electrode with corresponding Esab OK Flux 10.62 flux and implementing Caltrans approved Welding Procedure Specification (WPS)

At the request of Quality Control Field Supervisor, Bonifacio Daquinag, QA has randomly verified the QC VT/MT of the CJP welding of two (2) lifting lug holes. The QA verification was performed to verify that the welding and the VT/MT inspection performed by the QC inspector meet the requirements of the contract documents. At the conclusion of the QA verification it appeared that the weld and the QC inspection complied with the contract documents.

1. 10W-PP92-W3-#3 – QA VT/MT verified
2. 10W-PP92-W3-#4 – QA VT/MT verified
