DEPARTMENT OF TRANSPORTATION

Quality Assurance and Source Inspection

Contract #: 04-0120F4Cty: SF/ALA Rte: 80 PM: 13.2/13.9File #: 1.28**WELDING INSPECTION REPORT****Resident Engineer:** Casey, William**Address:** 333 Burma Road**City:** Oakland, CA 94607**Report No:** WIR-026490**Date Inspected:** 05-Oct-2011**Project Name:** SAS Superstructure**OSM Arrival Time:** 700**Prime Contractor:** American Bridge/Fluor Enterprises, a JV**OSM Departure Time:** 1730**Contractor:** American Bridge/Fluor Enterprises, a JV**Location:** Job Site**CWI Name:** Pat Swain**CWI Present:** Yes No**Inspected CWI report:** Yes No N/A**Rod Oven in Use:** Yes No N/A**Electrode to specification:** Yes No N/A**Weld Procedures Followed:** Yes No N/A**Qualified Welders:** Yes No N/A**Verified Joint Fit-up:** Yes No N/A**Approved Drawings:** Yes No N/A**Approved WPS:** Yes No N/A**Delayed / Cancelled:** Yes No N/A**Bridge No:** 34-0006**Component:** OBG Sections**Summary of Items Observed:**

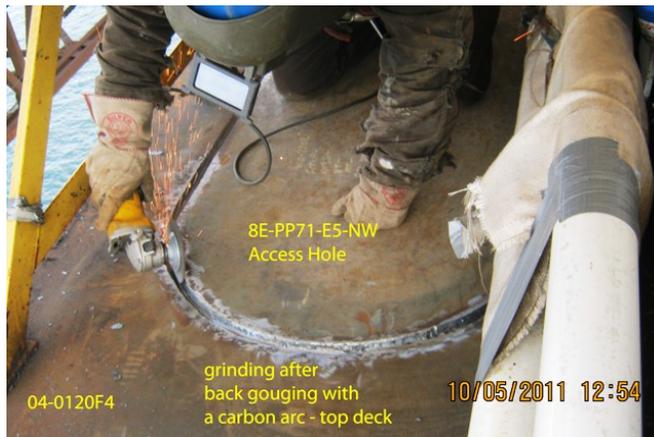
8E-PP71-E5 NW Access Hole: This QA Inspector observed that welding had been completed from the bottom (inside the OBG section) at this location and that back gouging was started this date from the top side using a carbon arc process. This QA Inspector observed after the carbon arc process ABF personnel were using a hand held grinder to remove the carbon deposits and contour the groove for welding, see photo below.
