Contract #: 04-0120F4Cty: SF/ALA Rte: 80 PM: 13.2/13.9File #: 1.28**WELDING INSPECTION REPORT****Resident Engineer:** Casey, William**Address:** 333 Burma Road**City:** Oakland, CA 94607**Report No:** WIR-026533**Date Inspected:** 17-Oct-2011**Project Name:** SAS Superstructure**OSM Arrival Time:** 700**Prime Contractor:** American Bridge/Fluor Enterprises, a JV**OSM Departure Time:** 1730**Contractor:** American Bridge/Fluor Enterprises, a JV**Location:** Job Site**CWI Name:** Fred Von Hoff**CWI Present:** Yes No**Inspected CWI report:** Yes No N/A**Rod Oven in Use:** Yes No N/A**Electrode to specification:** Yes No N/A**Weld Procedures Followed:** Yes No N/A**Qualified Welders:** Yes No N/A**Verified Joint Fit-up:** Yes No N/A**Approved Drawings:** Yes No N/A**Approved WPS:** Yes No N/A**Delayed / Cancelled:** Yes No N/A**Bridge No:** 34-0006**Component:** OBG Sections**Summary of Items Observed:**

Orthotropic Bridge Girder (OBG) Sections:

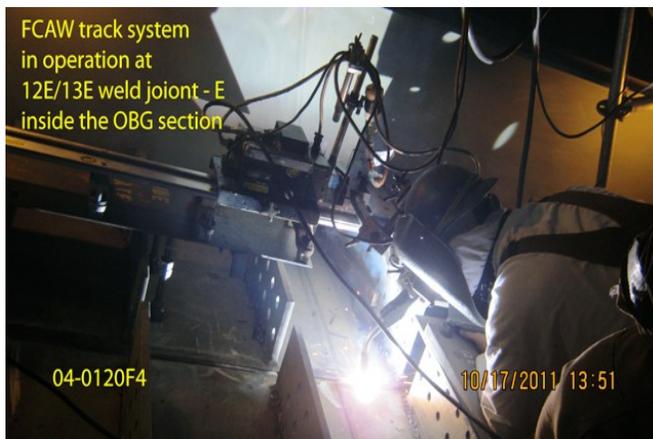
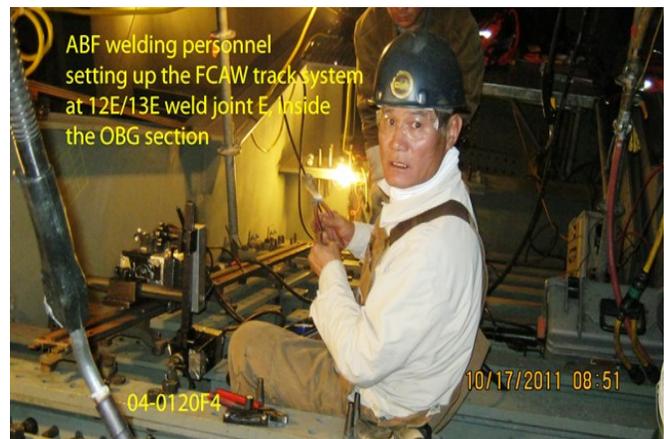
12E/13E weld joint E-1 and E-2: This QA Inspector randomly observed ABF personnel setting up the FCAW track systems at this location to begin welding, see photo below. This QA Inspector observed the seal/continuous tack welding had been performed prior to the beginning of the shift this date. This QA Inspector observed a track system was being set up for both weld joint E-1 and E-2. This QA Inspector observed the induction heating pads had been positioned on the outside of the weld joint to provide the required minimum preheat of 200°F. This QA

Inspector randomly observed as QC Inspector Fred Von Hoff verified the following welding parameters; FCAW track system at E-1 with ABF welding personnel Wai Kitlai (#2953) 255 amperes and 24.5 volts at a travel speed of 260 mm per minute to produce a heat input value of 1.44 Kj per mm and FCAW track system at E-2 with ABF welding personnel James Zhen (#6001) 260 amperes and 24.5 volts at a travel speed of 260 mm per minute to produce a heat input value of 1.47 Kj per mm. After welding was started at these locations above ABF welding personnel Jin Pei Wang started using the FCAW process by hand at the end of E-2, adjacent to weld joint D-1, where the track system did not have access and his welding parameters were as follows; 240 amperes and 24.4 volts with a travel speed of 401 mm per minute to produce a heat input value of 0.87 Kj per mm. The welding parameters for ABF welding personnel Jin Pei Wang were verified by QC Inspector Pat Swain. This QA Inspector randomly observed the welding performed and QC Inspector Fred Von Hoff monitoring the work at these locations during the shift. The welding observed appeared to comply with ABF-WPS-D15-3042A-1. By the end of the shift this date this QA Inspector observed the FCAW welding had been completed, except at the following locations; the top 2,000 mm (starting from weld joint F), at the end of E-1 and area approximately 1,000 mm in length separating the two track systems and an area approximately 1,000 mm in length 1,000 mm above the end of the weld joint (from weld joint D). In general the welding observed this date appeared to comply with the contract requirements.
