Contract #: 04-0120F4Cty: SF/ALA Rte: 80 PM: 13.2/13.9File #: 1.28**WELDING INSPECTION REPORT**

Report No: WIR-026556
Date Inspected: 22-Oct-2011

Project Name: SAS Superstructure
Prime Contractor: American Bridge/Fluor Enterprises, a JV
Contractor: American Bridge/Fluor Enterprises, a JV

Orthotropic Bridge Girder (OBG) Sections:

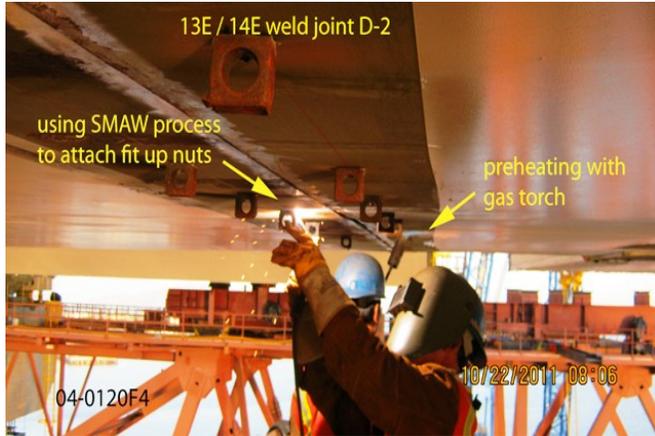
13E/14E weld joint D-1, D-2 and D-3: This QA Inspector randomly observed ABF welding personnel marking out the locations to attach the fit up aids to the bottom of D-2 from outside the OBG section. See photo below. This QA Inspector randomly observed ABF welding personnel Wai Kitlai (#2953) using the Shielded Metal Arc Welding process to attach fitting aids. This QA Inspector observed a hand held gas fired torch was being used to preheat the base metal, this QA Inspector observed an electronic temperature gauge was being used to verify the temperature was greater than 200°F by the welding personnel. This QA Inspector observed QC Inspector Pat Swain at this location to monitor and verify the following welding parameters; 135 amperes. This QA Inspector observed a 3.2 mm diameter E7018H4R electrode was being used from an electrode container. The welding observed appeared to comply with Welding Procedure Specification (WPS) ABF-WPS-D15-F1200A. This QA Inspector observed the fit up aids (nuts) were being welded in the same direction as the OBG section and welded on one side only for approximately 25-30 mm in length. The attachment welds appeared to comply with RFI-1361 Rev-3. Later this shift the backing bar was installed and wedged into place. This QA Inspector randomly observed QC Inspector Pat Swain layout and mark weld section D-2, which is the center section and has a plate thickness of 22 mm. This QA Inspector had previously been informed by QC Inspector Bonifacio Daquinag Jr.

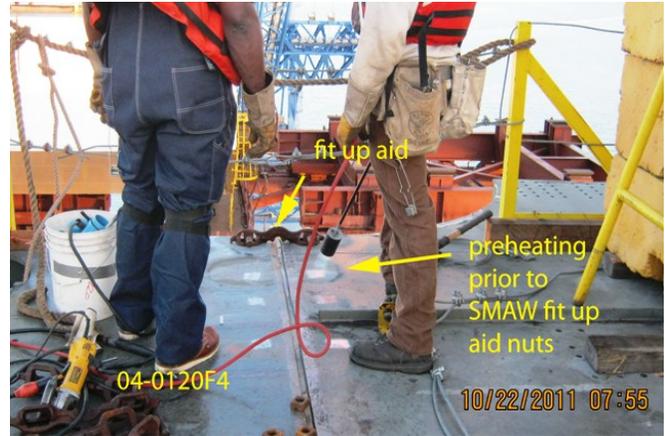
13E/14E weld joint A-2.2 thru A-5: This QA Inspector was informed by QC Inspector Bonifacio Daquinag Jr. that weld joint A-2 contained two reference points, A-2.1 and A-2.2 to reference the drop in plates for the cable access. This QA Inspector randomly observed ABF welding personnel Fred Kaddu (#2188) cleaning off various areas of the deck with a grinder to remove primer and use a hand held gas torch to preheat areas prior to using the SMAW process to attach fit up aids. See photo below. This QA Inspector observed QC Inspector Jesus Cayabyab was present and verified the preheat temperature and the following welding parameters; 140 amperes. This QA Inspector observed a 3.2 mm diameter E7018H4R electrode was being used from an electrode container. The welding observed appeared to comply with Welding Procedure Specification (WPS) ABF-WPS-D15-F1200A. This QA Inspector observed the fit up aids (nuts and/or U-bars) were being welded in the same direction as the OBG section and welded on one side only with an approximate length of 25-30 mm. The attachment welds appeared to comply with RFI-1361 Rev-3. After the fit up aids had been attached QC Inspector Jesus Cayabyab started to perform a preliminary measurement of the planar offset. This QA Inspector randomly observed and performed a random verification of the measurements marked on the deck in soapstone. The vast majority of the measurements appeared to comply with the measurements taken by this QA Inspector. This QA Inspector observed fit up aids were added where needed by ABF welding personnel Fred Kaddu (#2188). Later this shift QC Inspector Jesus Cayabyab stated he was ready to start the final measurement of the deck from A-2.2 thru A-5 for engineering approval. This QA Inspector observed ABF personnel were below A-Deck still installing pins and bolts in the closed ribs and vertical stiffeners, this QA Inspector informed QC Inspectors Jesus Cayabyab and Bonifacio Daquinag Jr. of the observation stating these operations could affect the planar offset and root opening. QC Inspector Bonifacio Daquinag Jr. stated the measurements should not be taken until the applicable pins and/or bolts had been installed and informed ABF welding Supervisor Danny Ieraci and this QA Inspector. QC Inspector Bonifacio Daquinag Jr. informed this QA Inspector that he had been informed by ABF welding Supervisor Danny Ieraci that he had called QCM Jim Bowers and had been informed that the final measurements for Engineering approval were to be taken first thing Monday morning. This QA Inspector observed the following during a random verification of the preliminary measurements taken this date; 3 short areas with planar offset of 3 mm (longest being 300 mm) and 1 area with planar offset of 4 mm (approximately 200 mm long). This QA Inspector did not observe production welding at this location this date.
