Contract #: 04-0120F4Cty: SF/ALA Rte: 80 PM: 13.2/13.9File #: 1.28**WELDING INSPECTION REPORT****Resident Engineer:** Casey, William**Address:** 333 Burma Road**City:** Oakland, CA 94607**Report No:** WIR-026615**Date Inspected:** 28-Oct-2011**Project Name:** SAS Superstructure**OSM Arrival Time:** 700**Prime Contractor:** American Bridge/Fluor Enterprises, a JV**OSM Departure Time:** 1530**Contractor:** American Bridge/Fluor Enterprises, a JV**Location:** Job Site**CWI Name:** Fred Von Hoff**CWI Present:** Yes No**Inspected CWI report:** Yes No N/A**Rod Oven in Use:** Yes No N/A**Electrode to specification:** Yes No N/A**Weld Procedures Followed:** Yes No N/A**Qualified Welders:** Yes No N/A**Verified Joint Fit-up:** Yes No N/A**Approved Drawings:** Yes No N/A**Approved WPS:** Yes No N/A**Delayed / Cancelled:** Yes No N/A**Bridge No:** 34-0006**Component:** OBG Sections**Summary of Items Observed:**

Orthotropic Bridge Girder (OBG) Sections:

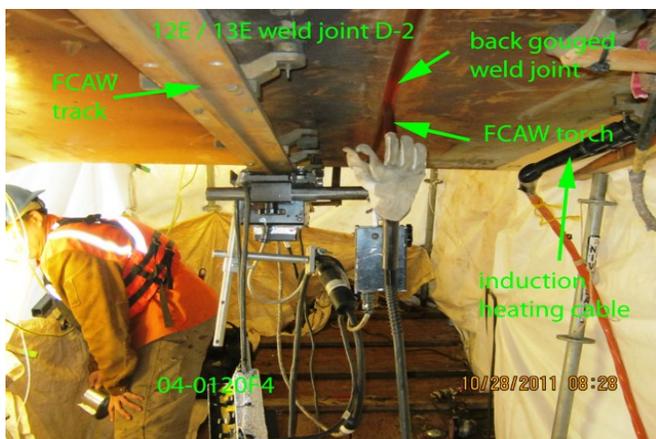
13E/14E – weld joint D-2: This QA Inspector observed ABF welding personnel James Zhen (#6001) setting up to begin welding from the bottom side of the OBG section using the Flux Cored Arc Welding (FCAW) process, see photo below. This QA Inspector observed the induction heat blankets were being used to preheat the base metal, this weld joint requires continuous preheat during welding and a 3 hours post weld heat at a minimum temperature of 200°F. This QA Inspector randomly observed QC Inspector Fred Von Hoff verify the base metal was greater than the minimum preheat with an electronic temperature gauge. This QA Inspector was present when QC Inspector Fred Von Hoff informed ABF welding personnel James Zhen (#6001) that a thin film of rust had formed on the base metal and requested it be removed prior to the start of welding. This QA Inspector randomly observed as ABF personnel used a power wire brush to remove the rust from the weld joint groove. This QA Inspector observed QC Inspector Fred Von Hoff verify the following welding parameters; 280 amperes and 24.6 volts at a travel speed of 228 mm per minute to produce a heat input value of 1.81 KJ per mm. The welding observed appeared to comply with the Welding Procedure Specification (WPS) being used by the QC Inspector; ABF-WPS-D15-3110-4. This QA Inspector observed the root pass had been completed at approximately 0930 hours this date. This QA Inspector randomly observed the welding and QC functions at this location this date.

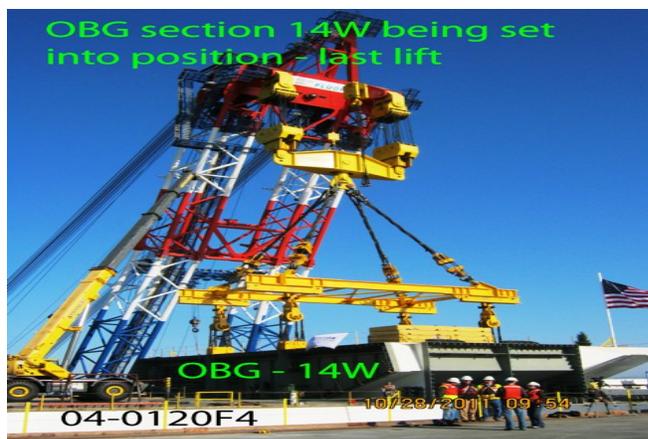
13W/14W – OBG section: This QA Inspector randomly observed the last lift of the project was performed this date and that OBG section 14W appeared to have been set into position for fit up at a later date, see photo below.
