Contract #: 04-0120F4Cty: SF/ALA Rte: 80 PM: 13.2/13.9File #: 82.28**WELDING INSPECTION REPORT****Resident Engineer:** Casey, William**Address:** 333 Burma Road**City:** Oakland, CA 94607**Report No:** WIR-026650**Date Inspected:** 31-Oct-2011**Project Name:** SAS Superstructure**OSM Arrival Time:** 600**Prime Contractor:** American Bridge/Fluor Enterprises, a JV**OSM Departure Time:** 1430**Contractor:** Westmont Industries**Location:** Santa Fe Springs, CA**CWI Name:** Chris Concha**CWI Present:** Yes No**Inspected CWI report:** Yes No N/A**Rod Oven in Use:** Yes No N/A**Electrode to specification:** Yes No N/A**Weld Procedures Followed:** Yes No N/A**Qualified Welders:** Yes No N/A**Verified Joint Fit-up:** Yes No N/A**Approved Drawings:** Yes No N/A**Approved WPS:** Yes No N/A**Delayed / Cancelled:** Yes No N/A**Bridge No:** 34-0006**Component:** Maintenance Travelers**Summary of Items Observed:**

WELDING INSPECTION REPORT

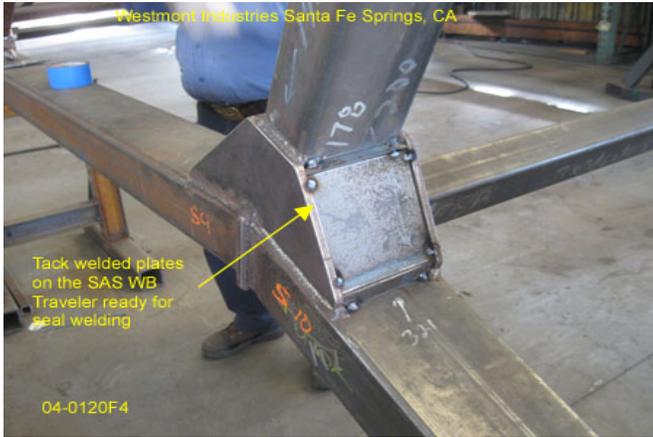
This QA Inspector performed random shop observations and observed that RPI is on site to continuing with the coating application on the E2/E3 WB Traveler. QA Inspector was informed by RPI Coating Mr. Preston Keen that RPI is going to spot blast area's that were repaired by welding, sweep blast and apply the Sherwin Williams Zinc Clad II prime coat to section 2 today, completed at 1330 hour. QA Inspector randomly observed that RPI personnel performing spot/sweep blasting activities on the E2/E3 WB Traveler. After spot/sweep blasting was completed, QA Inspector then observed Mr. Keen performing what appeared to be random surface profile checks on the sweep blasted base metal surfaces. This QA Inspector observed Mr. Keen utilizing a Testex Press-O-Film and a micrometer to perform the testing. This QA Inspector then observed Mr. Keen utilize a micrometer to measure the surface profile on the clear film part of the strip, in which the rubbing was performed. Mr. Keen explained to this QA Inspector that the initial setting on the micrometer was set at 2mils over, due to the thickness of the X-Coarse Press-O-Film paper. During observation, this QA Inspector observed that the readings appeared to be 2.9 mils, 3.3 mils, and 3.4 mils. This QA Inspector noted that the contract requires a surface profile of 1.5 mils, (40 um) - 3.4mils (86um) and that the above mentioned tested profile appears to be in general compliance with the contract requirements. This QA Inspector was then informed by Mr. Keen that primer application will soon start. Later in the shift, this QA Inspector randomly observed RPI Coating performing what appeared to be primer application activities within what appeared to be within and 8 hour time frame form the above mentioned blasting activities. Environmental readings taken by RPI at the time of primer application are as follows respectively: Air Temperature 56/74 F, Relative Humidity 59/45%, Wet Bulb Temperature 50/58 F, Dew point 46/50 F and Surface Temperature 54/75 F.

QA Inspector performed measurement on dry film thickness with Type 2 (magnetic gage), DFT's thickness reading of the prime coated section 1 coated on 10-28-11 are an average of three (3) thickness reading are as

follows 4.6 mils, 3.3 mils, 5.0 mils 3.6 mils, 3.4 mils, 3.7 mils, 4.0 mils, 4.1 mils, 3.6 mils, and 3.2 mils, average dry film thickness 3.9 mils. QA Inspector also, observed Mr. Keen documenting daily actives on RPI Coating QC Daily Inspection Report. QA Inspector informed SMR Mr. Nicolai Hvass of the above information.
