**DEPARTMENT OF TRANSPORTATION**

Contract #: 04-0120F4Cty: SF/ALA Rte: 80 PM: 13.2/13.9File #: 82.28**WELDING INSPECTION REPORT****Resident Engineer:** Casey, William**Address:** 333 Burma Road**City:** Oakland, CA 94607**Report No:** WIR-026657**Date Inspected:** 03-Nov-2011**Project Name:** SAS Superstructure**OSM Arrival Time:** 600**Prime Contractor:** American Bridge/Fluor Enterprises, a JV**OSM Departure Time:** 1430**Contractor:** Westmont Industries**Location:** Santa Fe Springs, CA**CWI Name:** Chris Concha**CWI Present:** Yes No**Inspected CWI report:** Yes No N/A**Rod Oven in Use:** Yes No N/A**Electrode to specification:** Yes No N/A**Weld Procedures Followed:** Yes No N/A**Qualified Welders:** Yes No N/A**Verified Joint Fit-up:** Yes No N/A**Approved Drawings:** Yes No N/A**Approved WPS:** Yes No N/A**Delayed / Cancelled:** Yes No N/A**Bridge No:** 34-0006 L & R**Component:** Maintenance Travelers**Summary of Items Observed:**

**Repair of Dented Truss Members on the E2/E3-WB Traveler (South end)**

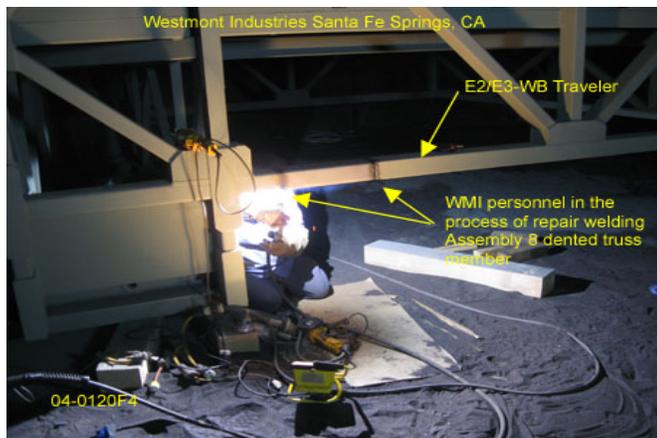
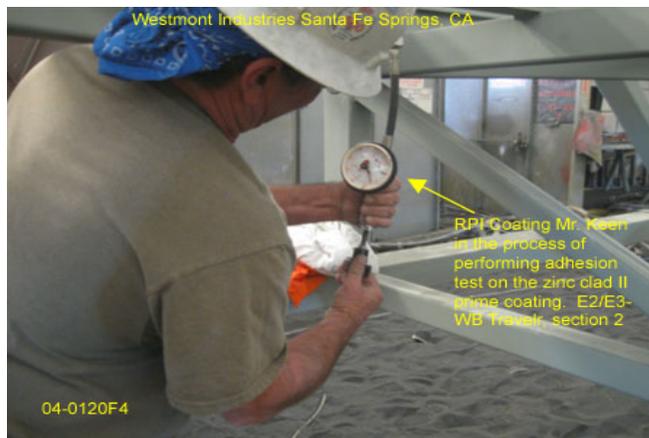
This QA Inspector performed random shop observations and observed that RPI is on site to continuing with the coating application on the E2/E3 WB Traveler. QA Inspector was informed by RPI Coating Mr. Preston Keen that RPI is going to strip coat welded areas in section 1 in the morning and mist coat section in the afternoon using the Sherwin Williams Polysiloxane XLE-80, perform adhesion tests and pressure wash section 2 today. Mr. Keen also stated that RPI is going to touch up areas of low DFT's reading found by QA Inspectors on 11-02-11 on the E2/E3-EB Traveler, and touch some area's on the SAS-EB Traveler QA Inspector randomly observed that RPI personnel performing the above activities on the travelers. Environmental readings taken by RPI at the time of coating application are as follows respectively: Air Temperature 53/77 F, Relative Humidity 41/41%, Wet Bulb Temperature 42/61 F, Dew point 29/50 F and Surface Temperature 52/76 F. QA Inspector also, observed Mr. Keen documenting daily actives on RPI Coating QC Daily Inspection Report.

Mr. Keen informed QA Inspector that on the interim coating of the Sherman Williams Zinc Clad II, Inorganic Zinc Rich prime coating he would be performing ASTM D4541 – Standard Test Method for Pull-Off Strength of Coating Using Portable Adhesion Tester, Mr. Keen stated that he will be using a calibrated Elcometer Hydraulic Adhesion Tester Model 108 for the adhesion test. Testing observed is as follows: Prime coated on 10-31-11 (section 2), Adhesion test 1000 psi and 725 psi. QA Inspector also, observed Mr. Keen documenting daily actives on RPI Coating QC Daily Inspection Report.
