**DEPARTMENT OF TRANSPORTATION**

Contract #: 04-0120F4Cty: SF/ALA Rte: 80 PM: 13.2/13.9File #: 99.28**WELDING INSPECTION REPORT****Resident Engineer:** Casey, William**Address:** 333 Burma Road**City:** Oakland, CA 94607**Report No:** WIR-026659**Date Inspected:** 04-Nov-2011**Project Name:** SAS Superstructure**OSM Arrival Time:** 700**Prime Contractor:** American Bridge/Fluor Enterprises, a JV**OSM Departure Time:** 1530**Contractor:** Watson Bowman ACME**Location:** Buffalo, NY**CWI Name:** Reno Davis, John Crabtree**CWI Present:** Yes No**Inspected CWI report:** Yes No N/A**Rod Oven in Use:** Yes No N/A**Electrode to specification:** Yes No N/A**Weld Procedures Followed:** Yes No N/A**Qualified Welders:** Yes No N/A**Verified Joint Fit-up:** Yes No N/A**Approved Drawings:** Yes No N/A**Approved WPS:** Yes No N/A**Delayed / Cancelled:** Yes No N/A**Bridge No:** 34-0006**Component:** Hinge A**Summary of Items Observed:**

On this date, Quality Assurance Inspector (QAI) Kenneth Riley was present at the Watson Bowman Acme Corporation (WBA) facility, as requested, in Buffalo, New York to observe fabrication activities of the Seismic Expansion Joint Hinge A lanes for the San Francis

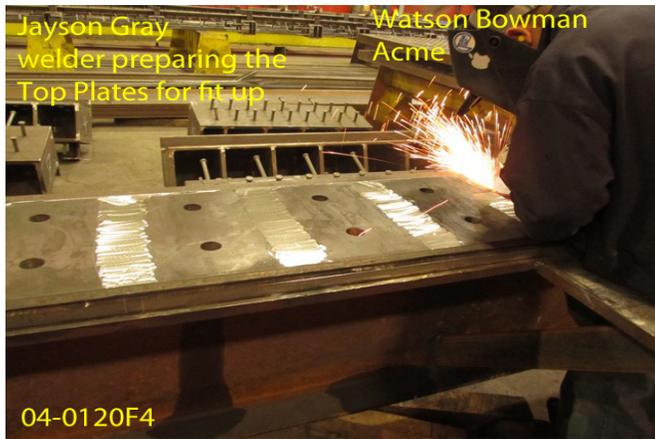
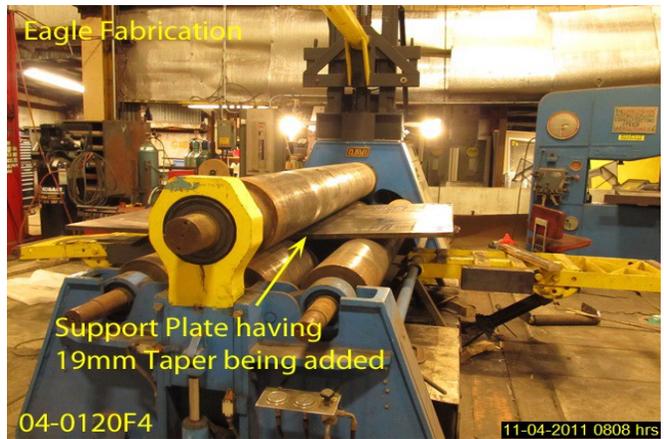
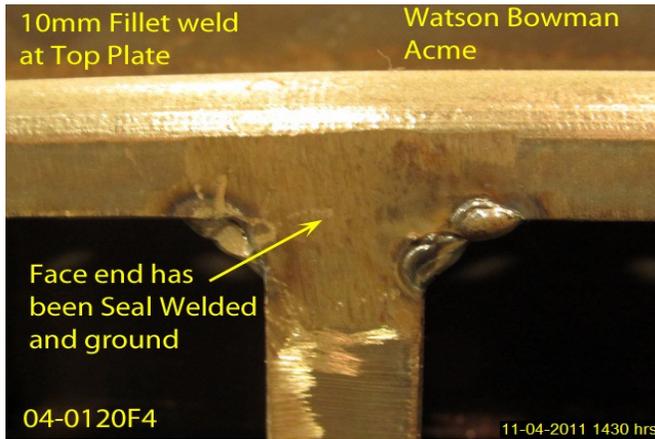
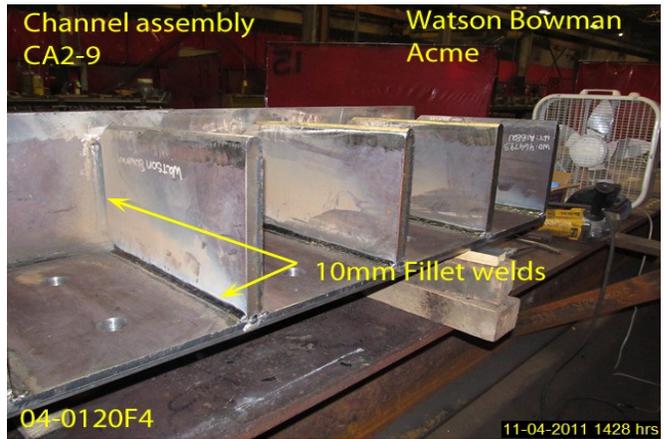
During random observations it was observed that WBA was adding a seal weld at the face of the stiffeners were the 10mm fillet weld and the PJP weld terminated. This weld is not approved on the shop drawings. An incident report will be generated for this issue and submitted to the Structural Materials Representative (SMR) see photos below.

Also noted was welder Jayson Gray performing Flux Core Arc Welding (FCAW) welding on component SEI112667-CA2-9, using Hobart (Tri-Mark) TM-811N1 electrode. The weld joint was identified as a 10mm fillet weld that joined the top plate and back plates to the stiffeners. WBA was using WPS, FCAW-11 for multi-pass fillet weld. The parameters were checked by ABF QC which appeared to be within the specified Welding Procedure Specification's (WPS). Mr. Gray was also observed using a rose bud torch to pre-heat the areas to 93 degrees Celsius (200F). John Crabtree is monitoring the welding for ABF on the night shift were James DiVirgillio is performing welding and fit up of CA2-10.
