DEPARTMENT OF TRANSPORTATION

Quality Assurance and Source Inspection

Contract #: 04-0120F4Cty: SF/ALA Rte: 80 PM: 13.2/13.9File #: 1.28**WELDING INSPECTION REPORT****Resident Engineer:** Casey, William**Address:** 333 Burma Road**City:** Oakland, CA 94607**Report No:** WIR-026671**Date Inspected:** 08-Nov-2011**Project Name:** SAS Superstructure**OSM Arrival Time:** 700**Prime Contractor:** American Bridge/Fluor Enterprises, a JV**OSM Departure Time:** 1730**Contractor:** American Bridge/Fluor Enterprises, a JV**Location:** Job Site**CWI Name:** Pat Swain**CWI Present:** Yes No**Inspected CWI report:** Yes No N/A**Rod Oven in Use:** Yes No N/A**Electrode to specification:** Yes No N/A**Weld Procedures Followed:** Yes No N/A**Qualified Welders:** Yes No N/A**Verified Joint Fit-up:** Yes No N/A**Approved Drawings:** Yes No N/A**Approved WPS:** Yes No N/A**Delayed / Cancelled:** Yes No N/A**Bridge No:** 34-0006**Component:** OBG Sections**Summary of Items Observed:**

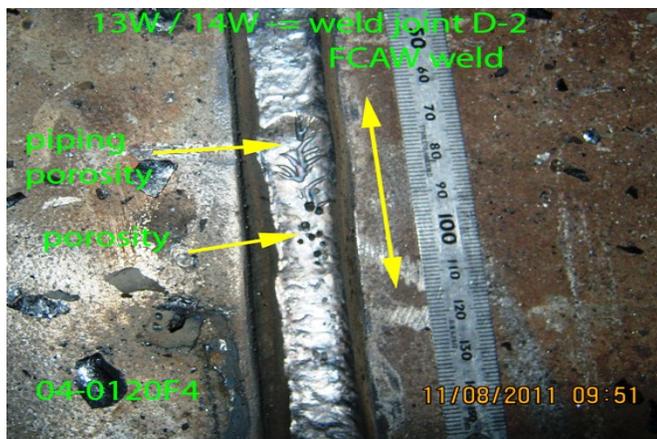
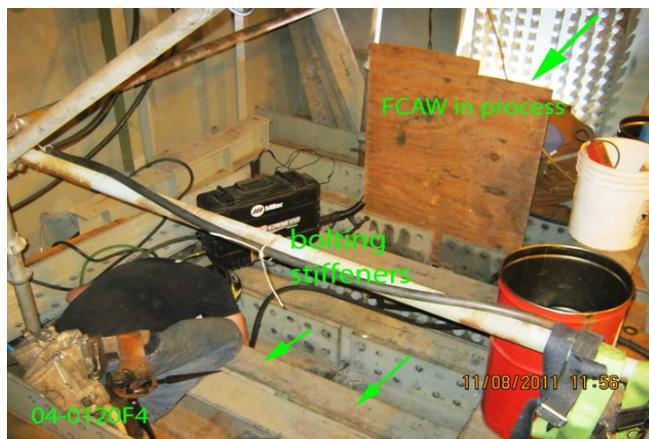
13W/14W – weld joint D-2: According to the documents being used by QC personnel this weld joint is designated as having continuous preheat including a 3 hour post weld heat. This QA Inspector observed ABF welding personnel Xiao Jian Wan (#9677) setting up to start using the Flux Cored Arc Welding (FCAW) process at the North end of this weld joint from Y-0 to approximately Y-430 to tie into where the Submerged Arc Welding (SAW) had ended due to the lack of space. This QA Inspector verified the preheat temperature was greater than 200°F using an electronic temperature gauge. This QA Inspector randomly observed as QC Inspector Pat Swain verified the following parameters; 263 amperes and 23.8 volts at a travel speed of 360 mm per minute to produce a heat input value of 1.04 KJ per mm. This QA Inspector performed a random visual verification on one of the weld passes and observed an area containing porosity, see photo below. This QA Inspector observed ABF welding personnel Xiao Jian Wan (#9677) was aware of the porosity and observed as a small electric grinder was used to remove the defect. QC Inspector Pat Swain performed an in process visual inspection and confirmed the porosity had been removed. The welding observed appeared to comply with Welding Procedure Specification (WPS) ABF-WPS-D15-3040A-1 being used by the QC Inspector. This QA Inspector observed welding at this location was completed at approximately 1130 hours this shift. This QA Inspector observed ABF welding personnel Xiao

13W/14W – weld joint A-2.2 to A-2 – Y- 3580 (full height vertical stiffener): This QA Inspector observed ABF welding personnel Jeremy Dolman (#5042) and ABF personnel Jeff Stone setting up the plasma arc back gouging equipment to start the removal of the backing strap and then back gouging of the weld at this location. This QA Inspector made several trips to this location during the shift and observed at multiple times there appeared to be issues with the equipment and/or technique regarding removing the backing strap. The work at this location was still in progress at this end of the shift this date.

13E/14E LS-4 and LS-5: This QA Inspector observed ABF welding personnel Fred Kaddu (#2188) performing Shielded Metal Arc Welding (SMAW) at this location. This QA Inspector was informed by QC Inspector John Pagliero the induction heating appeared to have been continuous thru the night and that the base metal temperature was greater than 200°F prior to the start of welding. QC Inspector John Pagliero informed this QA Inspector of the following welding parameters; 125 amperes. This QA Inspector observed a 3.2 mm diameter E9018H4R electrode was being used. The welding observed appeared to comply with ABF-WPS-D15-1012-3, being used by the QC Inspector. This QA Inspector observed welding was completed at approximately 0800 hours and that the induction heating blankets remained on the weld joint to start the 3 hour post heating. This QA Inspector observed QC Inspector John Pagliero perform a preliminary visual inspection of the weld to include the required transition due to an offset of the stiffener plates. This QA Inspector observed ABF welding personnel Fred Kaddu (#2188) started grinding on LS-4 in preparation of the fit up. Later this shift this QA Inspector observed the 3 hour post heat had been completed and informed by QC Inspector John Pagliero he had verified the temperature several times during the 3 hours.
