**DEPARTMENT OF TRANSPORTATION**

Contract #: 04-0120F4Cty: SF/ALA Rte: 80 PM: 13.2/13.9File #: 82.28**WELDING INSPECTION REPORT****Resident Engineer:** Casey, William**Address:** 333 Burma Road**City:** Oakland, CA 94607**Report No:** WIR-026673**Date Inspected:** 08-Nov-2011**Project Name:** SAS Superstructure**Prime Contractor:** American Bridge/Fluor Enterprises, a JV**Contractor:** Westmont Industries**OSM Arrival Time:** 600**OSM Departure Time:** 1430**Location:** Santa Fe Springs, CA**CWI Name:** Chris Concha**CWI Present:** Yes No**Inspected CWI report:** Yes No N/A**Rod Oven in Use:** Yes No N/A**Electrode to specification:** Yes No N/A**Weld Procedures Followed:** Yes No N/A**Qualified Welders:** Yes No N/A**Verified Joint Fit-up:** Yes No N/A**Approved Drawings:** Yes No N/A**Approved WPS:** Yes No N/A**Delayed / Cancelled:** Yes No N/A**Bridge No:** 34-0006**Component:** Maintenance Travelers**Summary of Items Observed:**

# WELDING INSPECTION REPORT

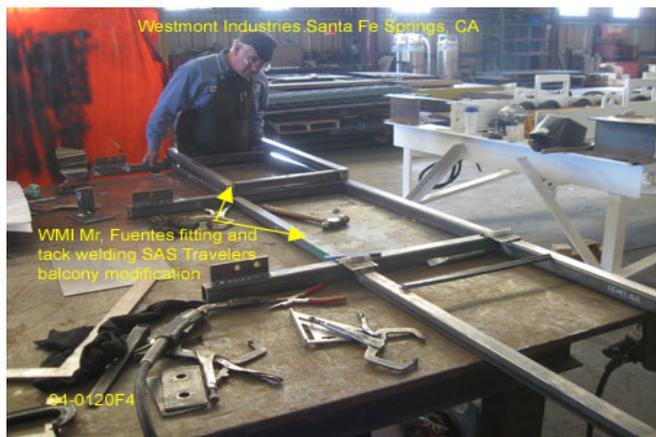
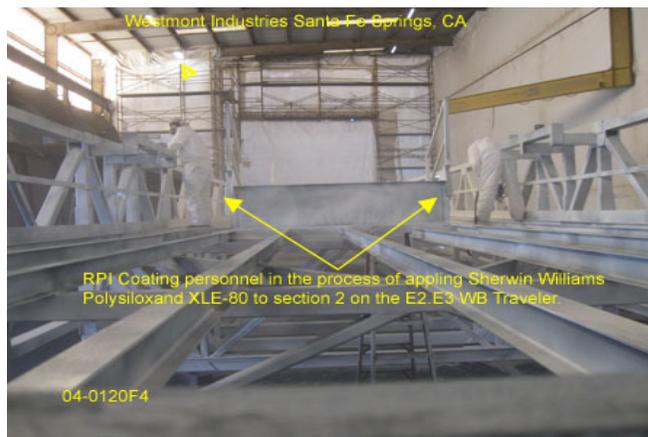
This QA Inspector performed random shop observations and observed that RPI is on site to continuing with the coating application on the E2/E3 WB Traveler. QA Inspector was informed by RPI Coating Mr. Preston Keen that RPI is going to sand section 3 out gassing areas and later in the day apply final top coat, and pressure wash in the morning and mist coat to the Caltrans test plate in the afternoon using the Sherwin Williams Polysiloxane XLE-80, today. Mr. Keen later in the shift informed QA Inspector that RPI will not complete the mist coat application on section 3 today. Environmental readings taken by RPI at the time of top coating application are as follows respectively: Air Temperature 45/76 F, Relative Humidity 70/40%, Wet Bulb Temperature 41/56 F, Dew point 36/39 F and Surface Temperature 44/72 F. QA Inspector also, observed Mr. Keen documenting daily actives on RPI Coating QC Daily Inspection Report.
