Contract #: 04-0120F4Cty: SF/ALA Rte: 80 PM: 13.2/13.9File #: 1.28**WELDING INSPECTION REPORT****Resident Engineer:** Casey, William**Address:** 333 Burma Road**City:** Oakland, CA 94607**Report No:** WIR-026732**Date Inspected:** 17-Nov-2011**Project Name:** SAS Superstructure**OSM Arrival Time:** 700**Prime Contractor:** American Bridge/Fluor Enterprises, a JV**OSM Departure Time:** 1730**Contractor:** American Bridge/Fluor Enterprises, a JV**Location:** Job Site

WELDING INSPECTION REPORT

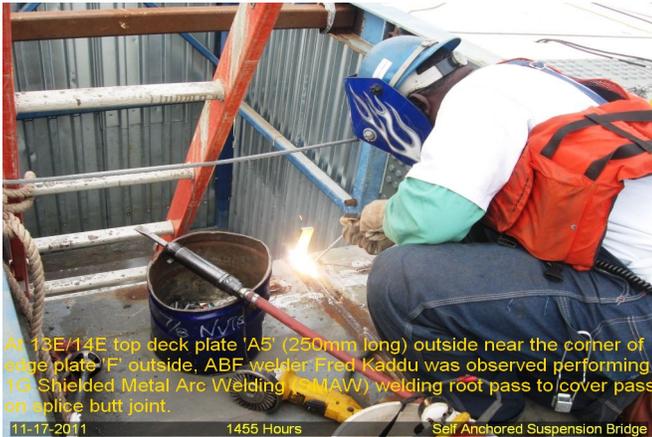
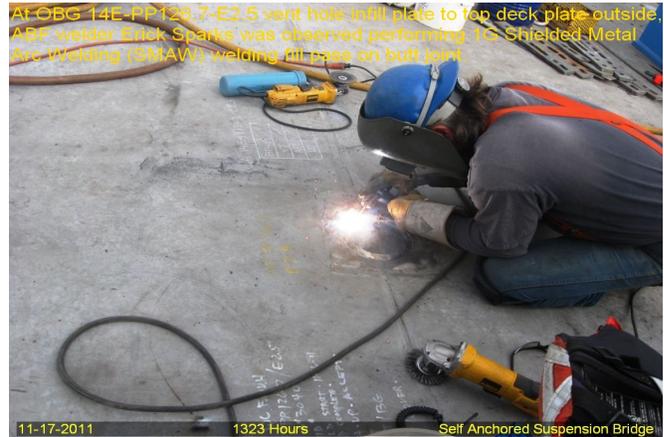
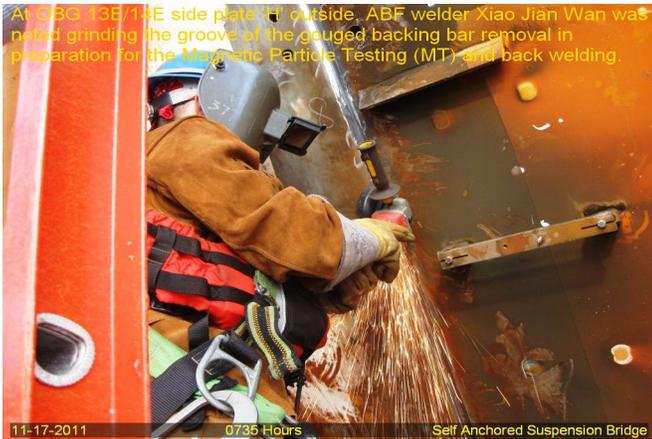
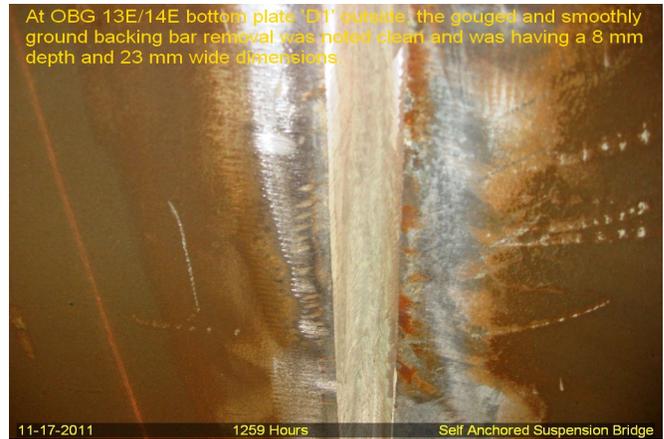
At OBG 14E-PP126.2-E2.4 vent hole infill plate to top deck plate outside, ABF welder Salvador Sandoval was observed continuing to perform 1G SMAW welding fill pass to cover pass on the infill plate to top deck plate butt joint. The welder was noted using 3/16" diameter E7018H4R electrode implementing Welding Procedure Specification (WPS) ABF-WPS-D15-1050A-CU for the Seismic Performance Critical Member (SPCM) butt joint. During welding, ABF QC Fred Von Hoff was noted monitoring the welder's welding parameters with measured working current of 235 amperes on the 3/16" electrode. The welder was noted preheating the plates to more than 150°F using propylene gas torch prior welding. During the shift, cover pass welding on the top side location of the butt joint was completed and the welder has moved to lifting lug hole 14E-PP125-E3-#2.

At OBG 14E-PP125-E3-#2 and #1 lifting lug hole infill plates to top deck plate outside, ABF welder Salvador Sandoval was observed continuing to perform 1G SMAW welding root pass to fill pass on the infill plate to top deck plate butt joint. The welder was noted using 1/8" diameter E7018H4R for root pass then switched to 5/32" diameter E7018H4R electrode for the fill pass. The welder was noted implementing Welding Procedure Specification (WPS) ABF-WPS-D15-1050A-CU for the Seismic Performance Critical Member (SPCM) butt joint. Prior welding, ABF QC Fred Von Hoff was observed inspecting the fit up of the butt joints. QA verified the fit up alignment of the lifting lug hole which deemed acceptable to the contract requirements. During welding, ABF QC Fred Von Hoff was noted monitoring the welder's welding parameters with measured working current of 120 amperes on the 1/8" electrode while 180 amperes on the 5/32" electrode. The welder was noted preheating the plates to more than 150°F using propylene gas torch prior welding. During the shift, fill pass welding on the top side location of the two butt joints was still continuing and should remain tomorrow.

At OBG 14E-PP126.7-E2.5 vent hole infill plate to top deck plate outside, ABF welder Erick Sparks was observed continuing to perform 1G SMAW welding fill pass to cover pass on the infill plate to top deck plate butt joint. The welder was noted using 1/8" diameter E7018H4R for root pass and fill pass. The welder was noted implementing Welding Procedure Specification (WPS) ABF-WPS-D15-1050A-CU for the SPCM butt joint. Prior welding, ABF QC Fred Von Hoff was observed inspecting the fit up of the butt joints. During welding, ABF QC Fred Von Hoff was noted monitoring the welder's welding parameters with measured working current of 130 amperes on the 1/8" E7018H4R electrode. During the shift, fill pass welding on the top side location of the butt joint was still continuing when the welder was pulled out and went to another job assignment.

At OBG 14E-PP125-E3.2 vent hole infill plate to top deck plate inside - ABF welder Rick Clayborn was observed 4G SMAW back welding fill pass to cover pass on the infill plate to top deck plate butt joint. The welder was noted using 1/8" diameter E7018H4R electrode implementing Caltrans approved Welding Procedure Specification (WPS) ABF-WPS-D15-1110A. Prior welding, ABF QC Bernie Docena was observed performing Magnetic Particle Testing (MT) on the back gouged of the welded butt joint. During welding, ABF QC Bernie Docena was noted monitoring the welder's welding parameters. At the end of the shift, the welder has completed the cover pass welding.

At 13E/14E top deck plate 'A5' (250mm long at the corner of edge plate 'F') outside, QA randomly observed ABF certified welder Fred Kaddu perform 1G (flat position) Shielded Metal Arc Welding (SMAW) welding root pass to cover pass on the CJP SPCM splice butt joint. The welder was utilizing 1/8" diameter E7018H4R on the root pass and 5/32" diameter E7018H4R on the fill pass to cover pass implementing Caltrans approved Welding Procedure Specification (WPS) ABF-WPS-D15-1040C Rev. 1. The joint being welded had a single V-groove butt joint with backing bar that will be removed then back welded. The plates were preheated to more than 150 degree Fahrenheit using propylene gas torch prior welding. Welding parameters were monitored by ABF/QC Fred Von Hoff. QA noted the welding parameters of 130amperes on the 1/8" diameter E7018H4R electrode while 155 amperes on the 5/32" diameter E7018H4R electrode. The workmanship and appearance of the completed root and cover pass deemed satisfactory. At the end of the shift, cover pass welding was completed.
