**DEPARTMENT OF TRANSPORTATION**

Quality Assurance and Source Inspection

Contract #: 04-0120F4Cty: SF/ALA Rte: 80 PM: 13.2/13.9File #: 1.28**WELDING INSPECTION REPORT****Resident Engineer:** Casey, William**Address:** 333 Burma Road**City:** Oakland, CA 94607**Report No:** WIR-026796**Date Inspected:** 01-Dec-2011**Project Name:** SAS Superstructure**OSM Arrival Time:** 700**Prime Contractor:** American Bridge/Fluor Enterprises, a JV**OSM Departure Time:** 1730**Contractor:** American Bridge/Fluor Enterprises, a JV**Location:** Job Site

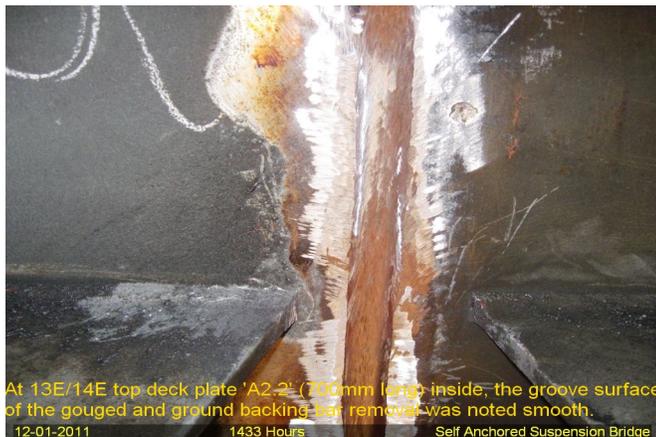
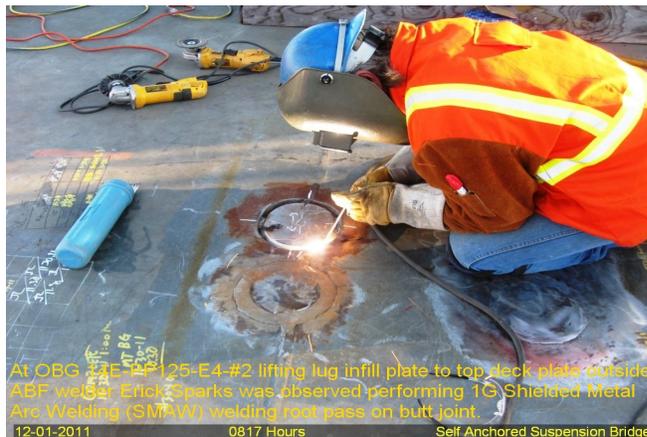
At OBG 14E-PP125-E4-#2 lifting lug hole infill plate to top deck plate inside, ABF welder Erick Sparks was observed continuing to perform 1G Shielded Metal Arc Welding (SMAW) welding fill pass on the infill plate to top deck plate butt joint. The welder was noted using 1/8" diameter E7018H4R implementing Welding Procedure Specification (WPS) ABF-WPS-D15-1050A-CU for the Seismic Performance Critical Member (SPCM) butt joint. Prior welding, ABF QC Fred Von Hoff was noted checking the fit up of the butt joint and found it acceptable. This QA performed the fit up verification and noted same result. During welding, ABF QC Fred Von Hoff was noted monitoring the welder's welding parameters with measured working current of 126 amperes on the 1/8" diameter E7018H4R electrode. The welder was noted preheating the plates to more than 150°F using propylene gas torch prior welding. During the shift, fill pass welding on the top side location of the butt joint was still continuing when the welder was pulled out and went to another work assignment leaving the work incomplete.

At OBG 13E/14E top deck plate A2.2 (870mm long) outside, QA randomly observed ABF/JV qualified welder Wai Kitlai was observed continuing to perform CJP groove (splice) back welding fill pass on the Seismic Performance Critical Member (SPCM) splice butt joint. The welder was observed perform manual welding in the 4G (overhead) position utilizing a dual shield Flux Cored Arc Welding (FCAW-G) with E71T-1M, 1/16" diameter wire electrode and implementing Caltrans approved Welding Procedure Specification (WPS) ABF-WPS-D15-3110-4. The joint being welded had a single V-groove butt joint with backing bar that has been

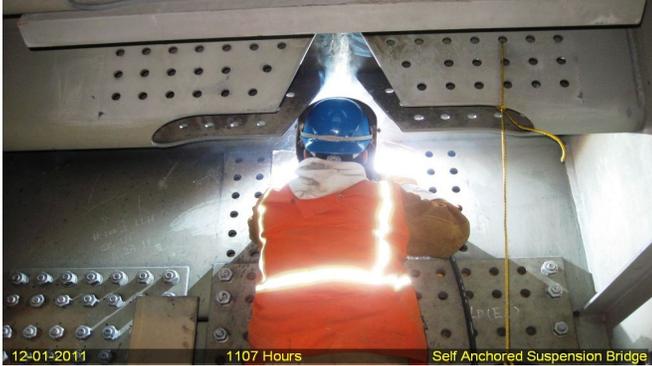
At OBG 13E/14E top deck plate 'A2.2' (870mm long) inside, ABF welder Wai Kitlai was observed performing 4G Flux Cored Arc Welding (FCAW-G) back welding fill pass on splice butt joint.

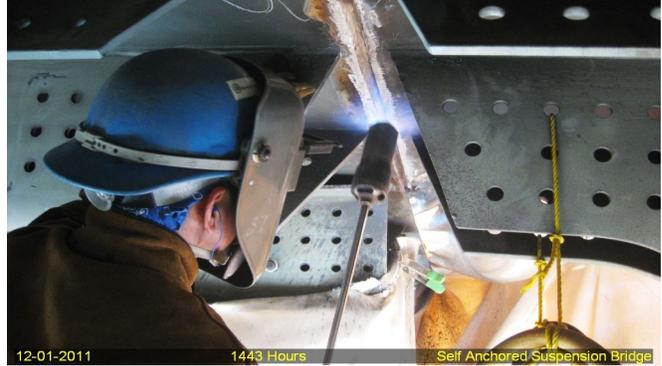
At 13E/14E top deck plate 'A2.2' (700mm long) inside, ABF welder Xiao Jian Wan was noted preheating the surface of the weld joint including the adjacent base metal prior 4G FCAW-G back welding.
