Contract #: 04-0120F4Cty: SF/ALA Rte: 80 PM: 13.2/13.9File #: 1.28**WELDING INSPECTION REPORT****Resident Engineer:** Casey, William**Address:** 333 Burma Road**City:** Oakland, CA 94607**Report No:** WIR-026814**Date Inspected:** 05-Dec-2011**Project Name:** SAS Superstructure**OSM Arrival Time:** 700**Prime Contractor:** American Bridge/Fluor Enterprises, a JV**OSM Departure Time:** 1730**Contractor:** American Bridge/Fluor Enterprises, a JV**Location:** Job Site**CWI Name:** Fred Von Hoff**CWI Present:** Yes No**Inspected CWI report:** Yes No N/A**Rod Oven in Use:** Yes No N/A**Electrode to specification:** Yes No N/A**Weld Procedures Followed:** Yes No N/A**Qualified Welders:** Yes No N/A**Verified Joint Fit-up:** Yes No N/A**Approved Drawings:** Yes No N/A**Approved WPS:** Yes No N/A**Delayed / Cancelled:** Yes No N/A**Bridge No:** 34-0006**Component:** OBG Sections**Summary of Items Observed:**

Orthotropic Box Girder (OBG):

13E/14E-weld D-1 (SPCM) Repair: This QA Inspector observed ABF welding personnel Wai Kitlai (#2953) and Xiao Jian Wan (#9677) using the Shielded Metal Arc Welding (SMAW) process for welding repairs at this location from outside the OBG section during thi

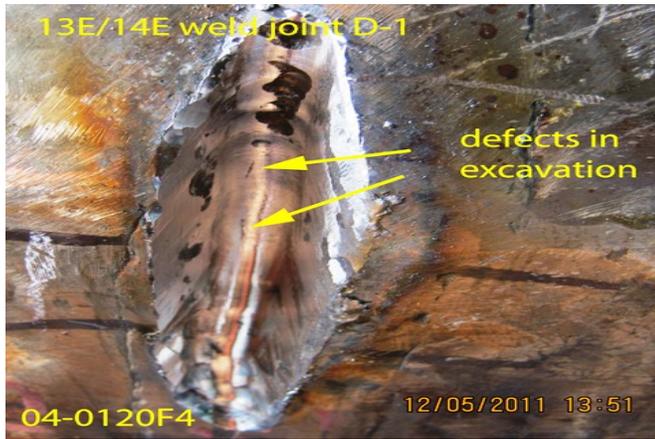
At Y-2080 and Y-2990 this QA Inspector observed ABF welding personnel Wai Kitlai (#2953) using the SMAW process to complete welding at this location. This QA Inspector observed the base metal preheat temperature was greater than 325°F and was informed by QC Inspector Fred Von Hoff the defect excavations were as follows; Y-2080 – length-105 mm, width-30 mm and depth-20 mm, Y-2990 – length-130 mm, width-30 mm and depth- 16 mm. QC Inspector Fred Von Hoff informed this QA Inspector the welding parameters for ABF welding personnel Wai Kitlai (#2953) were 137 amperes. This QA Inspector observed a 3.2 mm diameter E7018H4R electrode was being used in the overhead (4G) position. The welding observed appeared to comply with Welding Procedure Specification (WPS) ABF-WPS-D15-1004 Repair being used by the QC Inspector. This QA Inspector observed when the welding was completed the Post Weld Heat Treatment (PWHT) started and was informed by ABF welding personnel Wai Kitlai (#2953) the liquid induction heating equipment had been set for 1-1/2 hour of

PWHT. This QA Inspector periodically checked the temperature of the areas and observed the temperature was greater than 450°F and the PWHT was on for a minimum of 1-1/2 hours. The work at this location appeared to comply with ABF-WPS-D15-1004 Repair and be completed this date.
