Contract #: 04-0120F4Cty: SF/ALA Rte: 80 PM: 13.2/13.9File #: 1.28**WELDING INSPECTION REPORT****Resident Engineer:** Casey, William**Address:** 333 Burma Road**City:** Oakland, CA 94607**Report No:** WIR-026822**Date Inspected:** 06-Dec-2011**Project Name:** SAS Superstructure**OSM Arrival Time:** 700**Prime Contractor:** American Bridge/Fluor Enterprises, a JV**OSM Departure Time:** 1730**Contractor:** American Bridge/Fluor Enterprises, a JV**Location:** Job Site**CWI Name:** Bernard Decena**CWI Present:** Yes No**Inspected CWI report:** Yes No N/A**Rod Oven in Use:** Yes No N/A**Electrode to specification:** Yes No N/A**Weld Procedures Followed:** Yes No N/A**Qualified Welders:** Yes No N/A**Verified Joint Fit-up:** Yes No N/A**Approved Drawings:** Yes No N/A**Approved WPS:** Yes No N/A**Delayed / Cancelled:** Yes No N/A**Bridge No:** 34-0006**Component:** OBG Sections**Summary of Items Observed:**

WELDING INSPECTION REPORT

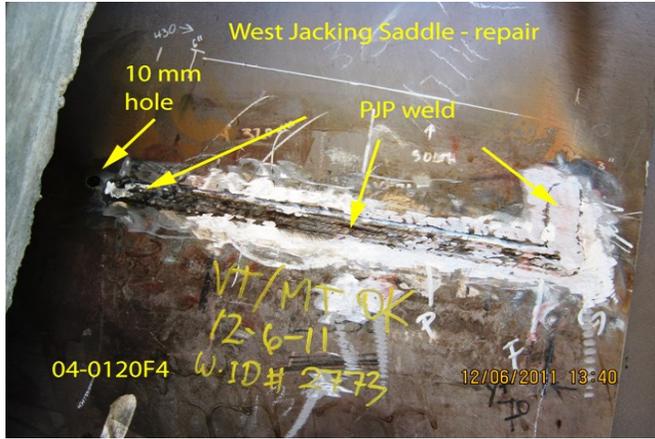
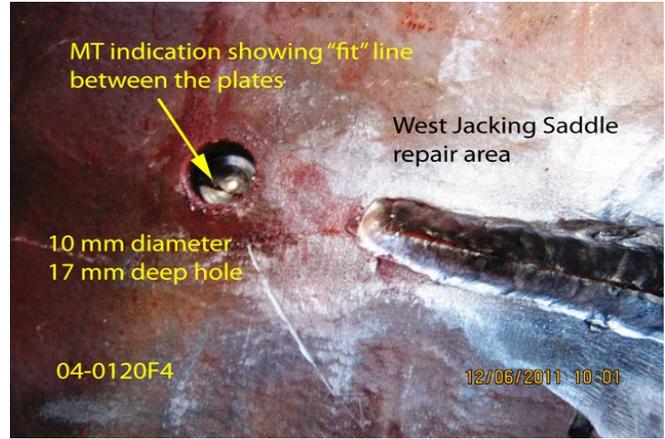
West Jacking Saddle – Repair: This QA Inspector was provided a copy of Request for Weld Repair Approval # 201111-003 and was informed by Lead QC Inspector Bonifacio Daquinag Jr. it had been approved by Structural Material Representative (SMR) Kittric Guest. This QA Inspector reviewed a copy of an email which appeared to be from SMR Kittric Guest approving the procedure. This QA Inspector arrived at the West Jacking Saddle and observed ABF personnel Ian Murphy using a portable drill motor to drill a pilot hole in the weld face adjacent to the previous excavation area. This QA Inspector observed as QC Inspector Bernard Decena used a depth gauge to verify the depth of the hole as 17 mm. This QA Inspector observed the drill bit was increased to what appeared to be a 10 mm (3/8-inch) diameter and drill using the larger diameter bit. This QA Inspector observed as QC

Inspector Bernard Decena verified the depth of the hole to be 17 mm. This QA Inspector performed a visual verification and observed the center of the hole appeared to be approximately 20 mm to the left of the previous excavation area. This QA Inspector observed as QC Inspector Bernard Decena measured and marked the depth of the previous excavation at various intervals and informed ABF welding personnel Rick Clayborn (#2773) the depth of the excavation needed to be 17 mm. This QA Inspector observed ABF welding personnel Rick Clayborn (#2773) using the carbon arc process to excavate the areas, a grinder and/or power wire brush to clean the base metal. This QA Inspector observed QC Inspector Bernard Decena use a depth gauge to verify the required depth of 17 mm had been obtained. This QA Inspector observed Bernard Decena perform a visual and Magnetic Particle Testing (MT) on the excavation area including the drilled hole. QC Inspector Bernard Decena informed this QA Inspector he had accepted the inspections. This QA Inspector performed a visual verification and the work appeared to meet the contract requirements. See photo below of drilled hole after MT. This QA Inspector observed a hand held gas torch was used to preheat the excavations. This QA Inspector observed QC Inspector Bernard Decena use an electronic temperature gauge to verify the preheat was greater than the minimum required on the Welding Procedure Specification (WPS). This QA Inspector observed the minimum preheat temperatures used by the QC inspector were as follows; 350°F for the 80 mm thick vertical cover plate and 200°F for the remainder of the 40 mm thick plates. This QA Inspector observed QC Inspector Bernard Decena verify the following Shielded metal Arc Welding (SMAW) parameters for ABF welding personnel Rick Clayborn (#2773); 130 amperes. This QA Inspector observed the electrodes were removed from a new sealed container and were identified as being a E9018 electrode. This QA Inspector was informed by ABF personnel Ian Murphy the remaining electrodes were placed into a heated storage container until needed. This QA Inspector observed the welding and cleaning between passes as work progressed. This QA Inspector observed QC Inspector Bernard Decena perform a visual and MT inspection on what appeared to be the completed weld. This QA Inspector observed QC Inspector Bernard Decena mark the area indicating the visual and MT inspection were completed at this time. This QA Inspector reminded QC Inspector Bernard Decena the contract requirements required a 48 hour waiting period prior to the final inspections, QC Inspector Bernard Decena concurred and stated this would be a preliminary inspection and the weld would re-inspected for the final inspection after 48 hours.
