Contract #: 04-0120F4Cty: SF/ALA Rte: 80 PM: 13.2/13.9File #: 82.28**WELDING INSPECTION REPORT****Resident Engineer:** Casey, William**Address:** 333 Burma Road**City:** Oakland, CA 94607**Report No:** WIR-026853**Date Inspected:** 08-Dec-2011**Project Name:** SAS Superstructure**OSM Arrival Time:** 600**Prime Contractor:** American Bridge/Fluor Enterprises, a JV**OSM Departure Time:** 1430**Contractor:** Westmont Industries**Location:** Santa Fe Springs, CA

Bridge No: 34-0006**Component:** Maintenance Travelers**Summary of Items Observed:**

WELDING INSPECTION REPORT

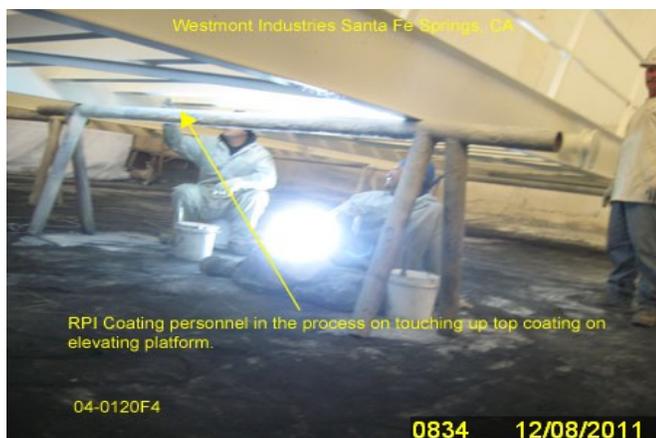
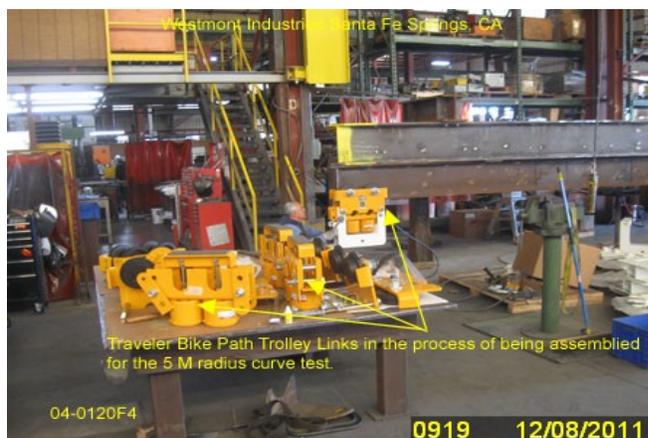
This QA Inspector randomly observed Smith Emery, CWI, QC Inspector Mr. Chris Concha performing visual inspection on the SAS WB traveler. Mr. Concha informed this QA Inspector that he had found several areas for in process grinding and welding. This QA Inspector randomly observed WMI production welder Mr. Eutimo Lopez (WID # 3035) grinding and welding areas found Mr. Concha using Flux Core Arc Welding (FCAW) process in all positions on tube steel and plate material, randomly throughout the shift. QC visual inspection and pick-up welding not completed on this date.

This QA Inspector performed random shop observations and observed that RPI is on site to continuing with the coating application. QA Inspector was informed by RPI Coating Mr. Preston Keen that RPI is going to apply touch up top coating on (3) elevating platforms, (3) balconies using the Sherwin Williams Polysiloxane XLE-80, today. This QA randomly observed RPI touching up top coating to the above. Coating application appeared to comply with contract documents. Note: RPI completed elevating platforms, balconies and bike path assemblies on this date. Mr. Keen informed this QA that RPI Coating will not be on site tomorrow.
