Contract #: 04-0120F4Cty: SF/ALA Rte: 80 PM: 13.2/13.9File #: 82.28**WELDING INSPECTION REPORT****Resident Engineer:** Casey, William**Address:** 333 Burma Road**City:** Oakland, CA 94607**Report No:** WIR-026854**Date Inspected:** 09-Dec-2011**Project Name:** SAS Superstructure**Prime Contractor:** American Bridge/Fluor Enterprises, a JV**Contractor:** Westmont Industries**OSM Arrival Time:** 500**OSM Departure Time:** 1330**Location:** Santa Fe Springs, CA

Bridge No: 34-0006**Component:** Maintenance Travelers**Summary of Items Observed:**

On this date, Caltrans Quality Assurance Inspector (QA) Sherri Brannon is present at the Westmont Industries (WMI) jobsite in Santa Fe Springs, California for the purpose of observing fabrication and QC functions for the SAS Superstructure, Bid Item #99, Maintenance Traveler and Bid Item #100, Maintenance Traveler (Bike Path).

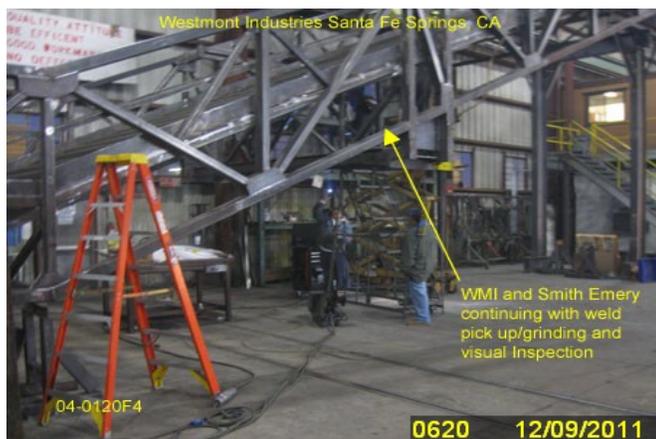
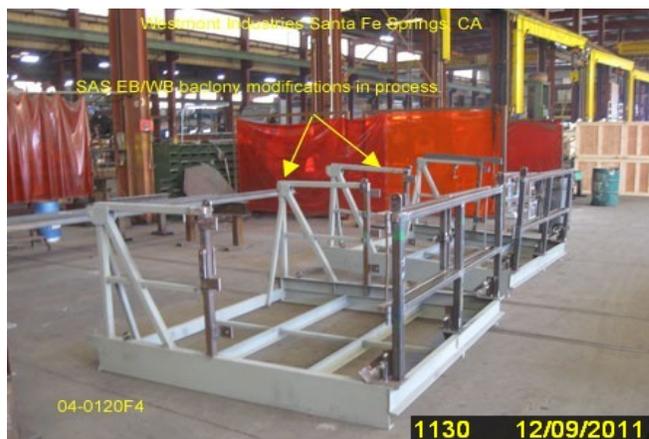
This QA Inspector observed WMI representative Mr. Cesar Canales performing random dimensional verification on the SAS-WB Traveler. QA Inspector noted that at this time all of the welding of the assemblies for SAS-WB Traveler appeared to be complete. During the activities, this QA Inspector noted that these locations included random sections of various frame assemblies, random sections of the primary and secondary suspension lift plates, and random dimensional measurements which include overall length, width and height of the completed traveler assembly. QA noted that random dimensional measurement appeared to be within approved tolerances in relation to shop drawings dimensions.
