Contract #: 04-0120F4Cty: SF/ALA Rte: 80 PM: 13.2/13.9File #: 82.28**WELDING INSPECTION REPORT****Resident Engineer:** Casey, William**Address:** 333 Burma Road**City:** Oakland, CA 94607**Report No:** WIR-026940**Date Inspected:** 20-Dec-2011**Project Name:** SAS Superstructure**OSM Arrival Time:** 600**Prime Contractor:** American Bridge/Fluor Enterprises, a JV**OSM Departure Time:** 1430**Contractor:** Westmont Industries**Location:** Santa Fe Springs, CA**CWI Name:** Chris Concha**CWI Present:** Yes No**Inspected CWI report:** Yes No N/A**Rod Oven in Use:** Yes No N/A**Electrode to specification:** Yes No N/A**Weld Procedures Followed:** Yes No N/A**Qualified Welders:** Yes No N/A**Verified Joint Fit-up:** Yes No N/A**Approved Drawings:** Yes No N/A**Approved WPS:** Yes No N/A**Delayed / Cancelled:** Yes No N/A**Bridge No:** 34-0006**Component:** Maintenance Travelers**Summary of Items Observed:**

WELDING INSPECTION REPORT

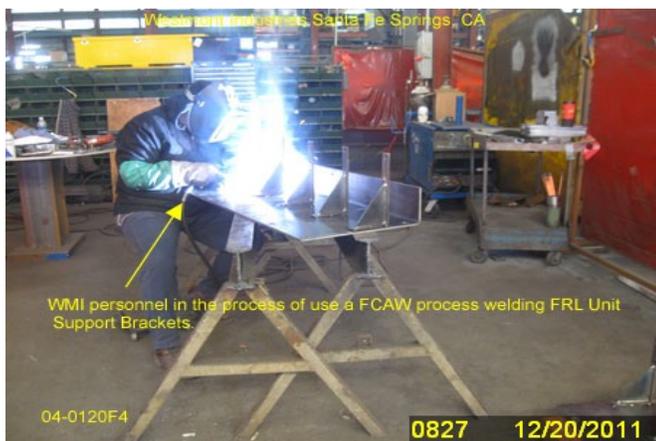
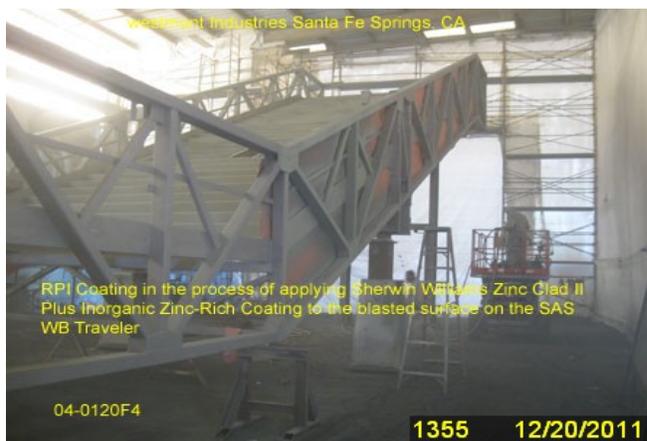
sweep/spot blasting was completed, QA Inspector then observed Mr. Keen performing random surface profile checks on the sweep blasted base metal surfaces. This QA Inspector observed Mr. Keen utilizing a Testex Press-O-Film and a micrometer to perform the testing. During observation, this QA Inspector observed that the readings appeared to be 3.2 mils, 3.1 mils, and 3.2 mils. QA Inspector then observed Mr. Keen perform a test for soluble salts on the previously blasted base metal surface. Testing observed by QA Inspector appears to be in compliance with the contract requirements.

Later in the shift, this QA Inspector randomly observed RPI Coating performing what appeared to be primer application activities within what appeared to be within and 8 hour time frame form the above mentioned sweep blasting activities. Environmental readings taken by RPI at the time of the coating application are as follows Air Temperature 47/70 F, Relative Humidity 70/51%, Wet Bulb Temperature 43/61 F, Dew point 38/54 F and Surface Temperature 45/57 F.

This QA noted above items observed appear to comply with contract documents.
