DEPARTMENT OF TRANSPORTATION

Quality Assurance and Source Inspection

Contract #: 04-0120F4Cty: SF/ALA Rte: 80 PM: 13.2/13.9File #: 1.28**WELDING INSPECTION REPORT****Resident Engineer:** Casey, William**Address:** 333 Burma Road**City:** Oakland, CA 94607**Report No:** WIR-026959**Date Inspected:** 27-Dec-2011**Project Name:** SAS Superstructure**OSM Arrival Time:** 700**Prime Contractor:** American Bridge/Fluor Enterprises, a JV**OSM Departure Time:** 1530**Contractor:** American Bridge/Fluor Enterprises, a JV**Location:** Job Site**CWI Name:** See below**CWI Present:** Yes No**Inspected CWI report:** Yes No N/A**Rod Oven in Use:** Yes No N/A**Electrode to specification:** Yes No N/A**Weld Procedures Followed:** Yes No N/A**Qualified Welders:** Yes No N/A**Verified Joint Fit-up:** Yes No N/A**Approved Drawings:** Yes No N/A**Approved WPS:** Yes No N/A**Delayed / Cancelled:** Yes No N/A**Bridge No:** 34-0006**Component:** SAS**Summary of Items Observed:**

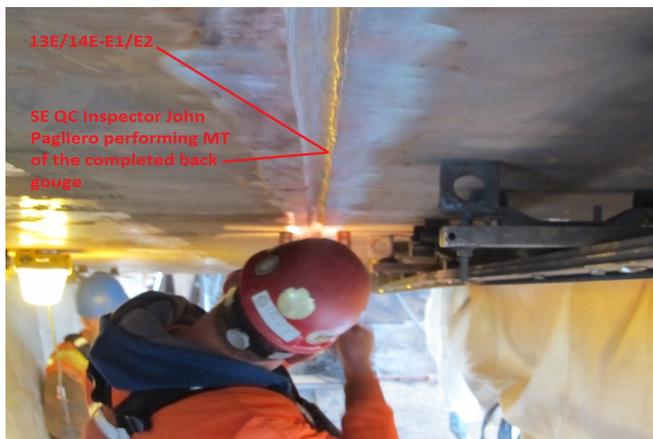
11E-pp100-E4-W4

The Caltrans Quality Assurance (QA) Inspector Rick Bettencourt randomly observed the American Bridge/Fluor (ABF) welder Salvador Sandoval performing carbon arc gouging and back grinding of the above identified weld joints. It was noted prior to the arrival of the QA Inspector the top side of the weld joints had been completed and ground flush with the top deck plate. The QA inspector randomly observed the ABF welder grind the back gouged weld joints to bright metal. The QA Inspector randomly observed the back gouged weld joints and noted they appeared to be in general compliance with the contract requirements. The QA Inspector randomly observed the SE QC Inspector Salvador Moreno perform magnetic particle testing (MT) of the back gouged weld joint and noted no relevant indications were present at the time of the testing. The QA Inspector randomly observed the ABF welder continue welding the in process lifting lug hole restoration of hole #4. The QA Inspector noted the weld joint was approximately 50% complete at the time of the SMAW 4G back weld. The QA Inspector randomly observed the ABF welder continue the SMAW cover pass. The QA Inspector noted the ABF welder completed the above identified weld joint on this date. The QA Inspector randomly observed the SMAW parameters were 1/8" E7018 low hydrogen electrodes with 112 Amps. The QA Inspector noted the parameters appeared to be in general compliance with ABF-WPS-1110A. The QA Inspector randomly observed the ABF welder did complete the above identified lifting lug holes on this date. The QA Inspector noted the weld reinforcement was ground flush on the QA Inspectors shift.
