DEPARTMENT OF TRANSPORTATION

Quality Assurance and Source Inspection

WELDING INSPECTION REPORT

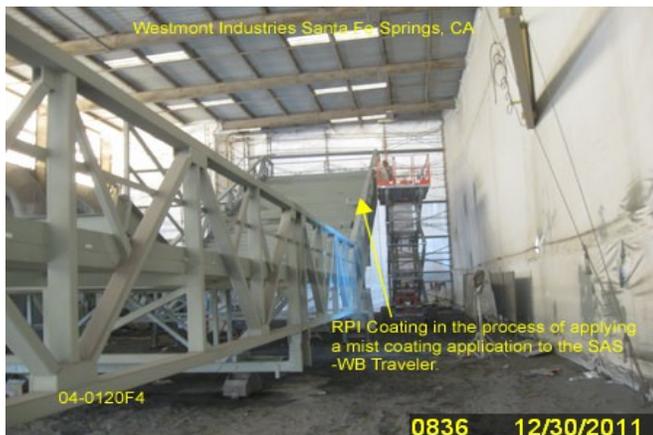
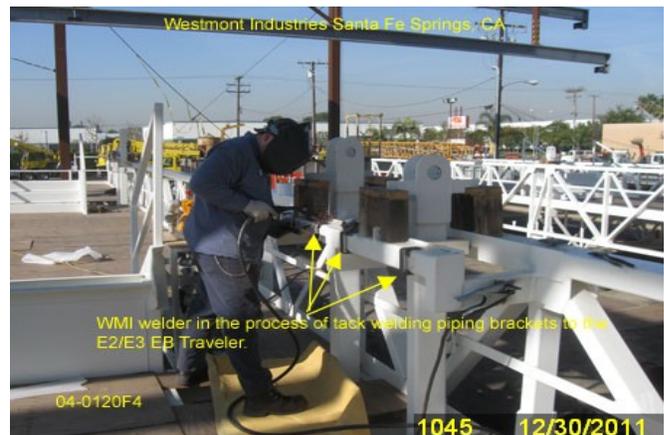
Prime coated on 12-21-11 – Fixed stairs - Adhesion Test – 1000 psi, 900 psi & 800 psi, Pencil Test (pass), Quarter Test (pass) and Rub test (pass). Prime coated on 12-22-1 – middle section, Lower Truss – Adhesion Test – 800 psi and glue failure) Pencil Test (pass), Quarter Test (pass) and Rub test (pass). Testing observed by QA Inspector appears to be in compliance with the contract requirements.

This QA noted above items observed appear to comply with contract documents.
