Contract #: 04-0120F4Cty: SF/ALA Rte: 80 PM: 13.2/13.9File #: 99.28**WELDING INSPECTION REPORT**

Project Name: SAS Superstructure
Prime Contractor: American Bridge/Fluor Enterprises, a JV
Contractor: L & M Industrial Fabricators

CWI Name:	Tom Dreyer	CWI Present:	Yes	No
Inspected CWI report:	Yes No N/A	Rod Oven in Use:	Yes No N/A	
Electrode to specification:	Yes No N/A	Weld Procedures Followed:	Yes No N/A	
Qualified Welders:	Yes No N/A	Verified Joint Fit-up:	Yes No N/A	
Approved Drawings:	Yes No N/A	Approved WPS:	Yes No N/A	
		Delayed / Cancelled:	Yes No N/A	
Bridge No:	34-0006	Component:	Tower Head Parapet

CCO: 196 - Description: Construct parapet walls at the Tower Head

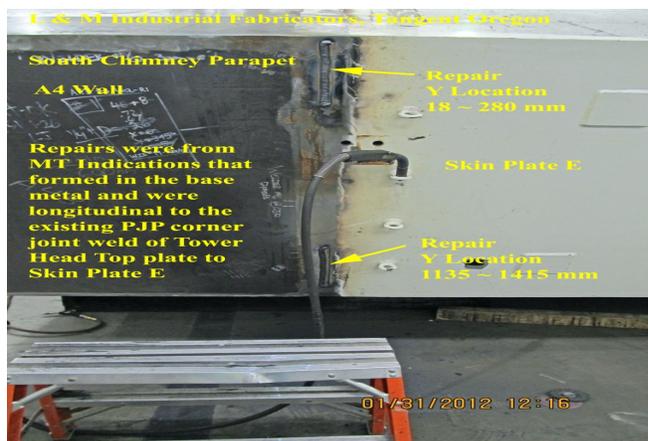
This QA Inspector randomly observed L & M welder Otis Smith (Welder ID #19) performing the repair weld operation per the Flux Cored Arc Welding (FCAW-G) gas shielding process in the (3G) vertical position on the partial-joint penetration (PJP) existing corner-joint weld connecting the Tower Head Top plate to Tower Head Skin Plate E of the South Tower Head Chimney. The QC NDT Inspector performed magnetic particle test inspection adjacent to the existing PJP weld and observed two (2) rejectable longitudinal linear indications at "Y" Locations (99~107) mm and (1342~1350) mm. The prepared U groove dimension after grinding out the rejectable indications were at "Y" Locations (18~280) mm and (1135~1415) and both were at a depth of (16) mm and widths varied from (16~18) mm.

This QA Inspector observed QC Inspector Tom Dreyer verify prior to the start of the repair weld operation that the minimum preheat temperature as per the approved repair WPS was established and afterwards verified that the welding parameters (Amps and Volts) were in accordance with WPS-LM-FC-01 Repair using Hobart Excel Arc E71T-1 (.052") diameter electrode.

The repair weld operation was completed at the end of this QA Inspectors shift.
