Quality Assurance and Source Inspection

Contract #: 04-0120F4Cty: SF/ALA Rte: 80 PM: 13.2/13.9File #: 1.28**WELDING INSPECTION REPORT****Resident Engineer:** Casey, William**Address:** 333 Burma Road**City:** Oakland, CA 94607**Report No:** WIR-027131**Date Inspected:** 03-Feb-2012**Project Name:** SAS Superstructure**OSM Arrival Time:** 700**Prime Contractor:** American Bridge/Fluor Enterprises, a JV**OSM Departure Time:** 1530**Contractor:** American Bridge/Fluor Enterprises, a JV**Location:** Job Site**CWI Name:** Steve Jensen**CWI Present:** Yes No**Inspected CWI report:** Yes No N/A**Rod Oven in Use:** Yes No N/A**Electrode to specification:** Yes No N/A**Weld Procedures Followed:** Yes No N/A**Qualified Welders:** Yes No N/A**Verified Joint Fit-up:** Yes No N/A**Approved Drawings:** Yes No N/A**Approved WPS:** Yes No N/A**Delayed / Cancelled:** Yes No N/A**Bridge No:** 34-0006**Component:** SAS OBG**Summary of Items Observed:**

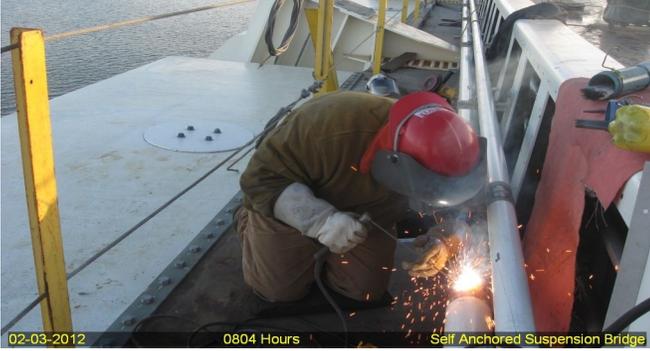
At OBG 8W panel point PP61 grid line W2, EW Spencer welder Damian L Lanes was observed performing EC shielded Metal Arc Welding (SMAW) welding root pass to cover pass on 2 5/8" and 4" diameter pipe splice butt joints.

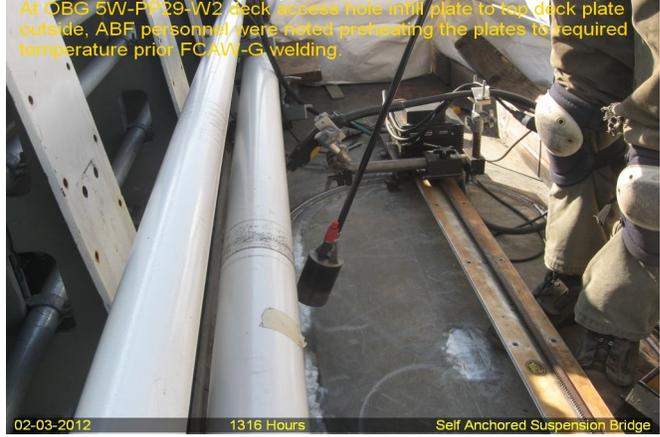
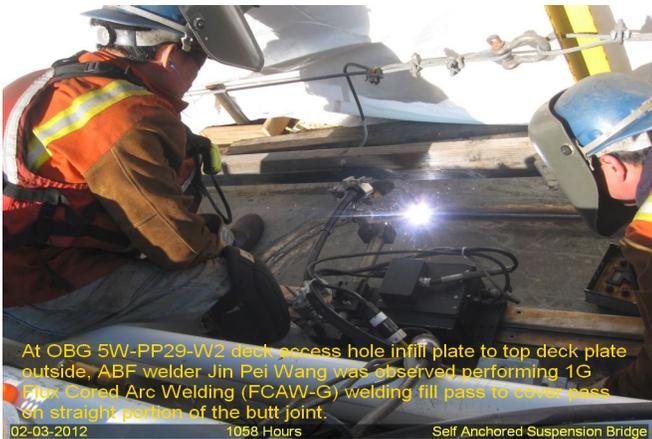
At OBG 5W-PP29-W2 deck access hole infill plate to top deck plate outside, ABF personnel were noted preheating the plates to required temperature prior FCAW-G welding.
