Contract #: 04-0120F4Cty: SF/ALA Rte: 80 PM: 13.2/13.9File #: 99.28**WELDING INSPECTION REPORT**

Report No: WIR-027200
Date Inspected: 15-Feb-2012

Project Name: SAS Superstructure
Prime Contractor: American Bridge/Fluor Enterprises, a JV
Contractor: L&M Industrial Fabricators

CWI Name:	Thomas Dreyer	CWI Present:	Yes	No
Inspected CWI report:	Yes No N/A	Rod Oven in Use:	Yes No N/A	
Electrode to specification:	Yes No N/A	Weld Procedures Followed:	Yes No N/A	
Qualified Welders:	Yes No N/A	Verified Joint Fit-up:	Yes No N/A	
Approved Drawings:	Yes No N/A	Approved WPS:	Yes No N/A	
		Delayed / Cancelled:	Yes No N/A	
Bridge No:	34-0006	Component:	CCO 196 and 203

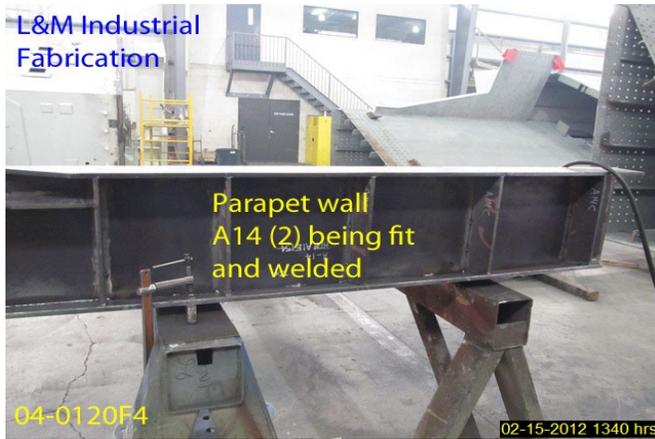
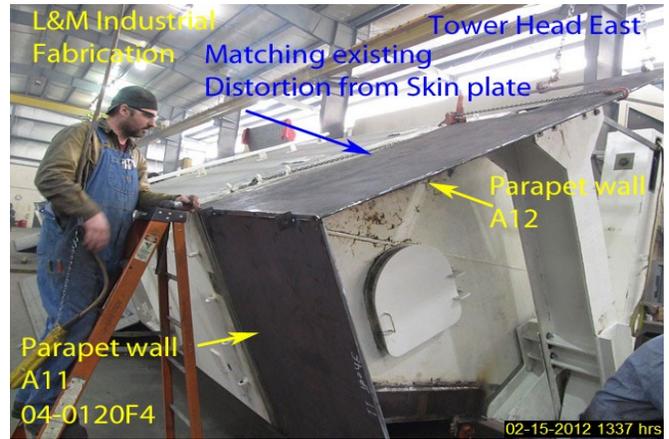
This QA Inspector randomly observed L & M welding personnel Bradford Schroyer (Welder ID #16) fitting and welding parapet wall assembly A14 (number 2) for Tower Head West, under Welding Procedure Specification (WPS) D1.5-FC-005-2F (Fillet) and D1.5-FC-TC-P4-GF-1&2G (Joint TC-P4-GF [PJP]). The welder was observed using the Flux Cored Arc Welding (FCAW) process with the electrode being used as Hobart Excel Arc 71, E71T-1; the welding is in the horizontal and flat positions placing fillet welds and Partial Joint Penetration (PJP) welds. The welding parameters checked by the QC inspector appeared to be within the specified WPS. This QAI observed QC inspector Tom Dreyer observing the work in process.

This QAI randomly observed that L&M personnel Otis Smith (Welder ID #19) Jake Schuld (Welder #17) Was fitting the parapet walls (A11 and A12) to the base plate and matching the distortion from the tower skin plate as outlined in the CCO196. Welder Jake Schuld was the Flux Cored Arc Welding (FCAW) process with the electrode being used as Hobart Excel Arc 71, E71T-1 to tack weld the plates in place prior to welding. The fabricator continued to perform the fit up of the parapet walls on the east tower head throughout this QAI working shift.
