**DEPARTMENT OF TRANSPORTATION**

Contract #: 04-0120F4Cty: SF/ALA Rte: 80 PM: 13.2/13.9File #: 1.28**WELDING INSPECTION REPORT****Resident Engineer:** Casey, William**Address:** 333 Burma Road**City:** Oakland, CA 94607**Report No:** WIR-027206**Date Inspected:** 13-Feb-2012**Project Name:** SAS Superstructure**OSM Arrival Time:** 700**Prime Contractor:** American Bridge/Fluor Enterprises, a JV**OSM Departure Time:** 1730**Contractor:** American Bridge/Fluor Enterprises, a JV**Location:** Job Site**CWI Name:** Steve Jensen**CWI Present:** Yes No**Inspected CWI report:** Yes No N/A**Rod Oven in Use:** Yes No N/A**Electrode to specification:** Yes No N/A**Weld Procedures Followed:** Yes No N/A**Qualified Welders:** Yes No N/A**Verified Joint Fit-up:** Yes No N/A**Approved Drawings:** Yes No N/A**Approved WPS:** Yes No N/A**Delayed / Cancelled:** Yes No N/A**Bridge No:** 34-0006**Component:** SAS OBG**Summary of Items Observed:**

Caltrans Office of Structural Material (OSM) Quality Assurance Inspector (QAI) Joselito Lizardo was present at the Self Anchored Suspension (SAS) job site as requested to perform observations on the welding of components for the San Francisco Oakland Bay Br

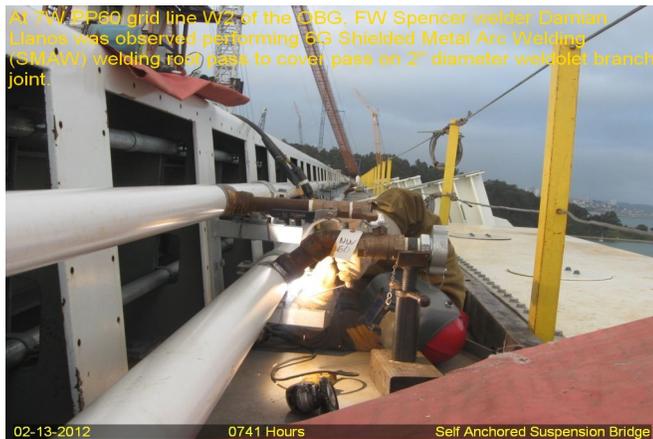
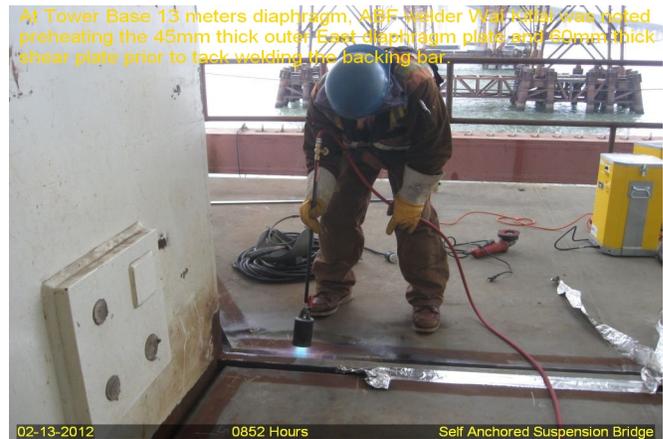
At the Tower Base, ABF welder Wai Kitlai was observed performing tack welding of backing bar for the Partial Joint Penetration (PJP) of the 13 meters diaphragm plates to tower shear plates. The welder was observed welding in the 2F (horizontal) position utilizing Shielded Metal Arc Welding (SMAW) with 1/8" diameter E7018H4R electrode and implementing Caltrans approved Welding Procedure Specification (WPS) ABF-WPS-D15-1160. The welder was noted preheating the plates to more than 150 degrees Fahrenheit using propane gas torch. Since the joints were PJP it was not required to have the backing bar continuous. The tack welding of the backing was monitored by ABF QC Steve Jensen. While the welder was tack welding the backing bar to the 13 meters diaphragm plates, this QA together with QC Steve Jensen measured the alignment of the diaphragm plates with respect to the shear plates. The following measurements were noted;

At location Panel Point PP60 of OBG grid line W2, FW Spender welder Damian Llanos was observed performing 6G (all position) Shielded Metal Arc Welding (SMAW) welding root pass to cover pass on the 2" weldolet branch of the 4" compressed air line. The welder was noted welding the root pass with 3/32" diameter E6010 electrode and followed by fill pass to cover pass using 3/32" diameter E7018H4R electrode implementing Caltrans approved procedure FW Spencer WPS 1-12-1. The welder was noted preheating and removing the moisture of the joint using a portable propane gas torch prior welding. During welding, ABF QC Steve Jensen was noted monitoring the parameters of the welder. At around 9:00 in the morning, the rain shower was more persistent and the welder decided to shut down their job and went home.
