Contract #: 04-0120F4Cty: SF/ALA Rte: 80 PM: 13.2/13.9File #: 1.28**WELDING INSPECTION REPORT**

Report No: WIR-027226
Date Inspected: 22-Feb-2012

Project Name: SAS Superstructure
Prime Contractor: American Bridge/Fluor Enterprises, a JV
Contractor: American Bridge/Fluor Enterprises, a JV

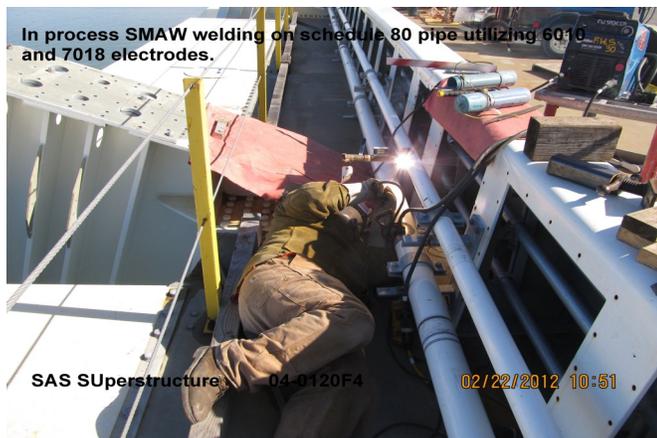
This QA Inspector observed F.W. Spencer welder Damian LLanos ID# (6645) performing Shielded Metal Arc Welding (SMAW) in all positions on schedule 80 4" domestic water pipe and 2.5" compressed air pipe outlets at the locations listed below. This QA Inspector verified the fit up of the joints and found it to be satisfactory and randomly observed QC Inspector Steve Jensen monitoring the welding to ensure the welding parameters were in compliance pertaining to WPS-1-12-1 Revision 2 (1.12). The welder was observed utilizing 6010 electrodes in the root pass with the balance using 7018 electrodes. The QA inspector made subsequent observations throughout the shift to monitor quality and noted that the work appears to be in general conformance with the contract documents.

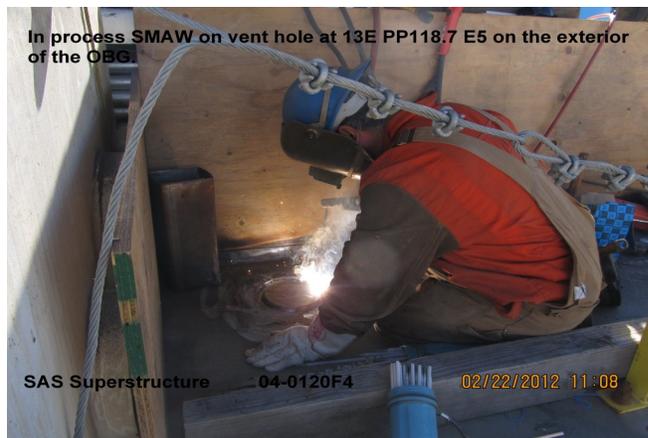
This QA Inspector randomly observed QC Inspector Fred Von Hoff perform fit-up operations on vent hole 13E PP118.7 E5. The QC Inspector was observed utilizing a Bridge Cam Gauge to measure the planar offset to be

within + or – 1 mm from “A” deck. The welder was then observed employing a propane burner to heat the joint and this QA Inspector verified the fit-up as acceptable and employed a 66°C Tempilstik to ensure the minimum pre-heat temperature had been achieved. This QA Inspector randomly observed ABF welder Salvador Sandoval (welder ID 2202) performing the SMAW process in the (1G) flat position and observed the QC Inspector verify the welding parameters were in accordance with ABF-WPS-D15-1050A-CU. The welder was observed grinding and blending the edges of each pass and kept the work sanitary throughout the joints depth. The QC Inspector was observed monitoring the welding and measured the inter-pass temperatures between passes. This QA Inspector made subsequent observations throughout the shift to monitor quality and noted that the work was completed on this date and appeared to be in general compliance with the approved WPS and the contract specifications.

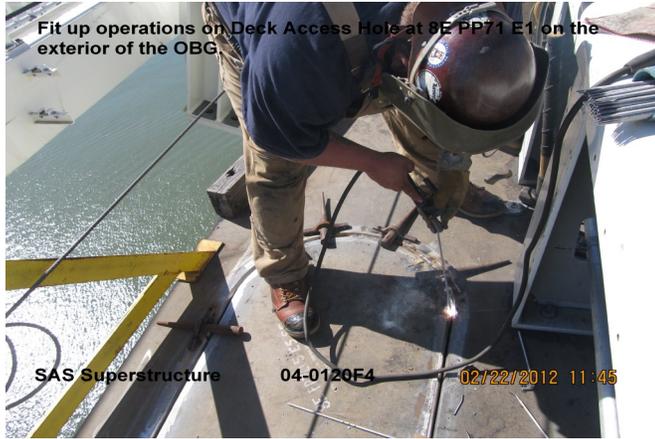
This QA Inspector at random intervals, observed the fit up of the deck access plate located at 8E PP71 at grid line E2. ABF welder Jason Collins was observed utilizing alignment aids and temporary attachment templates to achieve a uniform root gap along the plate’s perimeter. QC Inspector Chuck Storer measured the joint configuration and found it to be acceptable and the welder was observed implementing 3.2mm E7018-H4R electrodes to tack the plate in place. Upon completion of the fit-up, the welder utilized the SMAW process in the 1G flat position and the QC Inspector was observed monitoring the welding and the parameters to ensure conformance with ABF-WPS-D1.5-1010-Revision 1. This QA Inspector made subsequent observations throughout the shift to monitor quality and noted that the work is in progress and appears to be in general conformance with the contract specifications.
