Contract #: 04-0120F4Cty: SF/ALA Rte: 80 PM: 13.2/13.9File #: 99.28**WELDING INSPECTION REPORT****Resident Engineer:** Casey, William**Address:** 333 Burma Road**City:** Oakland, CA 94607**Report No:** WIR-027227**Date Inspected:** 23-Feb-2012**Project Name:** SAS Superstructure**OSM Arrival Time:** 700**Prime Contractor:** American Bridge/Fluor Enterprises, a JV**OSM Departure Time:** 1530**Contractor:** L & M Industrial Fabricators**Location:** Tangent, Oregon**CWI Name:** Tom Dreyer**CWI Present:** Yes No**Inspected CWI report:** Yes No N/A**Rod Oven in Use:** Yes No N/A**Electrode to specification:** Yes No N/A**Weld Procedures Followed:** Yes No N/A**Qualified Welders:** Yes No N/A**Verified Joint Fit-up:** Yes No N/A**Approved Drawings:** Yes No N/A**Approved WPS:** Yes No N/A**Delayed / Cancelled:** Yes No N/A**Bridge No:** 34-0006**Component:** Tower Chimney Parapet**Summary of Items Observed:**

CCO: 196 - Description: Construct parapet walls at the Tower Heads

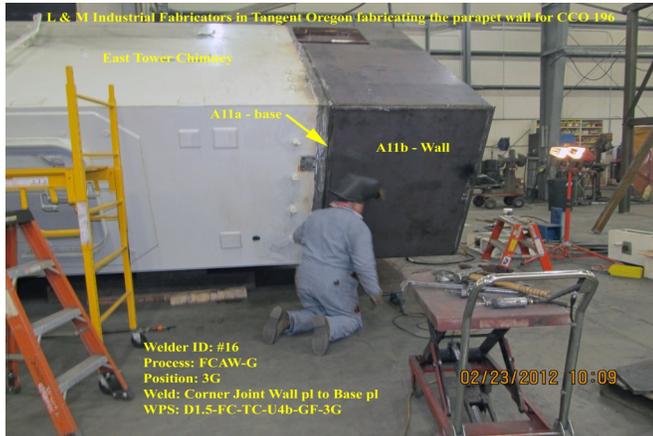
This QA Inspector randomly observed L & M welder Bradford Schroyer (Welder ID #16) performing the complete-joint-penetration (CJP) corner-joint groove weld operation per the Flux Cored Arc Welding (FCAW-G) gas shielding process in the (3G) vertical position connecting wall plate- (A11b) to base plate- (A11a) of the East Tower Head Chimney parapet wall. This QA Inspector observed QC Inspector Tom Dreyer verify prior to the start of the CJP corner-joint groove weld operation, that the minimum preheat temperature as per the approved WPS was established and afterwards; verified that the welding parameters (Amps, Volts and Travel Speed) were in accordance with WPS-D1.5-FC-TC-U4b-GF-3G using Hobart Excel Arc E71T-1 (.052") diameter electrode. The welding operation was still in-process at this location and the workmanship on this date appeared to be in general compliance with the contract specifications.

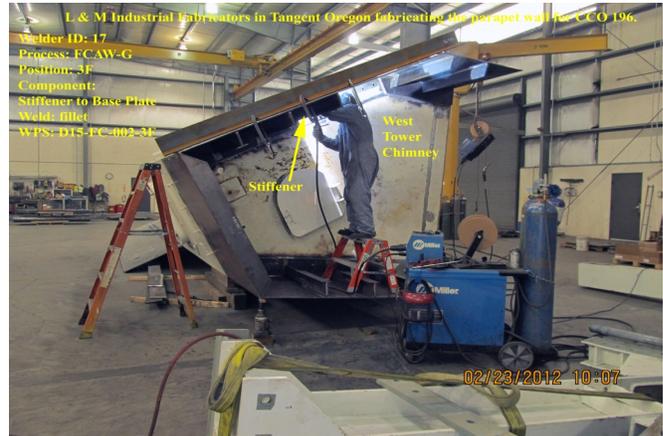
This QA Inspector randomly observed L & M welder Jake Schuld (Welder ID #17) performing the fillet weld operation per the Flux Cored Arc Welding (FCAW-G) gas shielding process in the (3F) vertical position connecting stiffener plates- (A12e), (A12f), and (A12g) to base plate- (A12a) of the West Tower Head Chimney parapet wall. This QA Inspector observed QC Inspector Tom Dreyer verify prior to the start of the fillet weld operation, that the minimum preheat temperature as per the approved WPS was established and afterwards; verified that the welding parameters (Amps, Volts and Travel Speed) were in accordance with WPS-D1. 5-FC-002-3F using Hobart Excel Arc E71T-1 (.052") diameter electrode. The welding operation was completed at this location and the workmanship appeared to be in general compliance with the contract specifications.
