Contract #: 04-0120F4Cty: SF/ALA Rte: 80 PM: 13.2/13.9File #: 1.28**WELDING INSPECTION REPORT****Resident Engineer:** Casey, William**Address:** 333 Burma Road**City:** Oakland, CA 94607**Report No:** WIR-027243**Date Inspected:** 25-Feb-2012**Project Name:** SAS Superstructure**OSM Arrival Time:** 700**Prime Contractor:** American Bridge/Fluor Enterprises, a JV**OSM Departure Time:** 1530**Contractor:** American Bridge/Fluor Enterprises, a JV**Location:** Job Site**CWI Name:** Steve Jensen**CWI Present:** Yes No**Inspected CWI report:** Yes No N/A**Rod Oven in Use:** Yes No N/A**Electrode to specification:** Yes No N/A**Weld Procedures Followed:** Yes No N/A**Qualified Welders:** Yes No N/A**Verified Joint Fit-up:** Yes No N/A**Approved Drawings:** Yes No N/A**Approved WPS:** Yes No N/A**Delayed / Cancelled:** Yes No N/A**Bridge No:** 34-0006**Component:** SAS Tower**Summary of Items Observed:**

WELDING INSPECTION REPORT

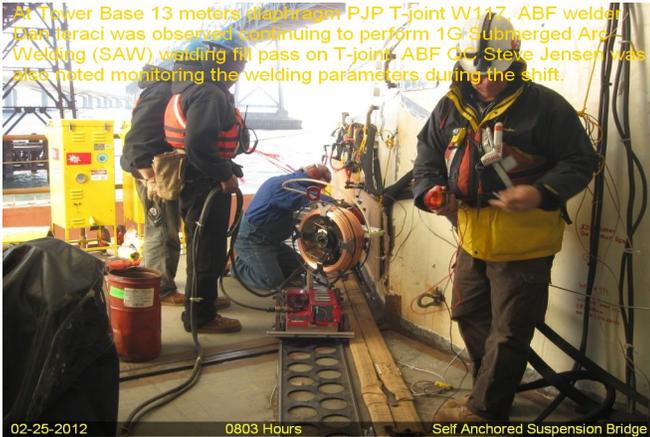
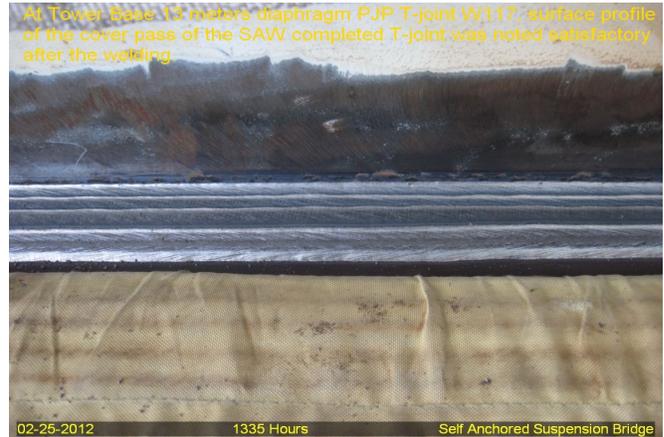
At Tower Base 13 meters diaphragm, weld joint number W117, QA randomly observed ABF certified welder James Zhen ID #6001 and Dan Ieraci ID #3232 continuing to perform 1G (flat position) Submerged Arc Welding (SAW) on the Partial Joint Penetration (PJP) T- joint between the 45mm thick outer East diaphragm and 45mm thick Tower East Shaft skin plate 'B'. The welders were utilizing F7A6-EM12K-H8, 3.2mm electrode with corresponding Esab OK Flux 10.62 flux and implementing Caltrans approved Welding Procedure Specification (WPS) ABF-WPS-D15-4062-1. The joint being welded has a 45 degree bevel groove T- joint with an average root opening of 3.0mm and C-channel installed underneath that will serve as the backing bar. The plates were preheated to more than 225 °F using Miller Proheat 35 Induction Heating System with one heater blanket located on top of each plate prior welding and moving it to the side and lifting the other during welding. ABF/QC Steve Jensen was noted monitoring the welding parameters of the welder with measured working current of 560 amperes, 31.5 volts with travel speed of 375 mm per minute and calculated heat input of 2.8 Kjoules/mm. QA noted the welding parameters, the workmanship and appearance of the completed fill deemed satisfactory. At the end of the shift, SAW cover pass welding was completed. The preheat of more than 225 degrees Fahrenheit was held for three more hours after welding as required.

After the completion of the PJP T-joint at W117, ABF personnel were noted moving their track mounted wire feeder and so with other SAW accessories in preparation for the SAW welding of another PJP T-joint W118.
