DEPARTMENT OF TRANSPORTATION

Contract #: 04-0120F4Cty: SF/ALA Rte: 80 PM: 13.2/13.9File #: 99.28**WELDING INSPECTION REPORT****Resident Engineer:** Casey, William**Address:** 333 Burma Road**City:** Oakland, CA 94607**Report No:** WIR-027253**Date Inspected:** 29-Feb-2012**Project Name:** SAS Superstructure**OSM Arrival Time:** 700**Prime Contractor:** American Bridge/Fluor Enterprises, a JV**OSM Departure Time:** 1530**Contractor:** L & M Industrial Fabrication**Location:** Tangent, Oregon**CWI Name:** Tom Dreyer**CWI Present:** Yes No**Inspected CWI report:** Yes No N/A**Rod Oven in Use:** Yes No N/A**Electrode to specification:** Yes No N/A**Weld Procedures Followed:** Yes No N/A**Qualified Welders:** Yes No N/A**Verified Joint Fit-up:** Yes No N/A**Approved Drawings:** Yes No N/A**Approved WPS:** Yes No N/A**Delayed / Cancelled:** Yes No N/A**Bridge No:** 34-0006**Component:** Tower Chimney Parapet**Summary of Items Observed:**

CCO: 196 - Description: Construct parapet walls at the Tower Heads

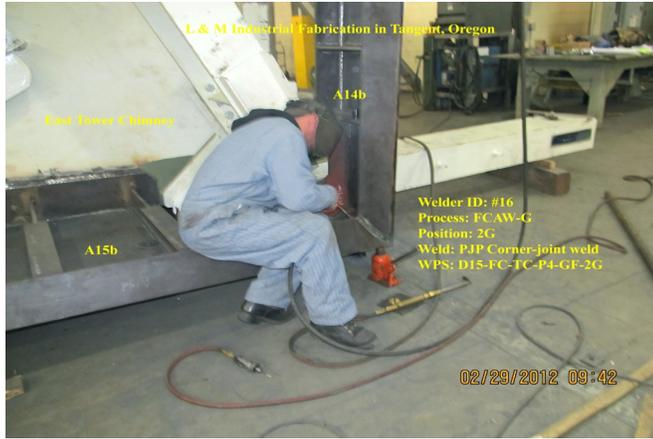
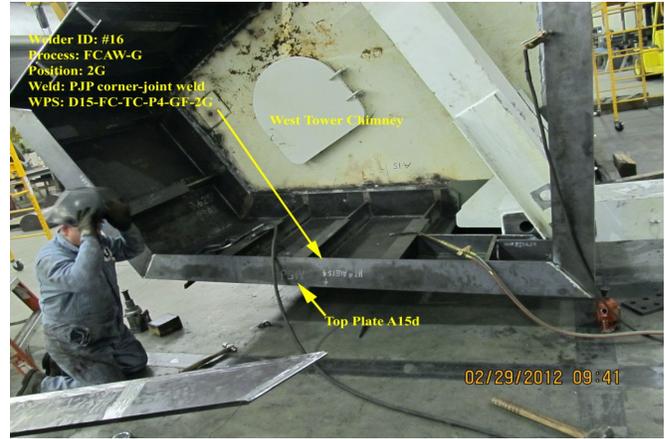
This QA Inspector randomly observed L & M welder Bradford Schroyer (Welder ID #16) performing the partial-joint-penetration (PJP) corner-joint groove weld operation per the Flux Cored Arc Welding (FCAW-G) gas shielding process in the (2G) horizontal position connecting wall plate- (A15b) to top plate- (A15d) on the West Tower Chimney parapet wall. This QA Inspector observed QC Inspector Tom Dreyer verify prior to the start of the PJP corner-joint groove weld operation, that the minimum preheat temperature as per the approved WPS was established and afterwards; verified that the welding parameters (Amps, Volts and Travel Speed) were in accordance with WPS-D1.5-FC-TC-P4-GF-2G using Hobart Excel Arc E71T-1 (.052") diameter electrode.

The welding operation was completed at this location and the workmanship on this date appeared to be in general compliance with the contract specifications.

This QA Inspector randomly observed L & M welder Jake Schuld (Welder ID #17) performing the partial-joint-penetration (PJP) corner-joint groove weld operation per the Flux Cored Arc Welding (FCAW-G) gas shielding process in the (2G) horizontal position connecting wall plate- (A15b) to top plate- (A15d) of the East Tower Chimney parapet wall. This QA Inspector observed QC Inspector Tom Dreyer verify prior to the start of the PJP corner-joint groove weld operation, that the minimum preheat temperature as per the approved WPS was established and afterwards; verified that the welding parameters (Amps, Volts and Travel Speed) were in accordance with WPS-D1.5-FC-TC-P4-GF-2G using Hobart Excel Arc E71T-1 (.052") diameter electrode.

This QA Inspector randomly observed L & M welder Jake Schuld (Welder ID #17) performing the partial-joint-penetration (PJP) corner-joint groove weld operation per the Flux Cored Arc Welding (FCAW-G) gas shielding process in the (2G) horizontal position connecting wall plate- (A14b) to wall plate- (A15b) of the East Tower Chimney parapet wall. This QA Inspector observed QC Inspector Tom Dreyer verify prior to the start of the PJP corner-joint groove weld operation, that the minimum preheat temperature as per the approved WPS was established and afterwards; verified that the welding parameters (Amps, Volts and Travel Speed) were in accordance with WPS-D1.5-FC-TC-P4-GF-2G using Hobart Excel Arc E71T-1 (.052") diameter electrode.

The welding operation on the internal side only was completed at this location and the workmanship on this date appeared to be in general compliance with the contract specifications.
