**DEPARTMENT OF TRANSPORTATION**

Contract #: 04-0120F4Cty: SF/ALA Rte: 80 PM: 13.2/13.9File #: 1.28**WELDING INSPECTION REPORT****Resident Engineer:** Casey, William**Address:** 333 Burma Road**City:** Oakland, CA 94607**Report No:** WIR-027285**Date Inspected:** 06-Mar-2012**Project Name:** SAS Superstructure**OSM Arrival Time:** 700**Prime Contractor:** American Bridge/Fluor Enterprises, a JV**OSM Departure Time:** 1730**Contractor:** American Bridge/Fluor Enterprises, a JV**Location:** Job Site

# WELDING INSPECTION REPORT

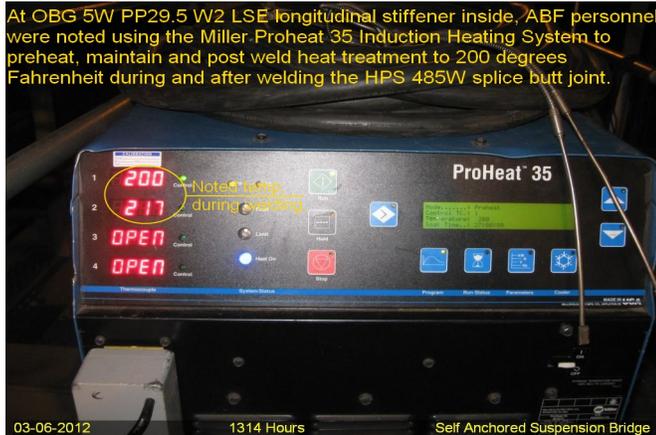
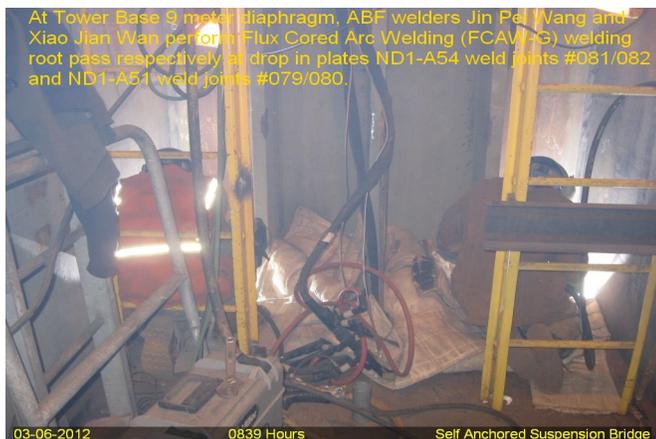
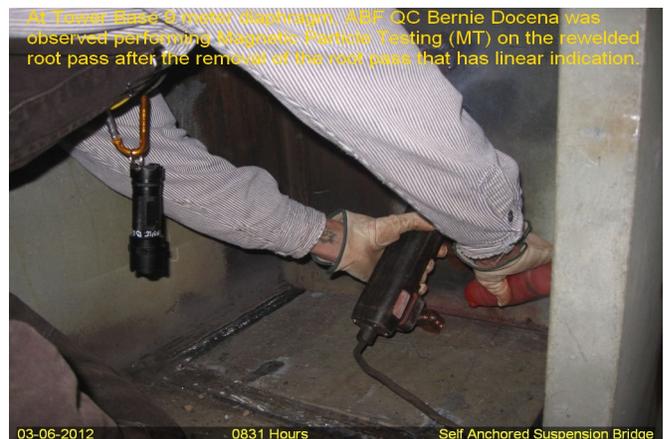
At OBG 5W PP29.5 W2 LS-W longitudinal stiffener inside, QA randomly observed ABF welder Xiao Todd Jackson perform 3G (vertical) Shielded Metal Arc Welding (SMAW) complete joint penetration (CJP) welding root pass to fill pass on the stiffener splice butt joint. The stiffener plates being welded are made of high strength plate material HPS 485W and has a thickness of 30mm. The joint has a double V joint preparation that is being welded from one side and after the completion from one side to be back gouged. Prior welding, the fit up was inspected and accepted by ABF QC Steve Jensen. QA also verified the root gap of less than 5mm and alignment of less than 2mm which deemed acceptable to the contract requirements. The welder was noted using E9018H4R with 1/8" diameter electrode implementing Caltrans approved welding procedure specification (WPS) ABF-WPS-D1.5-1012-3. The splice joint was preheated to greater than 200 degrees Fahrenheit using Miller Proheat 35 Induction Heating System heater blanket located at the opposite side of the plate prior/during welding. The QA Inspector noted the ABF QC Steve Jensen was on site monitoring the in process preheats and welding parameters. During the shift, QA noted ABF QC was closely monitoring the issuance of E9018H4R electrodes due to its limited exposure time allowed. At the end of the shift, fill pass welding was still continuing and should remain tomorrow. The welder held the preheat of 200°F for three more hours after welding for the post weld heat treatment as required.

Collins perform 3G (vertical) Shielded Metal Arc Welding (SMAW) complete joint penetration (CJP) welding root pass to fill pass on the stiffener splice butt joint. The stiffener plates being welded are made of high strength plate material HPS 485W and has a thickness of 30mm. The joint has a double V joint preparation that is being welded from one side and after the completion from one side to be back gouged. Prior welding, the fit up was inspected and accepted by ABF QC Steve Jensen. QA also verified the root gap of less than 5mm and alignment of less than 2mm which deemed acceptable to the contract requirements. The welder was noted using E9018H4R with 1/8" diameter electrode implementing Caltrans approved welding procedure specification (WPS) ABF-WPS-D1.5-1012-3. The splice joint was preheated to greater than 200 degrees Fahrenheit using Miller Proheat 35 Induction Heating System heater blanket located at the opposite side of the plate prior/during welding. The QA Inspector noted the ABF QC Steve Jensen was on site monitoring the in process preheats and welding parameters. During the shift, QA noted ABF QC was closely monitoring the issuance of E9018H4R electrodes due to its limited exposure time allowed. At the end of the shift, fill pass welding was still continuing and should remain tomorrow. The welder held the preheat of 200°F for three more hours after welding for the post weld heat treatment as required.

1. Inner East external diaphragm drop in plate WD1-A59 weld joint #071-3, ABF welder Wai Kitlai was observed performing root repair per Caltrans approved Weld Repair Report (WRR) 201203-001 dated March 2, 2012. Prior welding, the 530mm long linear indication was ground removed and tested by ABF QC Bernie Docena using Magnetic Particle Testing (MT). There was no relevant indication noted during the test. This QA also performed MT on the same welded root removal and noted same result. The welder preheated the plates to more than 150 degrees Fahrenheit and performed the root pass repair welding using Shielded Metal Arc Welding (SMAW) with 1/8" diameter E7018H4R electrode implementing Caltrans approved ABF-WPS-D15-1001 Repair. The root pass was completed and MT tested by ABF QC Bernie Docena. The root pass MT was verified by this QA. The plates were preheated to more than 225 degrees Fahrenheit using propylene gas torch and the welder continued welding the fill pass to cover pass utilizing a dual shield Flux Cored Arc Welding (FCAW-G) with E71T-1M, 1/16" diameter wire electrode and implementing Caltrans approved Welding Procedure Specification (WPS) ABF-WPS-D15-3160-1. At the end of the shift, the root pass repair and the subsequent fill and cover passes were completed on this particular joint. The welder held the preheat of 225°F for three more hours after welding for the post weld heat treatment as required.

2. South external diaphragm drop in plate ND1-A51 weld joints #079 (1 & 2) and #080 (1), ABF welder Xiao Jian Wan was observed continuing to perform fill passes to cover passes welding on the PJP T-joint between the 45mm drop in plate to shear/tower skin plate T-joints. The welder was noted welding at 1G (flat) position utilizing a dual shield Flux Cored Arc Welding (FCAW-G) with E71T-1M, 1/16" diameter wire electrode and implementing Caltrans approved Welding Procedure Specification (WPS) ABF-WPS-D15-3160-1. During the shift, FCAW-G cover pass welding was completed on joints mentioned above and the welder has held the same preheat of more than 225°F for three hours after welding as required.

3. South external diaphragm drop in plate ND1-A54 weld joints #081 (1 & 2) and #082 (1), ABF welder Jin Pei Wang was observed continuing to perform fill passes to cover passes welding on the PJP T-joint between the 45mm drop in plate to shear/tower skin plate T-joints. The welder was noted welding at 1G (flat) position utilizing a dual shield Flux Cored Arc Welding (FCAW-G) with E71T-1M, 1/16" diameter wire electrode and

implementing Caltrans approved Welding Procedure Specification (WPS) ABF-WPS-D15-3160-1. During the shift, FCAW-G cover pass welding was completed on joints mentioned above and the welder has held the same preheat of more than 225°F for three hours after welding as required.
